Report on the investigation
into the flooding and abandonment
of the general cargo ship

Sea Breeze

11.6nm off Lizard Point, Cornwall

9 March 2014

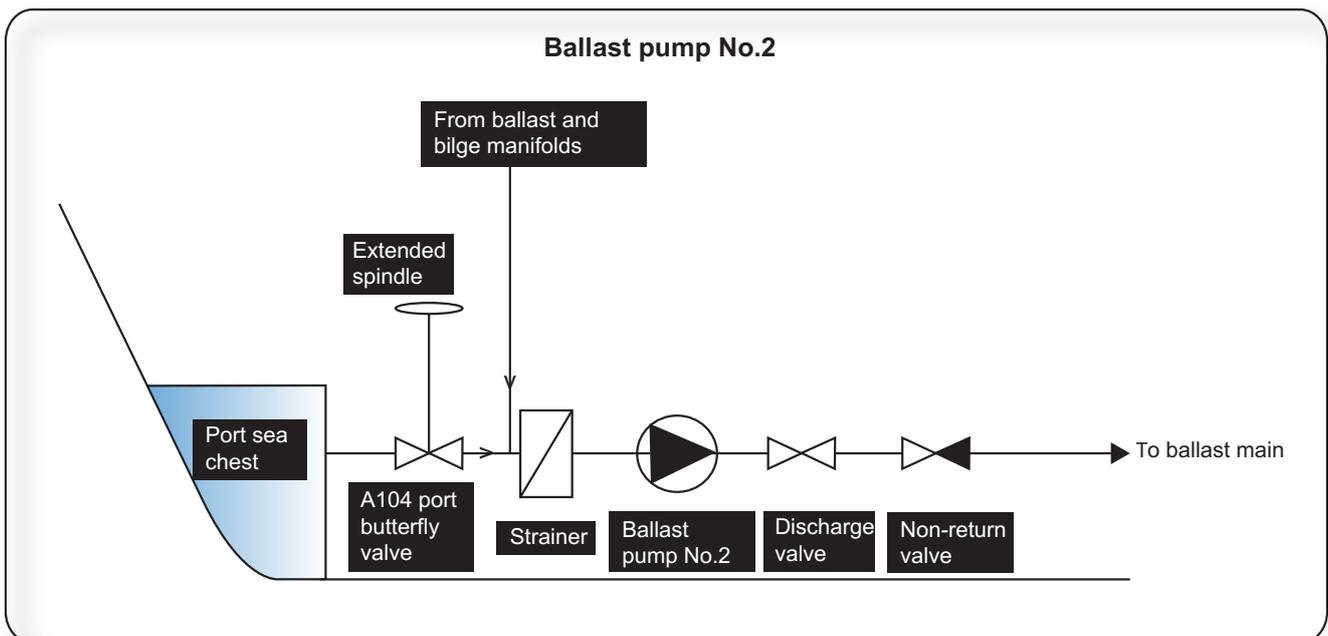
Figure 1: Port ballast system schematic

Having isolated the electrical breaker for the ballast pump, the chief engineer went to isolate the pump from the ballast system and the sea water inlet. This involved closing the bilge and ballast manifold suction valves, the ballast pump's discharge valve and the single isolating butterfly valve between the port sea chest and the port ballast pump, valve A104 port (**Figure 1**). Assisted by the AB the motorman then removed the horizontally mounted electric motor from the ballast pump. He then slackened and removed the pump's suction and discharge flange bolts to enable the pump to be lifted onto the bottom plates so as to facilitate access to the mechanical seal.

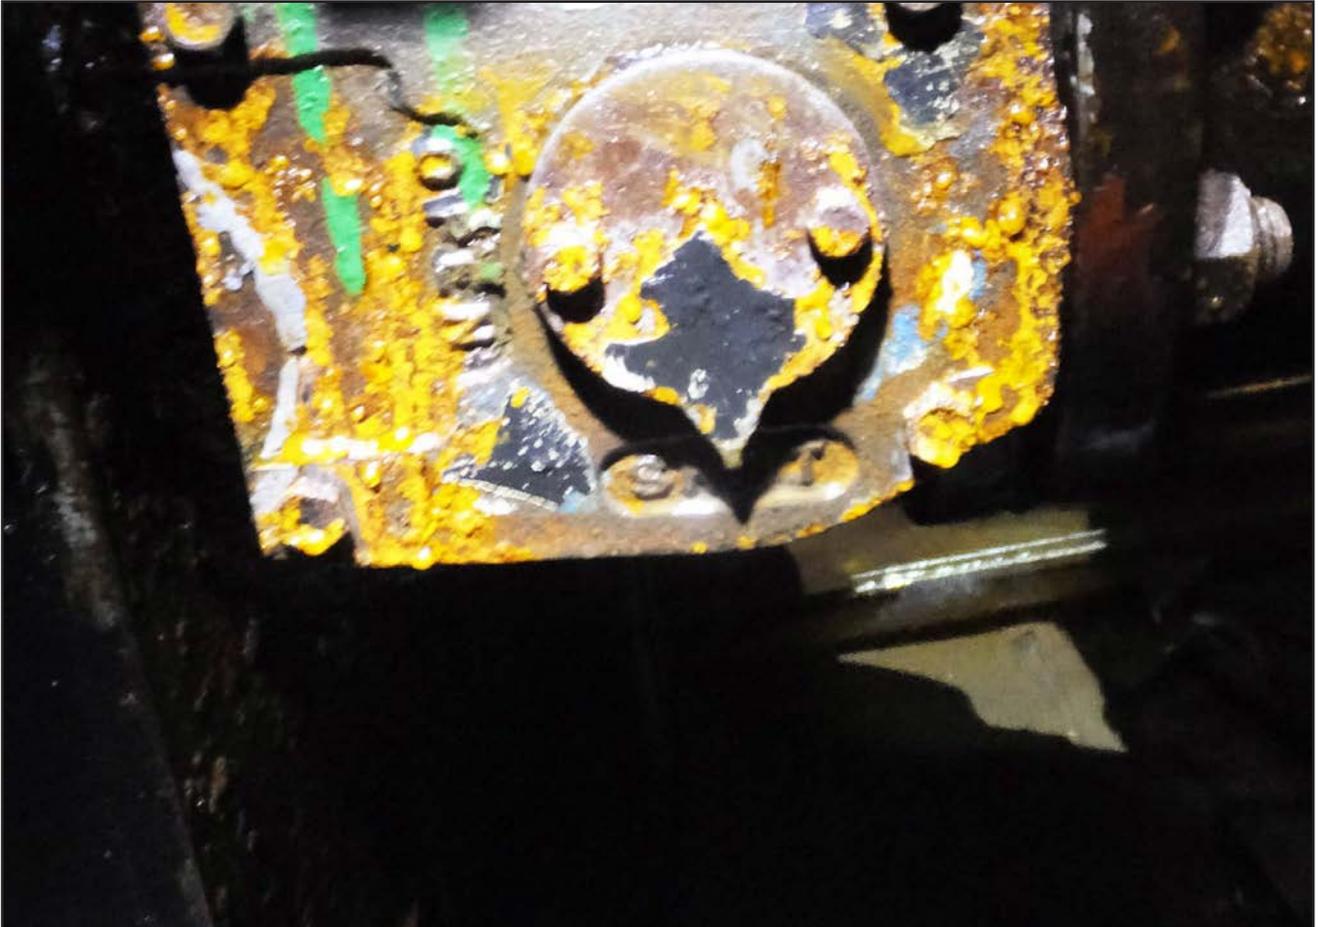
Figure 2: Valve A104 port position indicator

A little water was seen to flow out of the 15cm diameter pipework as the flange bolts were removed, but when the pump was lifted clear of the pipework this became a full bore torrent of water from the pump's suction pipe. Initially the three crew tried to stem this flow of water using rags and wooden chocks, but this action had little effect. None of the crew inspected the position indicator on valve A104 port (**Figure 2**) or made any attempt to confirm that this or any of the other valves were fully closed.

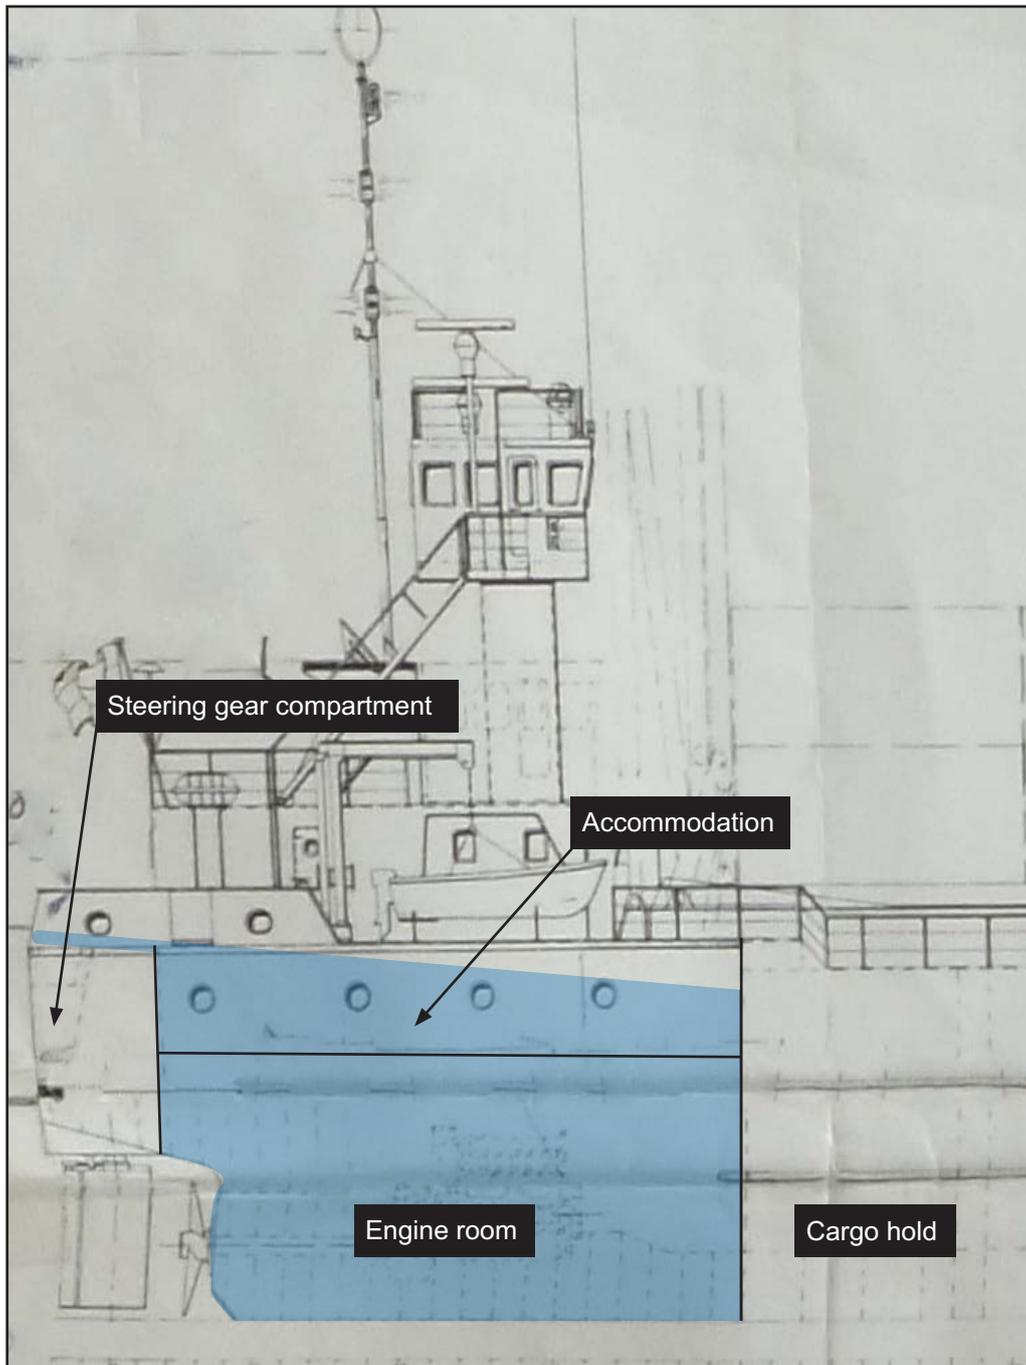
Figure 4: Extent of flooding

At 1545 a line was made fast between the tug *Tennaherdhya* and *Sea Breeze* in order to pull *Sea Breeze* head to wind and so reduce rolling. The tug *Vortex* was then released by the MCA and returned to Falmouth. The salvors carried out an initial assessment of *Sea Breeze*. The emergency generator was not running when they boarded and they discovered that in addition to the engine room now being fully flooded, the lower deck of the vessel's accommodation was partially submerged (Figure 4).

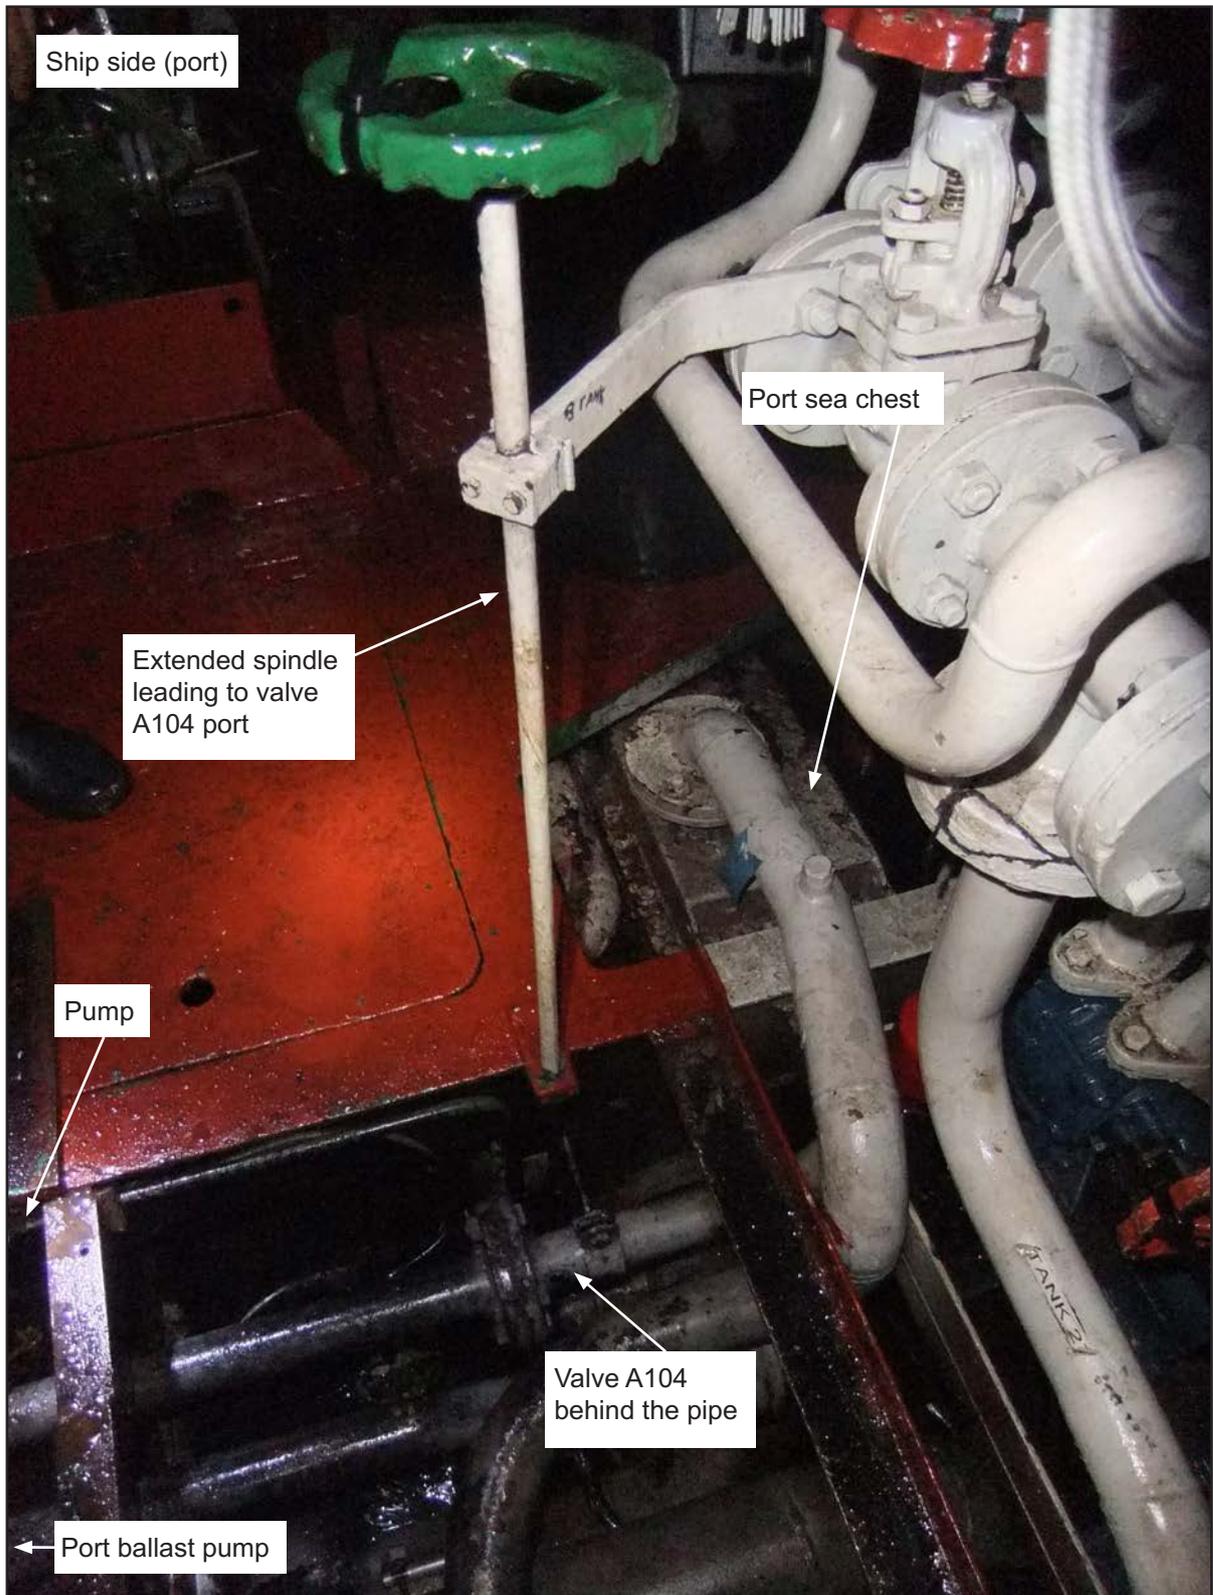
Figure 5: Valve A104 port in situ

When salvage engineers entered the engine room on the morning of 10 March 2014 they found valve A104 port to be open. Although the valve wheel was initially tight, they were able to turn it and close the valve. Subsequent testing of the valve, following its removal from the vessel, showed that the nature of the repair was totally inadequate, and the condition of the worm and quadrant gearing was such that it could jam intermittently. Such jamming caused the hand wheel to become tight, thereby giving the impression that the valve was closed when it was not.

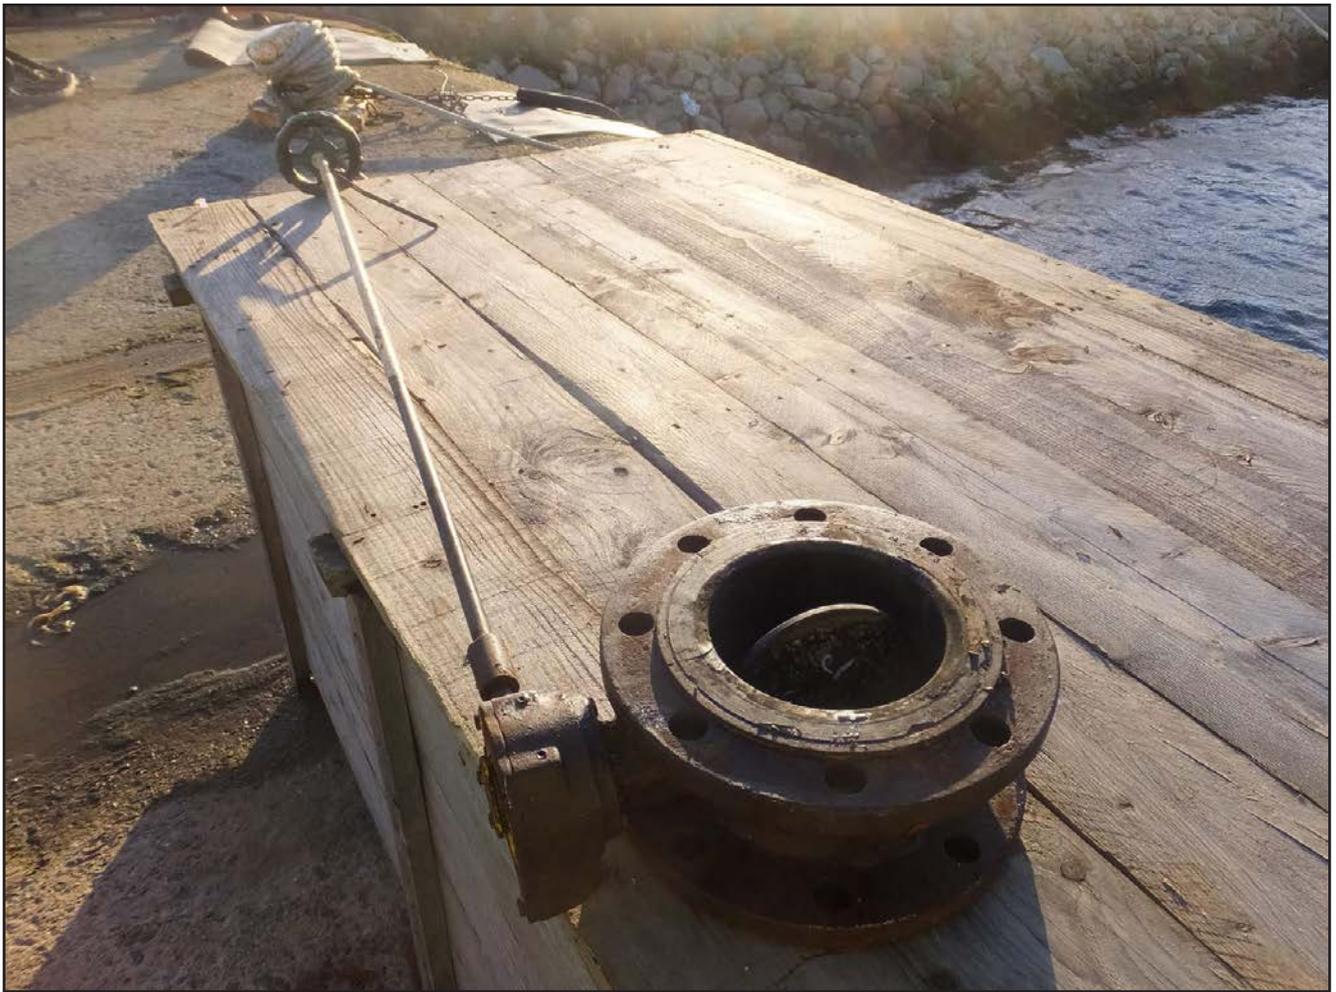
Figure 7: Valve A104 port removed from vessel

- The bent extended spindle and the cracked gearbox casing indicated that excessive load had been applied at some point.
- The quadrant gear and worm wheel had suffered excessive wear and were not fit for use.
- An inappropriate weld repair had been attempted on the quadrant gear teeth. The repair had been poorly executed and was inadequate (**Figure 9**).
- The absence of top hat bearings on the worm wheel allowed it to come into contact with the casing during operation, jamming the actuator gearbox.
- Evidence of corrosion inside the actuator gearbox indicated that it had not been regularly greased.
- The valve was closed and pressure tested, no leakage was detected up to 3.6bar.

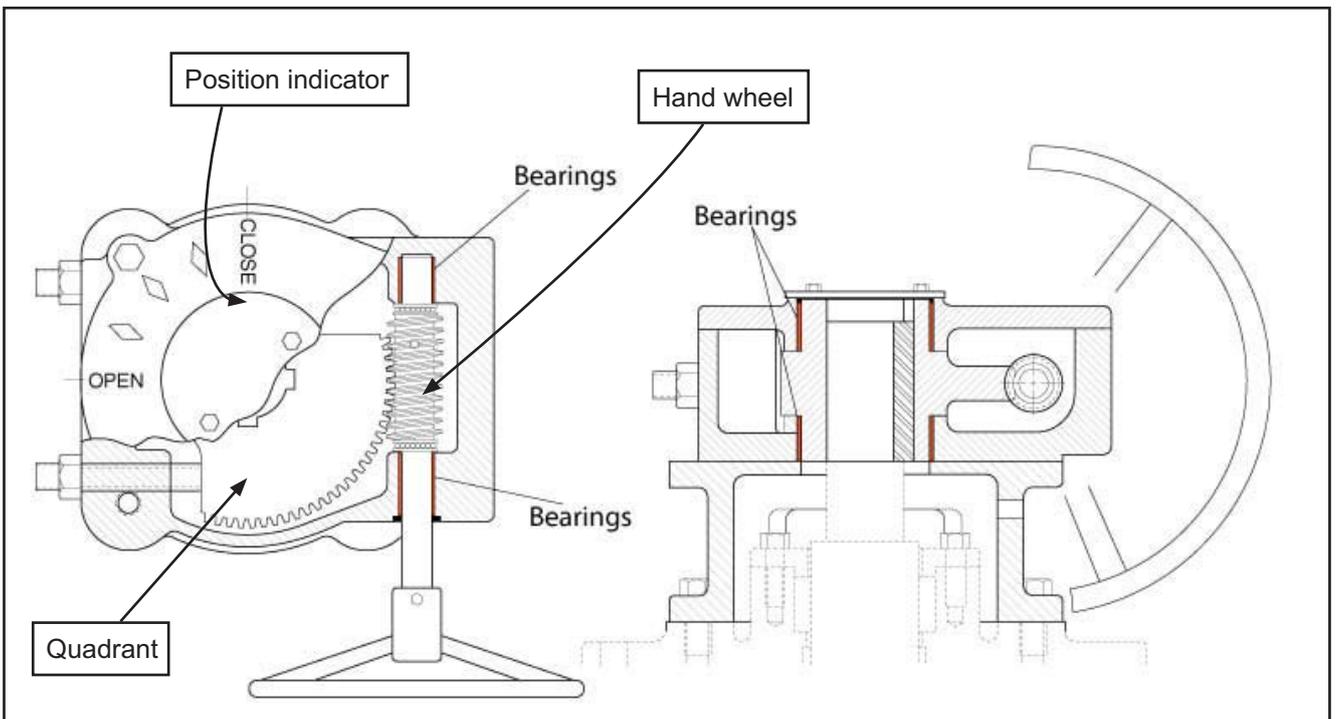
Figure 8: Arrangement of actuator gearbox for valve A104 port

The thrust bushes that should have been present on the valve worm spindle were not present. Either these had been removed and not replaced at some stage during maintenance, or they had simply disintegrated over time.

When operating the hand wheel to shut the valve, the worm wheel jammed after approximately six turns, giving the impression that the valve had been shut, when it had not. With further manipulation of the hand wheel, it was possible to free up the actuator gearbox, eventually enabling the valve to be shut fully. The inconsistent nature of the valve actuator mechanism meant it was not possible to determine the position of the valve without reference to the valve position indicator located on the side of the valve actuator gearbox.

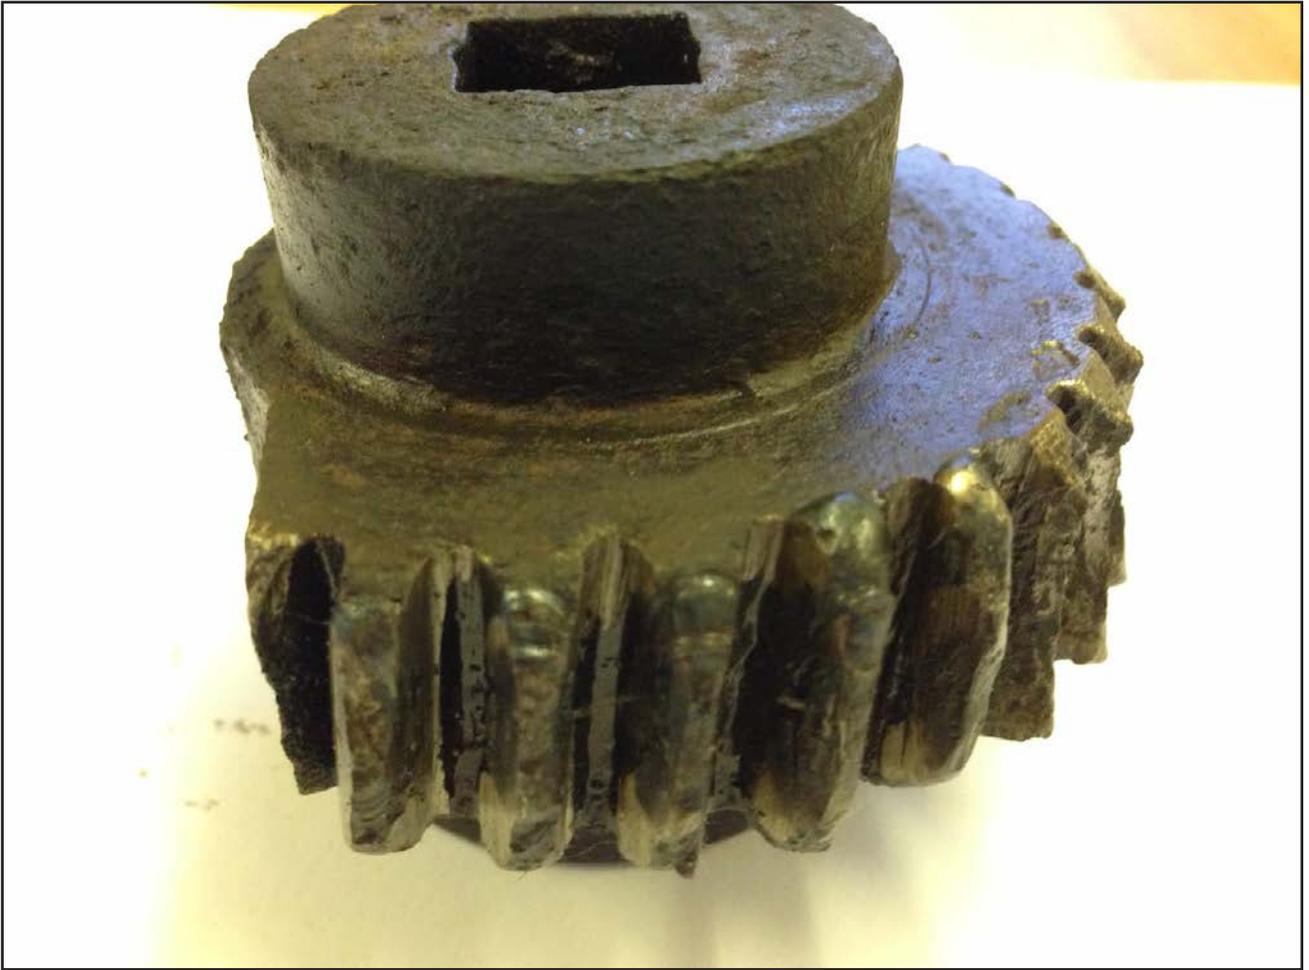
Figure 9: Gearbox quadrant, showing signs of damage and previous repair

It was not possible to establish when or by whom the attempted weld repair to the quadrant gear had been carried out.
