Condition assessment of *Sea Breeze* by Braemar Technical Services for MAIB

Final Report

27 May, 2014

Report on Failure of Butterfly Valve

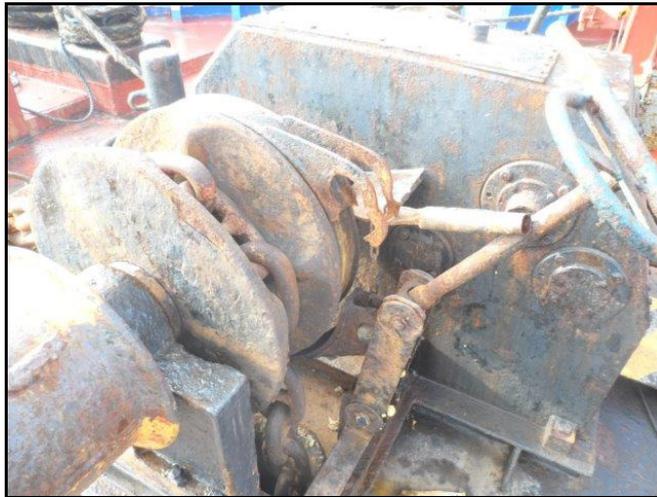
6.1.1 The starboard side anchor windlass machinery brake system was noted damaged beyond use. It is apparent that the cause of the damage is due to insufficient maintenance. The condition as found renders the vessel unseaworthy, and was probably in the same condition as sighted, prior to the casualty.

Figure 1 Starboard windlass brake mechanism, defective.

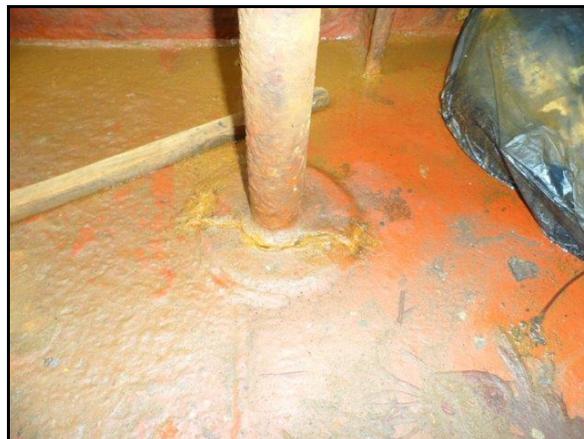
6.1.2 The forward mezzanine deck, immediately aft' of the forward mooring deck was noted to be cracked in way of several ballast tank sounding pipes, thus allowing any water remaining on the deck to enter forward compartments. The condition as found is a contravention of Load-Line regulations and renders the vessel unseaworthy. It is probable that these cracks were present prior to the casualty.

Figure 2 Crack within main watertight deck.

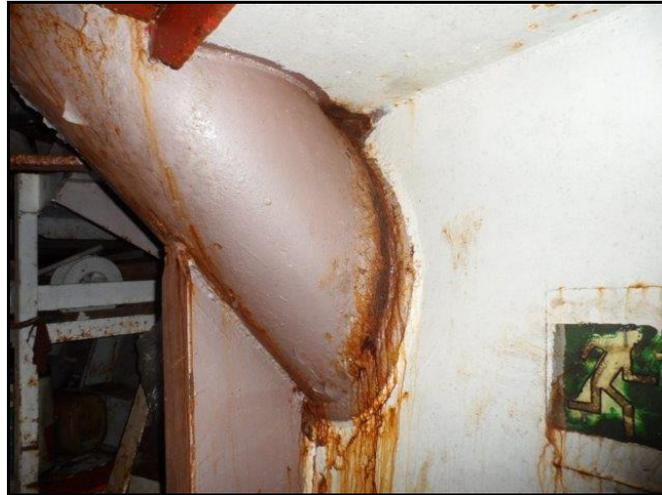
6.1.3 The port side anchor hawse pipe was noted showing indication of corrosion and leakage, although the full extent of the defect could not be positively confirmed during our attendance. Such loss of watertight integrity would render the vessel unseaworthy. It is probable that the condition, as sighted, was present pre-casualty.

Figure 3 Port side anchor hawse pipe, leakage.

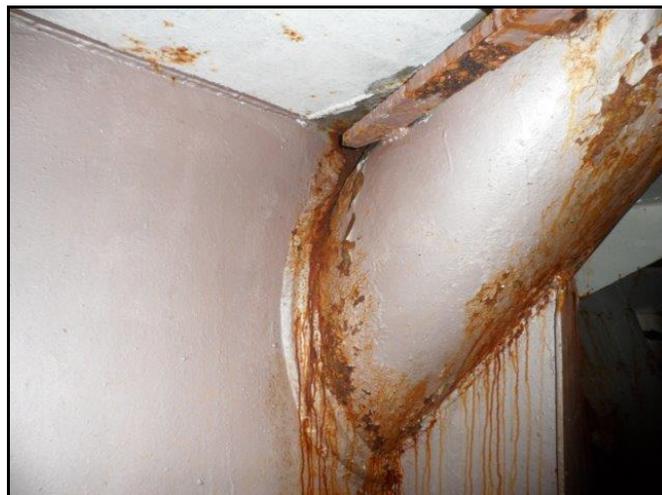
6.1.4 The starboard side anchor hawse pipe was also noted showing indication of corrosion and leakage, although the full extent of the defect could not be positively confirmed during our attendance. Such loss of watertight integrity would render the vessel unseaworthy. It is probable that the condition, as sighted, was present pre-casualty.

Figure 4 Starboard side anchor hawse pipe, leakage.

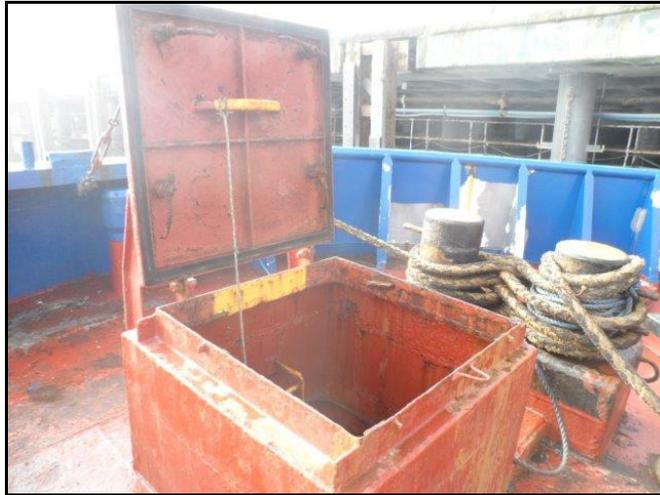
6.1.5 The forward mooring deck access hatch to the space below was noted not to be fitted with rolled edges. The as-fitted edges were partially wasted allowing certain leakage into the space. Such loss of watertight integrity would render the vessel unseaworthy. It is probable that the condition, as sighted was present pre-casualty.

Figure 5 Forward space access hatch, damage lip edge.

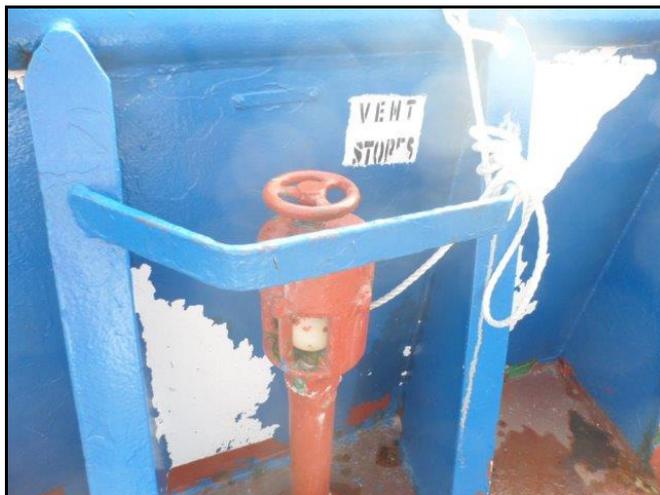
6.1.6 The forward space vent head was noted to have seized open, preventing the vent head from being manually closed. This condition prevents the forward space being made watertight, rendering the vessel unseaworthy. It is probable that the condition, as sighted, was present pre-casualty.

Figure 6 Forward space vent head, seized.

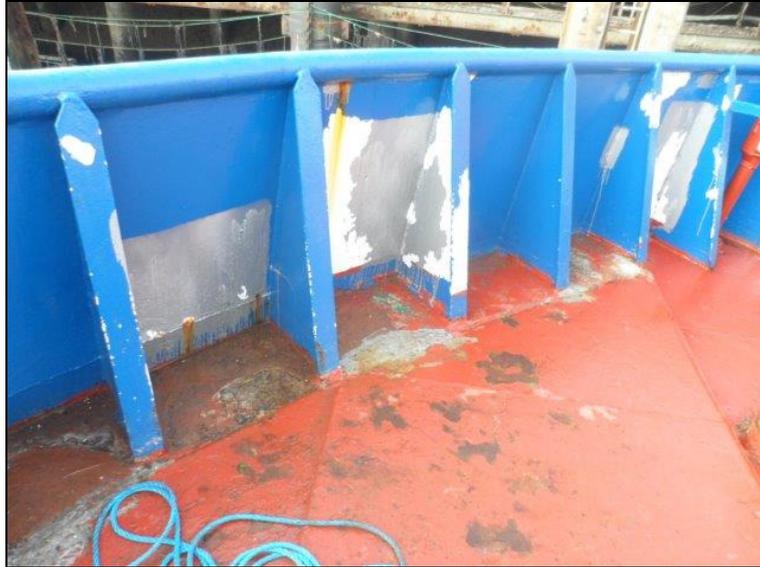
6.1.7 Various areas of cementing patches/ skimming were noted throughout on the forward mooring deck. Such practise generally suggests attempts to mask steel damage and/ or wastage. Precise determination would require removal of such cementing.

Figure 7 Evidence of cementing/ skimming on forward mooring deck.

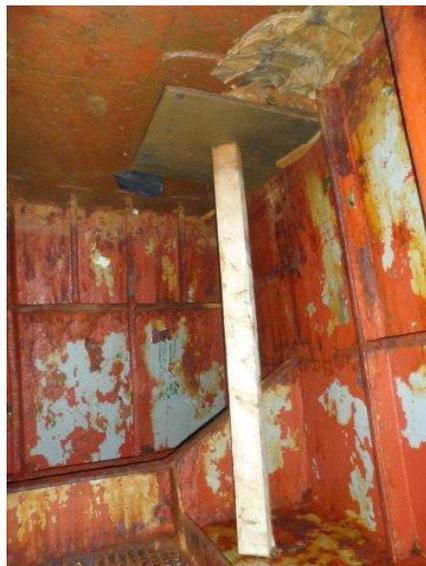
6.1.8 Immediately below the above cementing patch/ skimming, under-deck, a wooden board supported by a prop was noted. This suggests the general practise of skimming over wasted/ penetrating corrosion within the main watertight deck to prevent leakage. This inappropriate repair is not Class approved and prevents the forward space being made watertight rendering the vessel unseaworthy. It is probable that the condition, as sighted, was present pre-casualty.

Figure 8 Supported wooden plate beneath forward mooring deck.

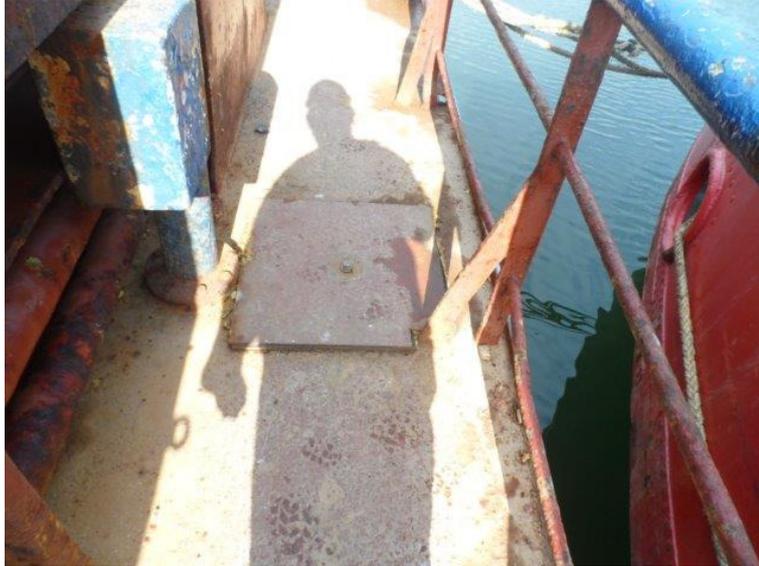
- 6.1.9 Located at the midpoint of the port side main deck, we noted an extraordinary and inappropriate temporary patch repair which is not Class approved. We are unable to confirm the purpose for such but would suggest this exists to mask steel damage/ penetrating wastage with loss of watertight integrity to the space below. In our opinion it makes the vessel unseaworthy and provides further concern to the strength and integrity of the main deck as this localised repair patch may be indicative of more widespread wastage of the deck plating. It is probable that the condition as sighted during the survey was present pre-casualty.

Figure 9 Temporary patch, port side main deck.

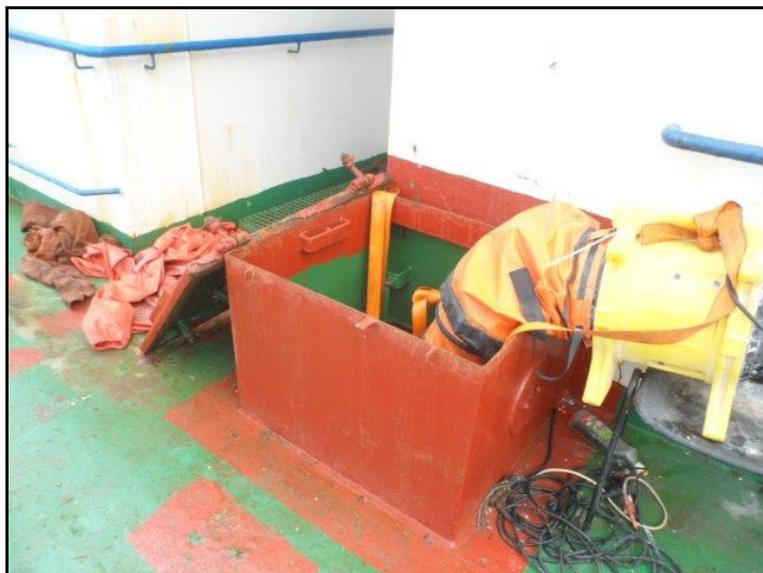
- 6.1.10 It was noted that the aft' mooring deck hatch giving entry to the machinery space had been removed, possibly by Salvors. The poor condition of the hatch lid fixings, hinges and securing dogs, indicates this hatch probably was not correctly attached pre-casualty.

Figure 10 Aft' mooring deck, machinery space hatch.

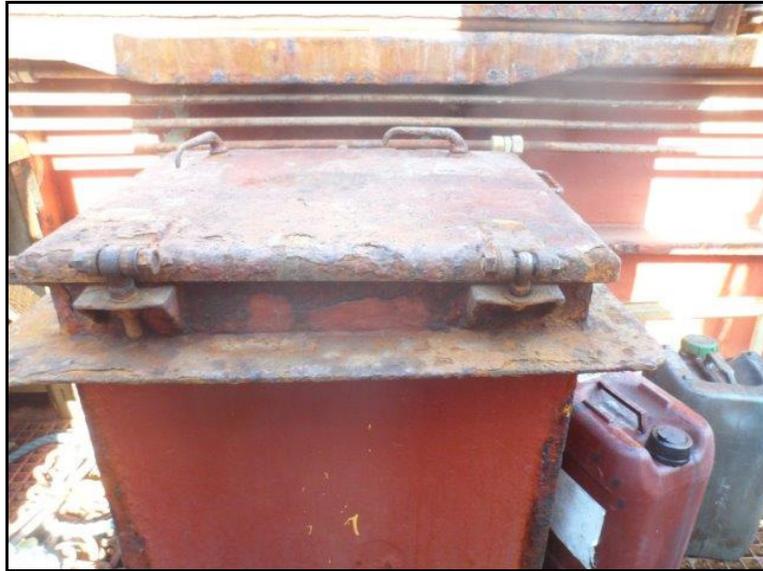
6.1.11 The main cargo space access hatch (aft') was sighted to be in poor condition. The hatch lid fixings, hinges and securing dogs as fitted, did not provide for efficient closing, rendering the hatch not watertight in contravention of Load Line Rules and the vessel subsequently unseaworthy.

Figure 11 Main cargo space access hatch, not watertight.

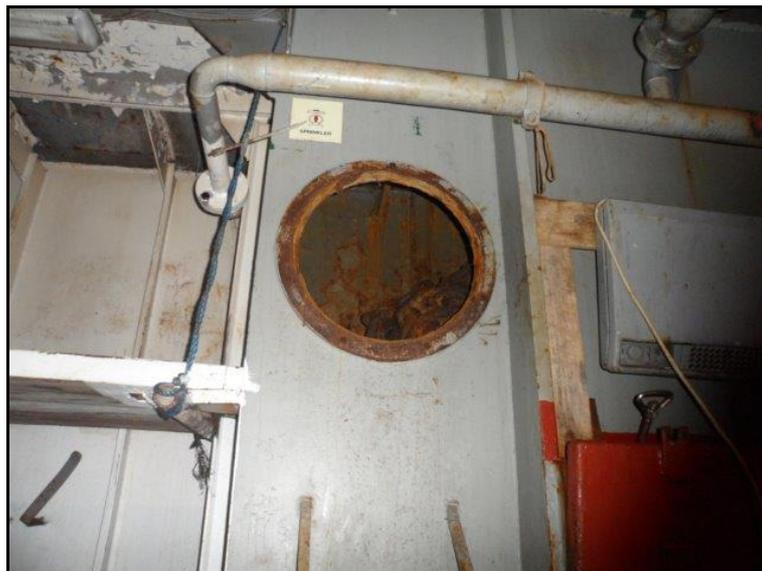
6.1.12 The starboard side chain locker access hatch was sighted as open, although the cover was not immediately available. Speculation exists that the cover was removed by Salvors to provide access to the locker, but this has not been confirmed. In its present condition, this would render the vessel unseaworthy.

Figure 12 Starboard side chain locker, access hatch cover missing.

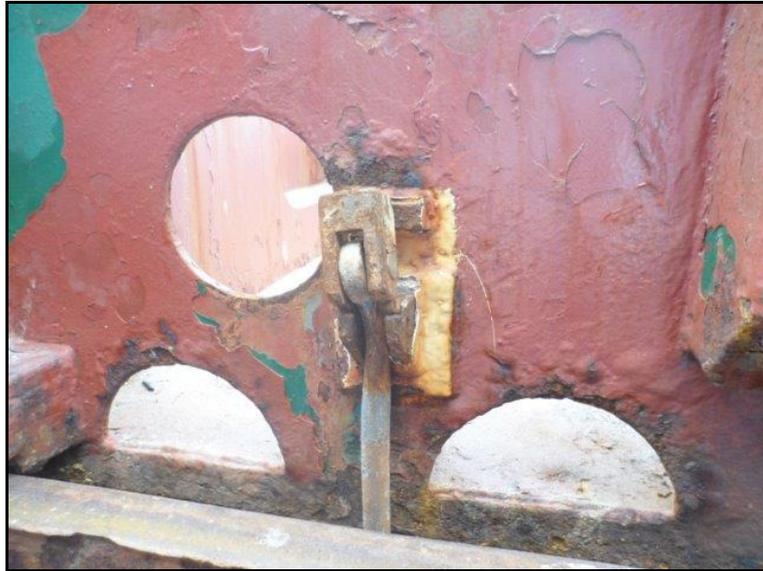
- 6.1.13 A number of hatch cover side cleats were sighted to be defective through buckling or missing entirely, rendering the vessel unseaworthy. We cannot confirm whether these conditions were present pre-casualty but suspect they were, due to their general condition.

Figure 13 Defective hatch cover cleat.

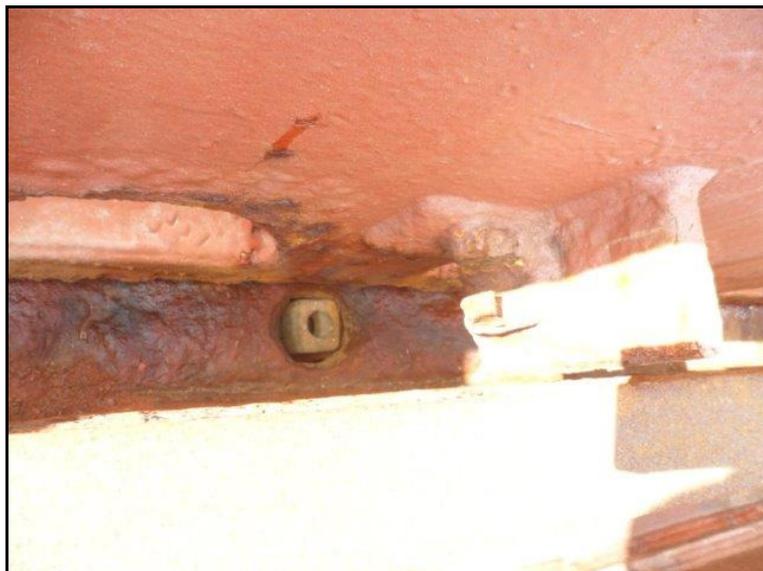
- 6.1.14 Several hatch cover cleats were rendered inoperative due to absent/damaged snugs, rendering the vessel unseaworthy. As remedial repairs to the coatings had apparently been effected around these areas, it is probable these conditions had existed pre-casualty.

Figure 14 Defective hatch cover cleat, missing snug.

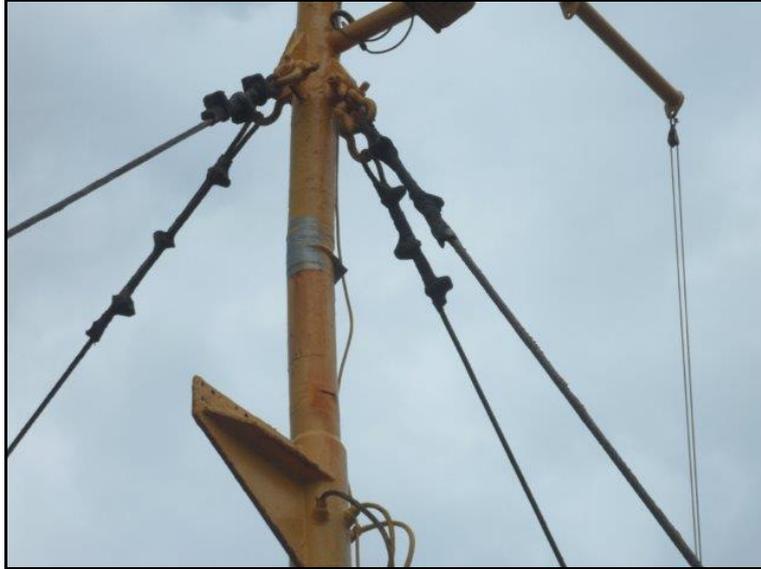
- 6.1.15 The forward mast was observed with minor deflection towards aft'. In way of the immediate area of the bend, we noted an apparent soft patch, most likely "duct tape" or similar, which may have been applied to mask corrosion or a steel perforation and painted. It is probable that this condition existed pre-casualty, and would render the vessel unseaworthy, not only for structural safety but navigation lights would be affected and out of line.

Figure 15 Temporary patch on forward mast.

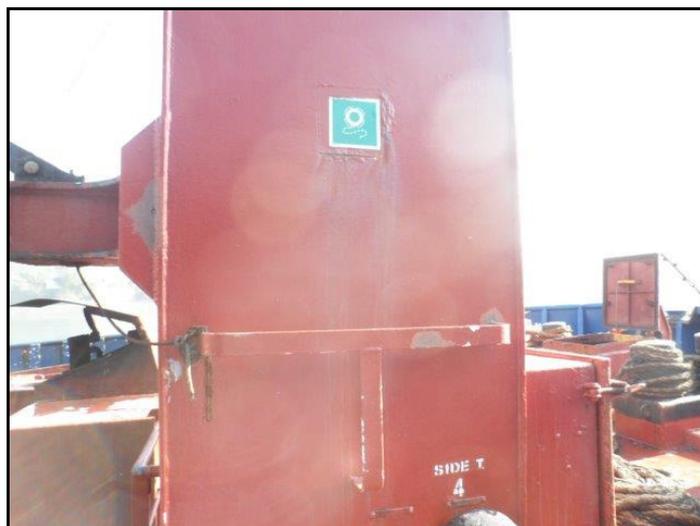
- 6.1.16 The forward deck lifebuoy was notably absent from its stowage position and not apparently available on board. Whilst we cannot confirm this condition existed pre-casualty, it would however contravene SOLAS Regulations and render the vessel unsafe.

Figure 16 Absent lifebuoy.

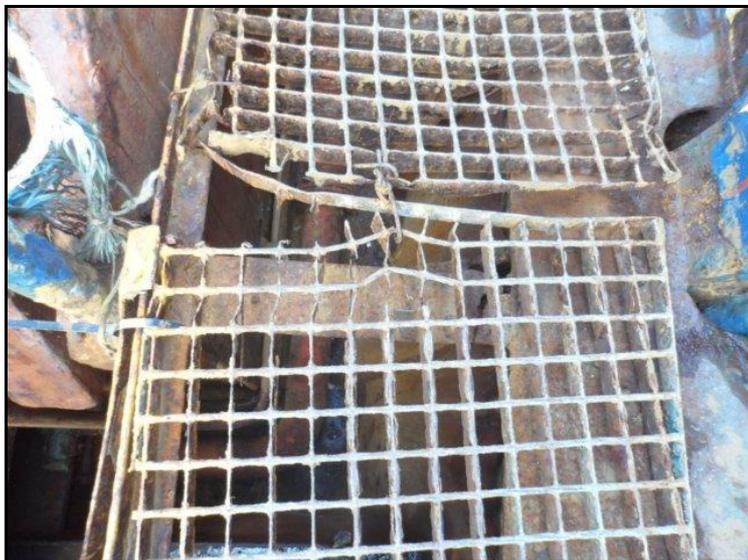
- 6.1.17 A number of raised walkway platforms, particularly those at the forward mooring deck area were noted to be damaged, rendering the vessel unsafe. In view of the nature and extent of damage and corrosion sighted, it is probable the condition existed pre-casualty.

Figure 17 Damaged walkway.

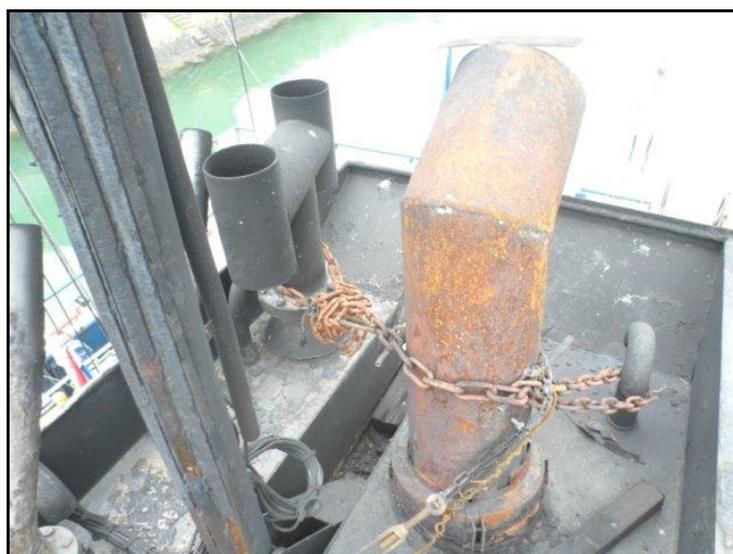
- 6.1.18 The main engine final exhaust section was detached through corrosion and material wastage. In our opinion, this was not a recent defect. The exhaust pipe section had subsequently been temporarily secured using various types of lashing equipment. This was not reported to have been done by Salvors or a third party. Based on the degree of corrosion evident, in our opinion, we would suggest this condition had probably existed pre-casualty.

Figure 18 Main engine final exhaust, detached.

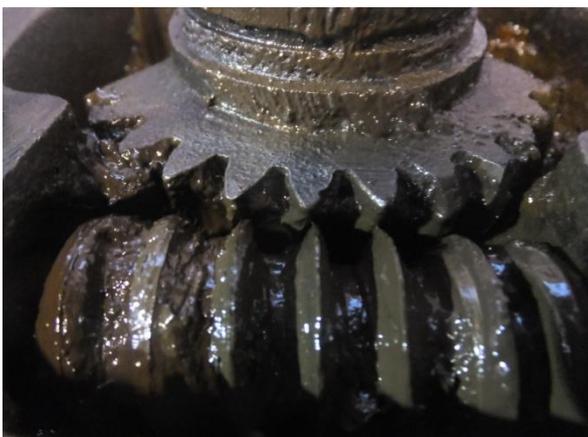
The actuator gear box has been inadequately maintained. It appeared from the photograph in Fig. 4 that grease was present on initial dismantling carried out by others. This would have been sufficient to protect the internals and the spindle from corrosion but since there is evidence of corrosion, it is assumed that the grease had not always been present. The bent spindle and the cracked gearbox housing indicate that excessive load had been applied in actuating the valve at some time in the past.

Fig. 4 MAIB photograph of actuator worm and gear

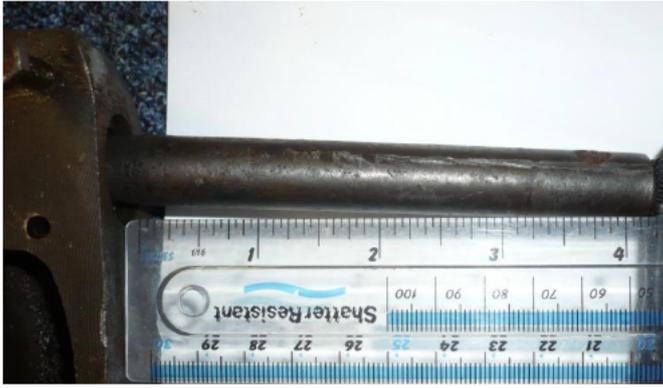
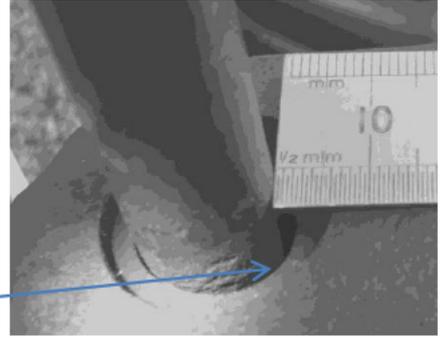
1. As seen in Figs 5 A & B, the spindle extension of the worm was bent out of alignment and was also loose in its bearing as a result of wear and corrosion of approximately 1mm (this has not been measured accurately since this was not required).

Fig. 5A & B.
Bent spindle on left and around 1mm wear and corrosion on spindle in right photograph

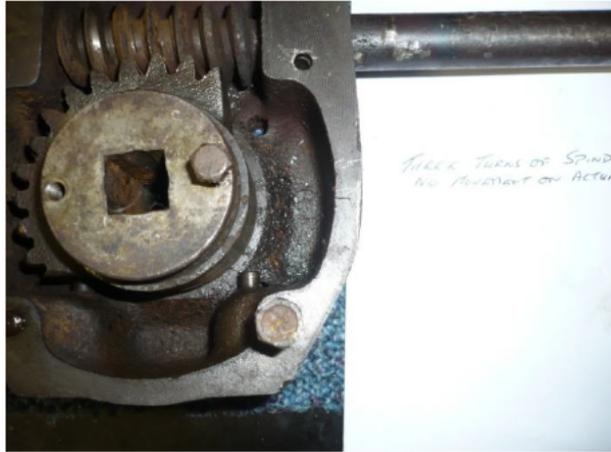
2. Actuation was undertaken by MTL to give an indication of the amount of slackness between the worm and the spindle gear. When fully rotated to the closed position, the spindle could then be turned through three revolutions before the spindle gear moved; this can be seen in Fig. 6. The body of the gearbox has one spacer in the spindle hole whereas from the diagram shown in fig. 15, top hat bushes should have been fitted at either end of the operating spindle worm wheel. The absence of these bearings, coupled with the wear on the spindle gear and worm wheel teeth are responsible for the out of mesh movement between the spindle gears and worm wheel.

Fig. 6. View after spindle had been rotated three revolutions before gear wheel commenced movement.

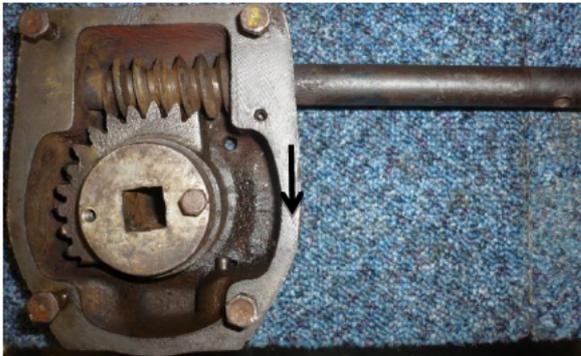
3. Examination showed that the gearbox housing was cracked as seen in Figs 7 & 8
4. The examination of the removed gear showed that many of the teeth had been overlaid with what appears to be a manual metal arc weld deposit presumably in an attempt to correct wear/corrosion which had been present.

Fig. 7 General view of actuator and body, note crack, arrowed

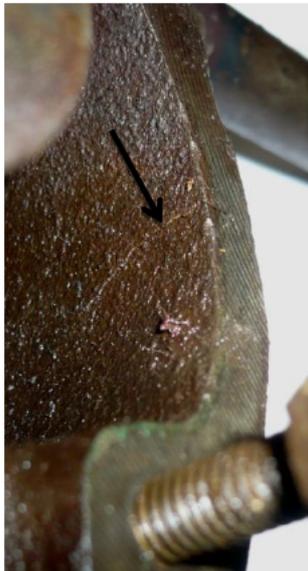
Fig. 8. View of crack in body see Fig 6 for location.

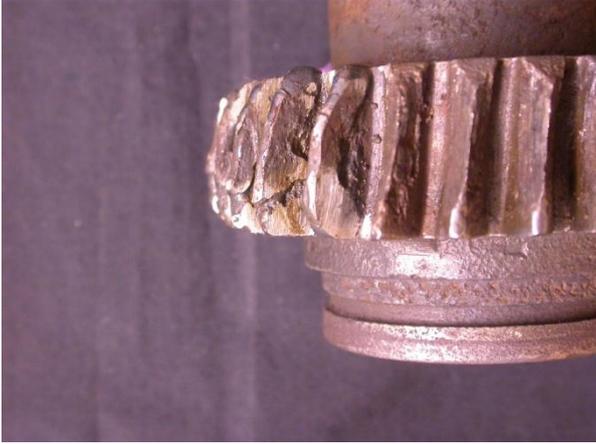
Fig. 9 Damage and weld repair on gear wheel teeth

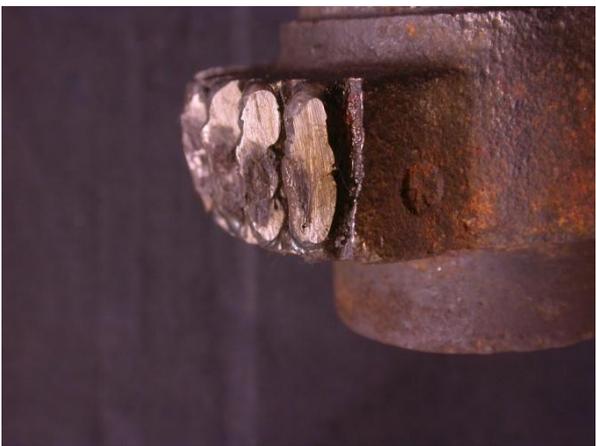
Fig. 10. Weld repair on gear wheel teeth, also note corrosion on body of gear

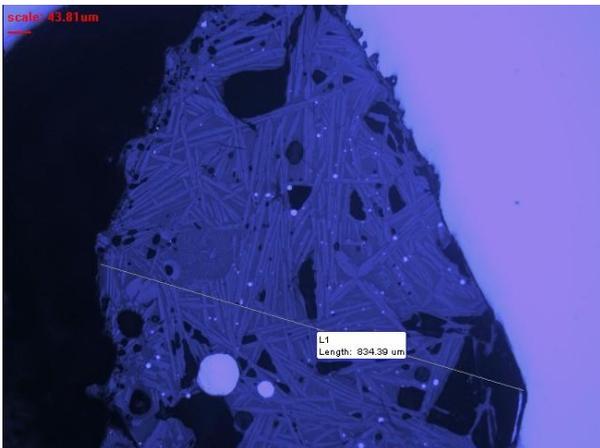
6. The microstructure examined under optical microscopy, revealed that the weld contained, cracks, porosity and slag inclusions, see Figs. 11 & 12.

Fig. 11 Slag inclusion in weld
100x mag.

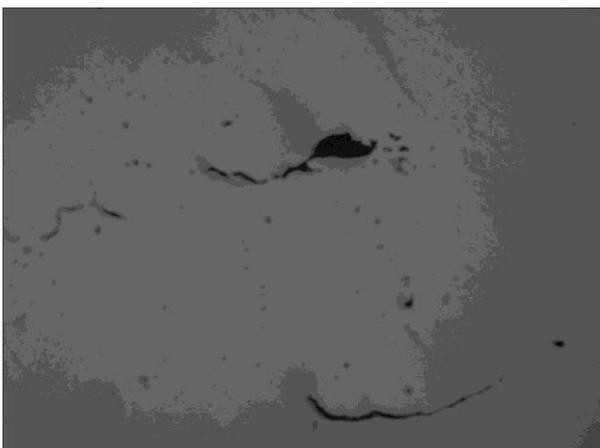
Fig. 12 cracks in weld. 100x magnification

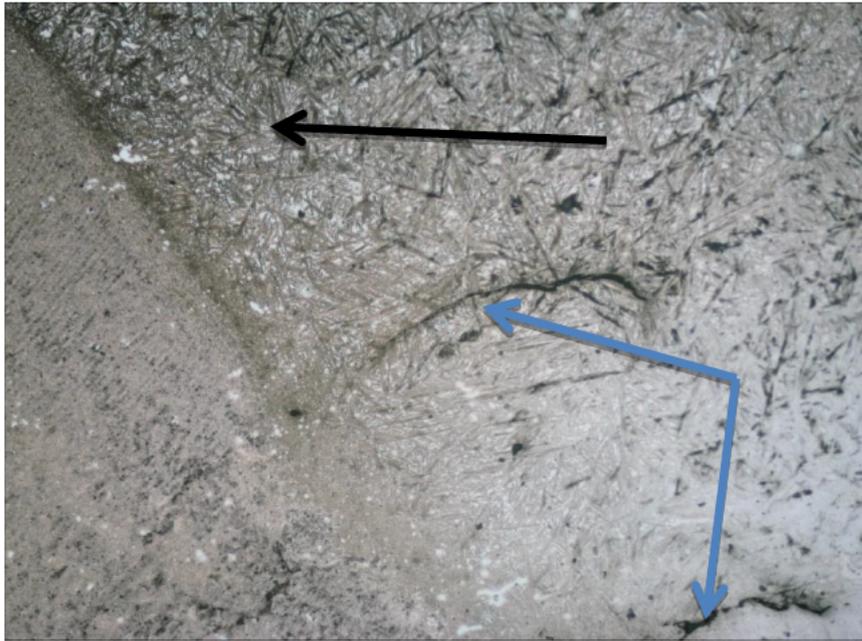
5. In Fig. 14, the microstructure of the gear at the teeth can be seen. This shows that the material of construction is spheroidal graphite cast iron. This material can only be welded with a very careful weld procedure. The procedure adopted was unsuitable for welding of this cast iron which is demonstrated in

Fig. 13 where brittle martensite is present between the weld and the cast iron and cracks are found.

The material of construction of the spindle gear is spheroidal graphite cast iron. Welding on this material can only be performed with a carefully prepared and executed weld procedure. The brittle and cracked martensite seen arrowed black in Fig.13, demonstrates that the procedure adopted was completely inadequate and the welds would ultimately have fractured at the weld interface. It is not possible to determine when the welds were deposited.

Fig. 13.
Microstructure at
weld, parent metal
interface showing
brittle martensite
and cracks, arrowed
blue. Photograph
taken at 100x
magnification

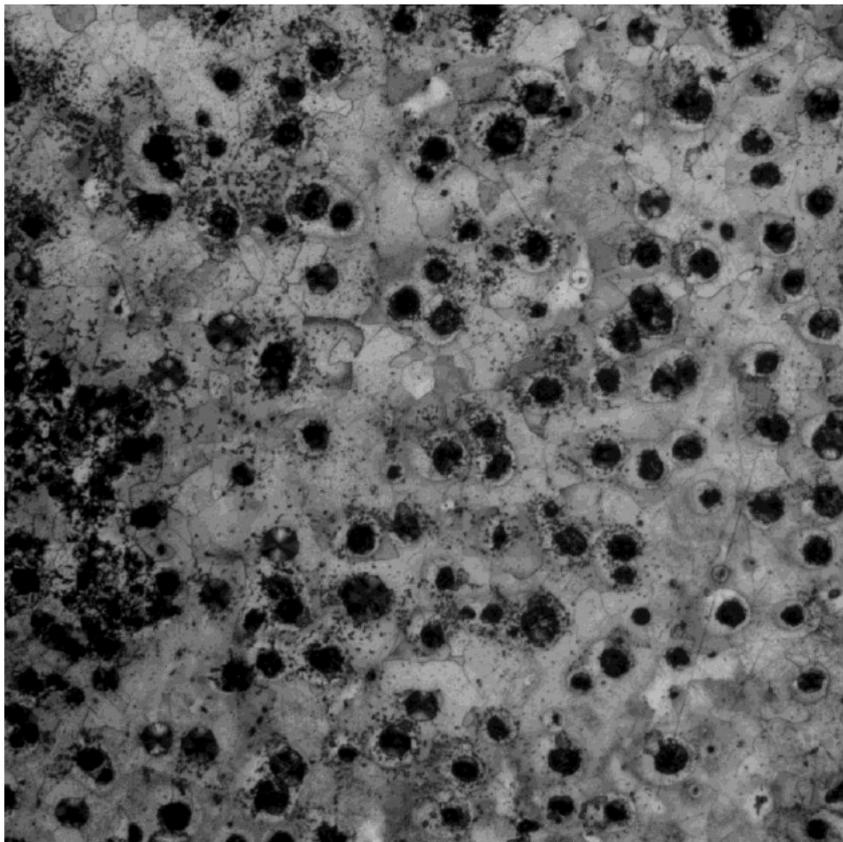
Fig. 14. Spheroidal
graphite cast iron
microstructure of the
teeth on the gear.
100x magnification
