Grounding of the general cargo ship

Vectis Eagle

Gijon, Spain

30 November 2014

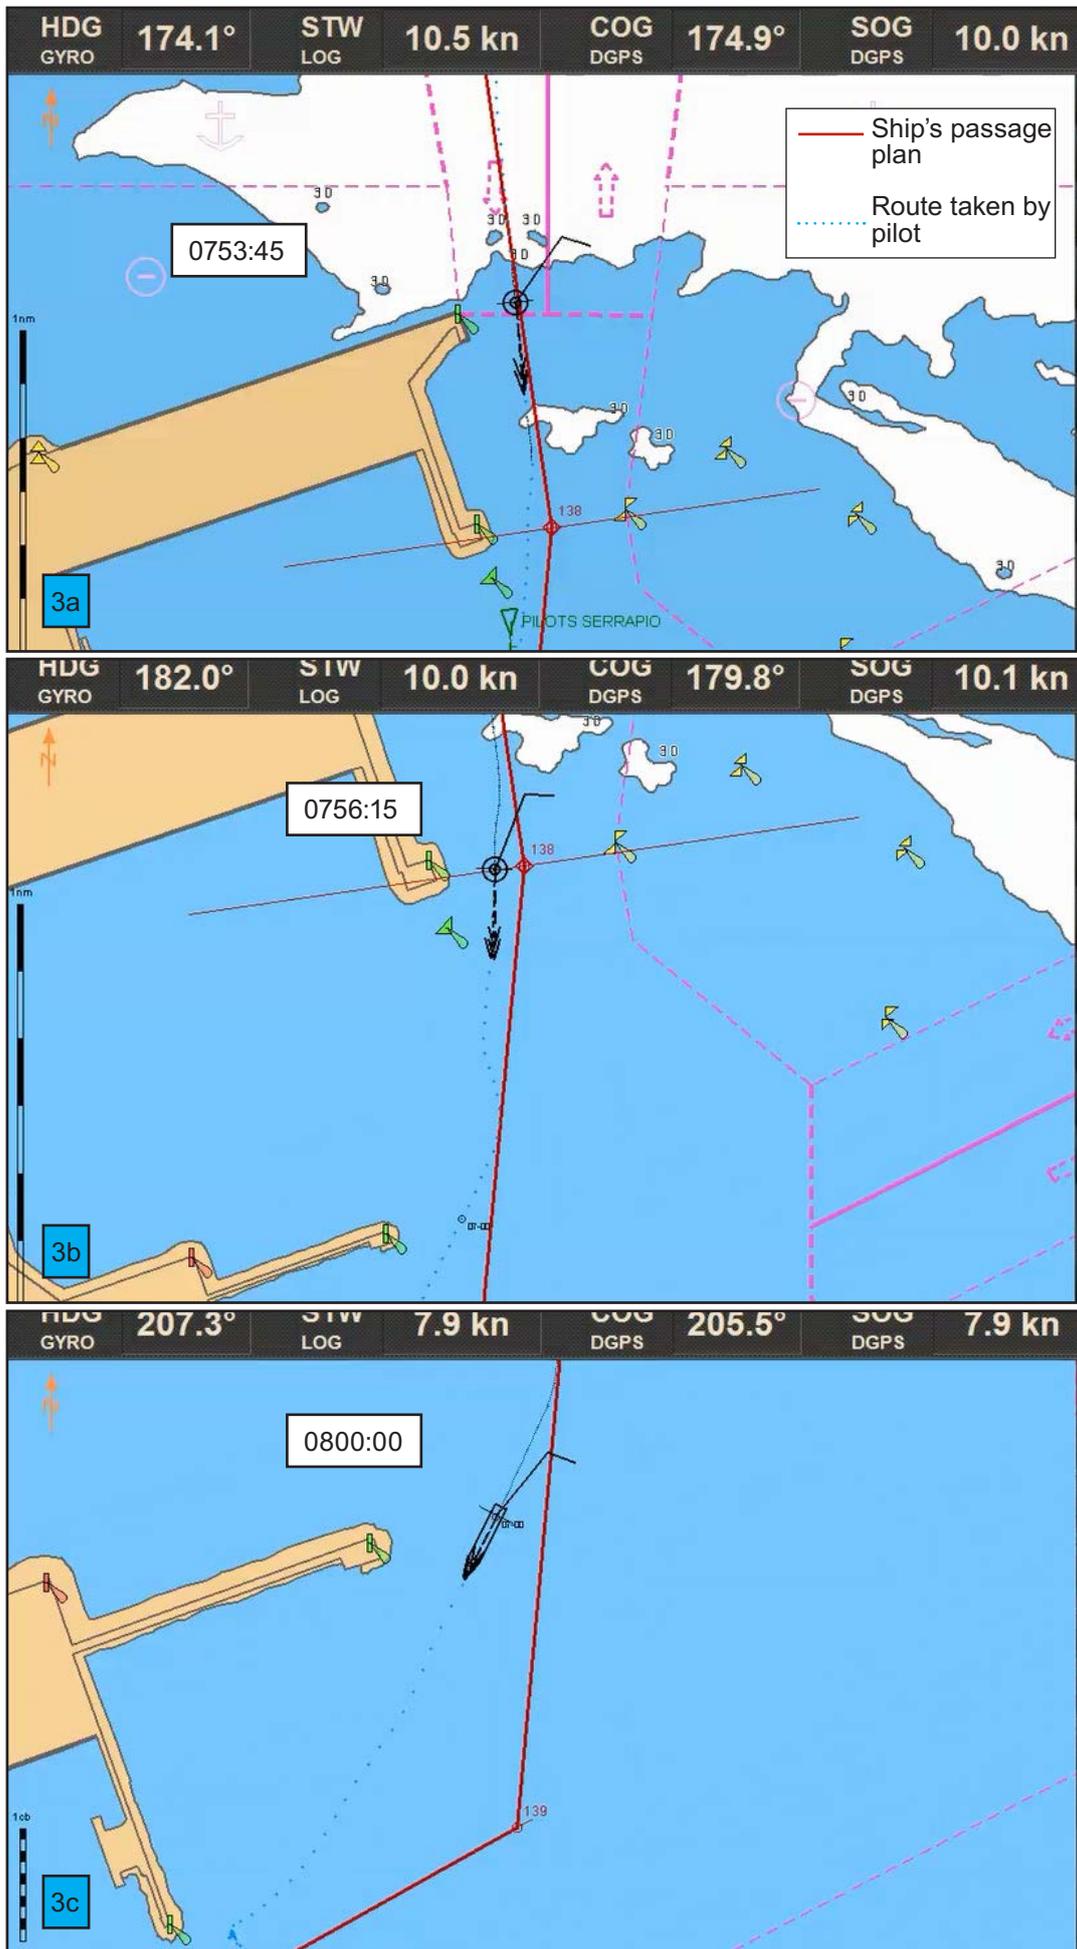
Figure 3: Screenshots from ECDIS replay 0753 - 0800

At 0754, *Vectis Eagle* passed approximately 200m east of No1 breakwater⁴ (**Figure 3a**). The master asked the pilot if he could test the vessel's engines operating astern. The pilot replied that it would be safer to test them between No2 and No3 breakwaters where there was more safe water.

At 0756, *Vectis Eagle* passed 110m east of No2 breakwater heading 180° at 10kts (**Figure 3b**). The pilot informed the master that he could now test the engines astern. Accordingly, the master moved the engine control lever from 'full ahead' to 'full astern'. The vessel's speed rapidly reduced and its heading sheered to port.

At 0800, *Vectis Eagle* passed No3 breakwater at a distance of 134m (**Figure 3c**). The vessel's heading was 207° and its speed was 7.9kts. By 0802, *Vectis Eagle* was approaching No4 breakwater, heading 214° at 6.7kts (**Figure 4a**). At this point, the pilot ordered "starboard 20°" with the aim of turning the vessel around the breakwater, towards the inner harbour. The chief officer applied 20° of starboard rudder and *Vectis Eagle* started to turn. However, the vessel turned more quickly than the pilot had expected so he ordered "midships" quickly followed by "port 10" and "hard to port" to check the swing.

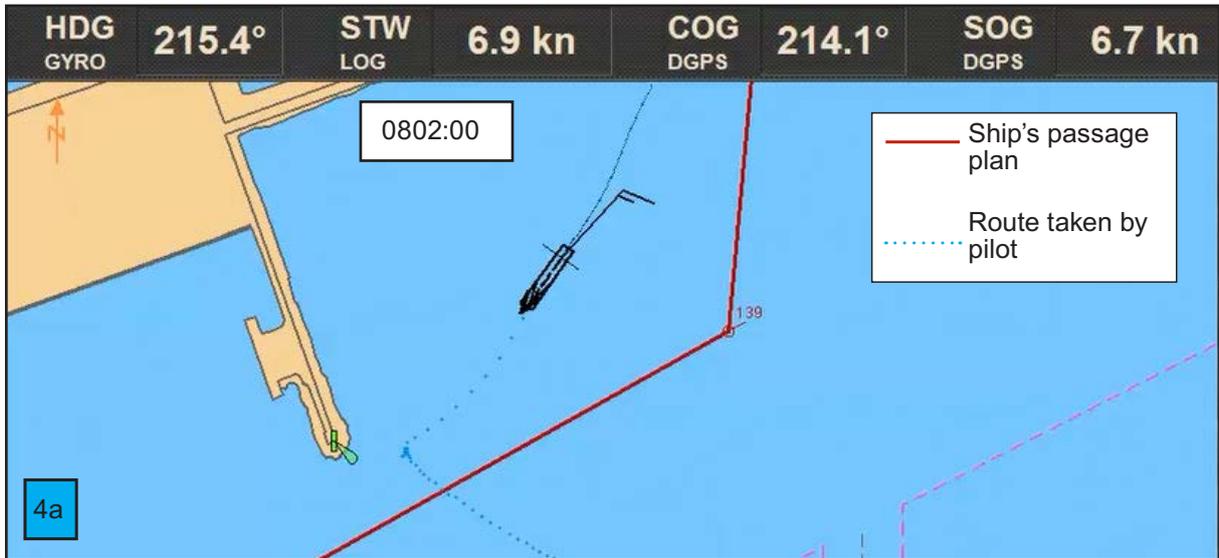
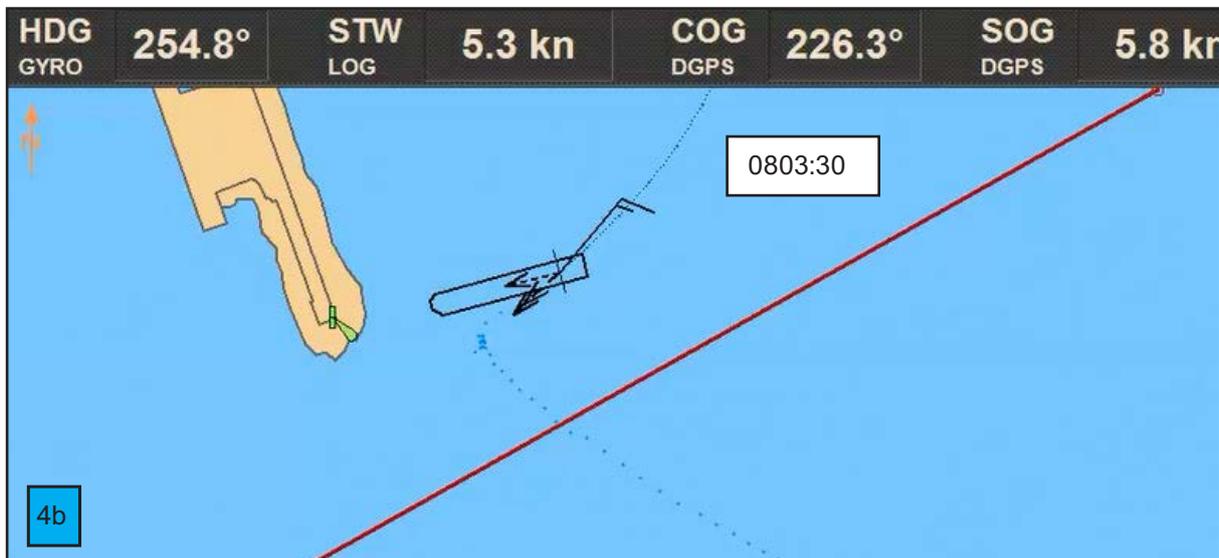
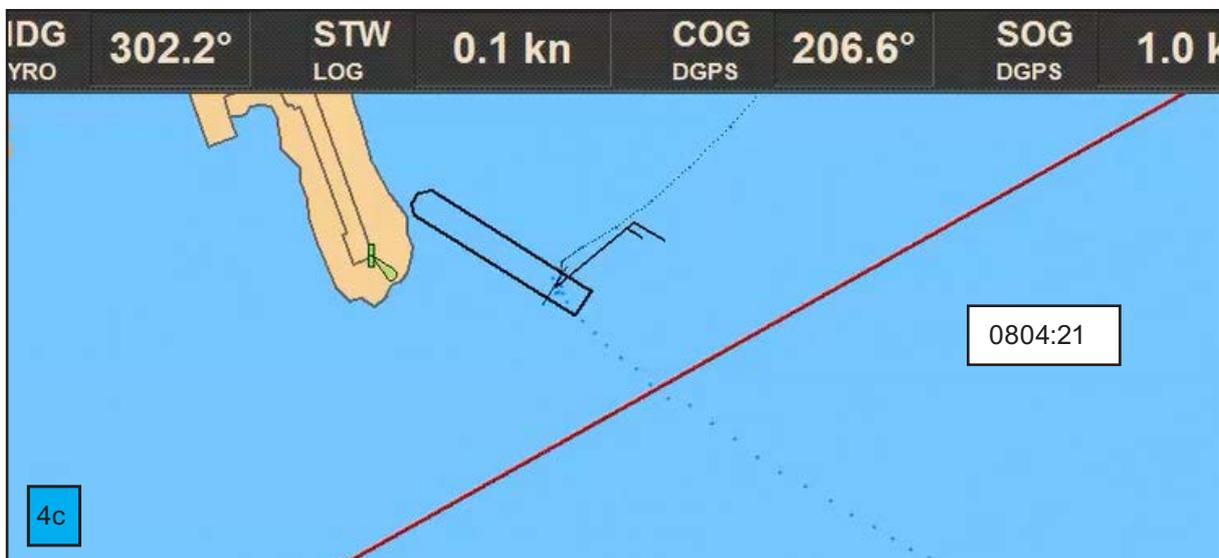
Figure 4: Screenshots from ECDIS replay 0802 - 0804:21

Vectis Eagle's heading was still swinging to starboard (**Figure 4b**) when the forward mooring party let go the port anchor with approximately 15m of chain cable. By 0804, *Vectis Eagle* was virtually stopped with its bow close to the breakwater (**Figure 4c**). Although the engine continued to run at 'full astern', the vessel remained stationary for about 2 minutes on a heading of 304°. During this period, the forward mooring party felt the vessel touch the base of the breakwater.

As *Vectis Eagle* remained stationary next to No4 breakwater between 0804 and 0806 (**Figure 4c**), apparently neither the master nor the pilot was certain that *Vectis Eagle* had grounded. The noise and vibration of the engine running astern, the noise of the anchor cable paying out and the movement of the vessel would have masked the occurrence to some degree. Nonetheless, it is evident from the rapid checking of the forward tanks, followed by the pilot's external inspection of the hull once the vessel was alongside, that the master and the pilot were aware that *Vectis Eagle* might have been damaged.

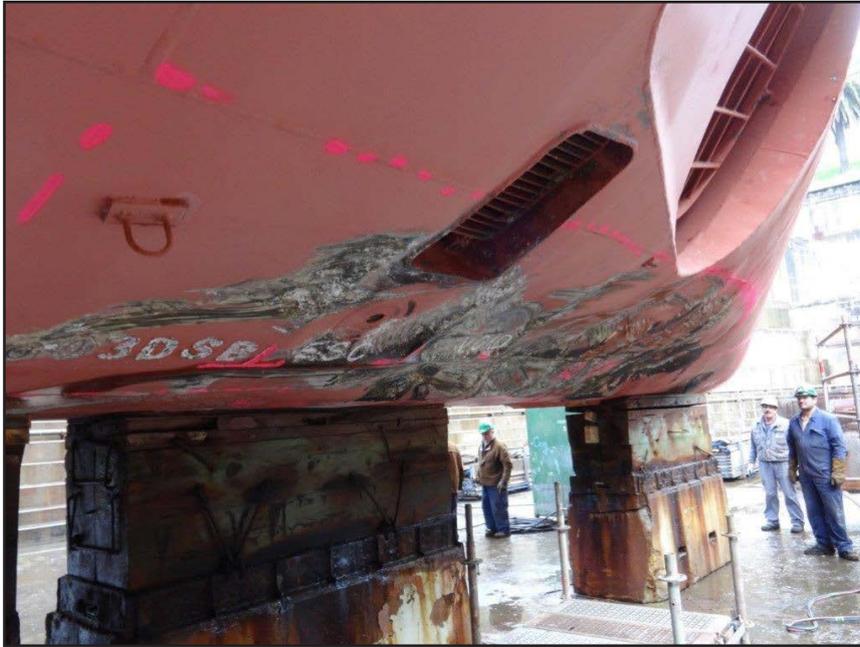
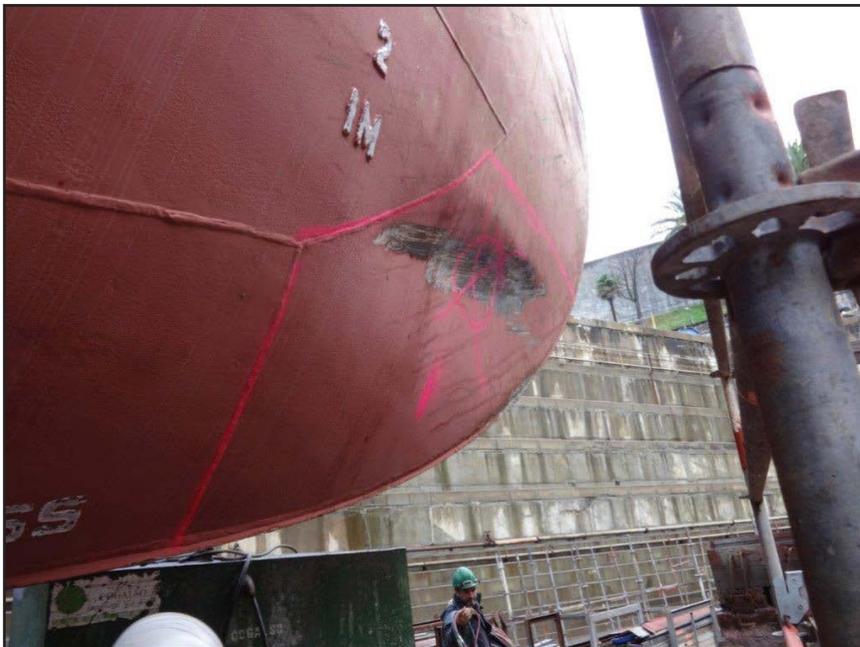
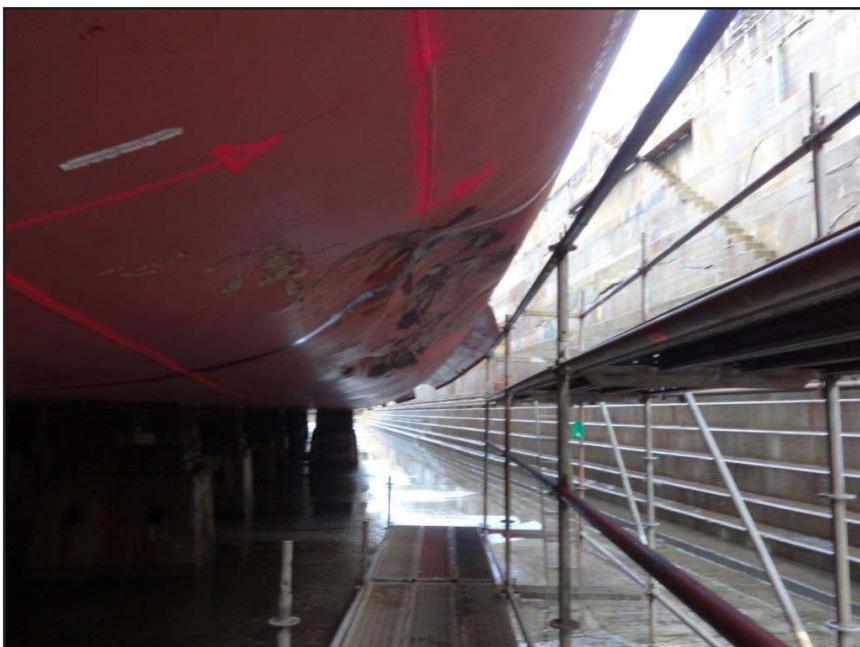
Figure 5: Damaged bow section below the waterline

Vectis Eagle suffered damage to its bottom structure and framing in way of the forepeak tank and speed log void space. Additionally, hull plating on the bow section, and both sides of the forward bilge keels had been set in (**Figure 5**).

The nature of the damage (**Figure 5**), the accounts from the forward mooring station crew and the ECDIS replay (**Figures 3 and 4**), show that *Vectis Eagle* grounded adjacent to No4 breakwater. The charted depth of water immediately off the breakwater was 5.1m (**Figure 6**). Given a predicted height of tide of 2.7m, the depth of water at *Vectis Eagle's* bow (7.8m) was very close to the vessel's forward draught of 7.64m.

The surveyors issued a condition of class that required *Vectis Eagle* to proceed to dry dock for repairs. *Vectis Eagle* sailed that evening and arrived at the dry dock in Ferrol, Spain at 1407 the following afternoon (2 December) where significant damage to the forward section of the hull was discovered.
