Collision between MV *Orakai* and FV *Margriet*

North Hinder Junction, North Sea

21 December 2014

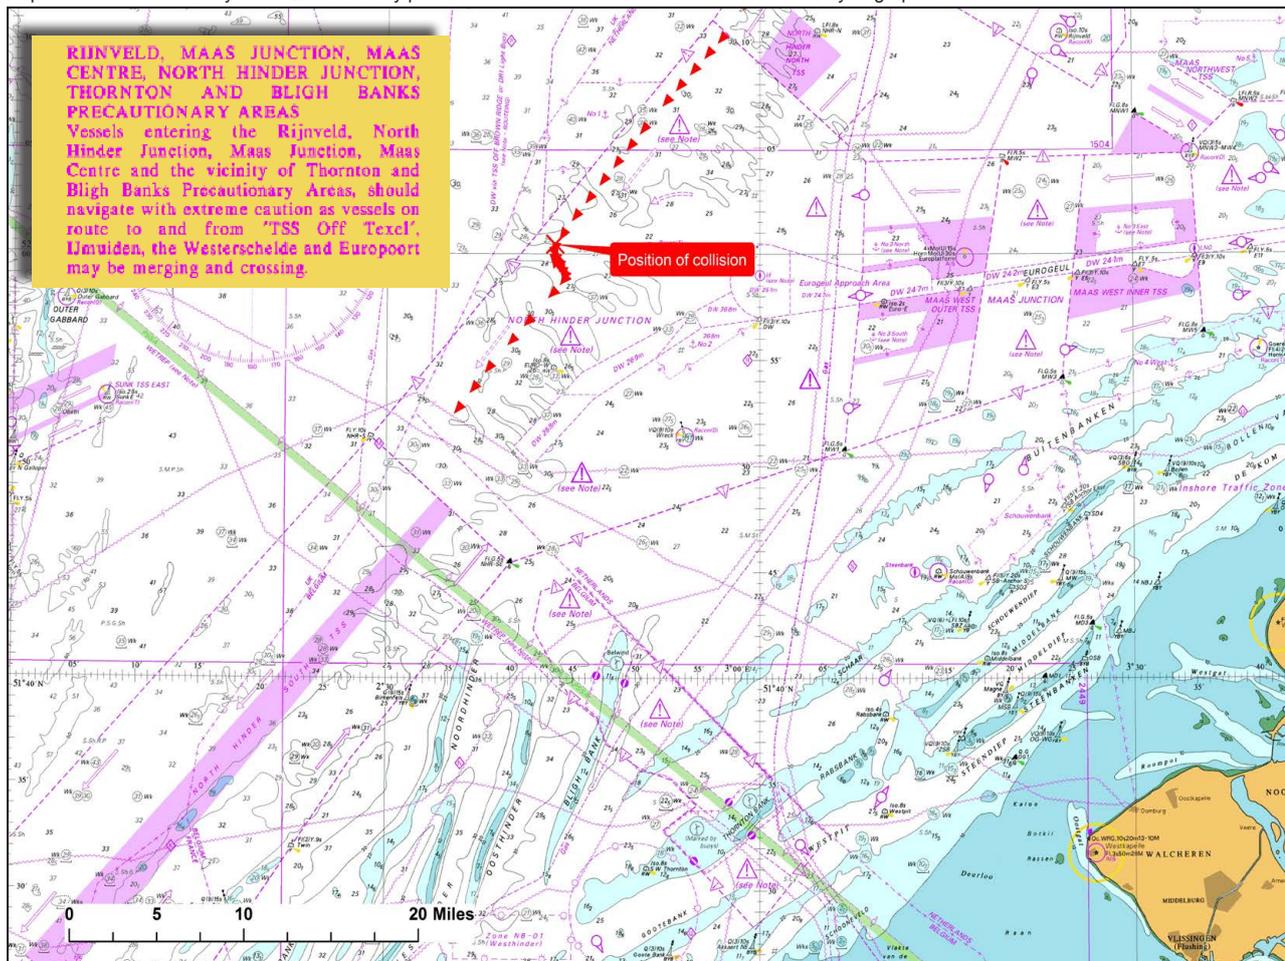
Figure 1: Extract of Chart BA 1406-0 showing *Orakai's* track and position of accident (with precautionary note)

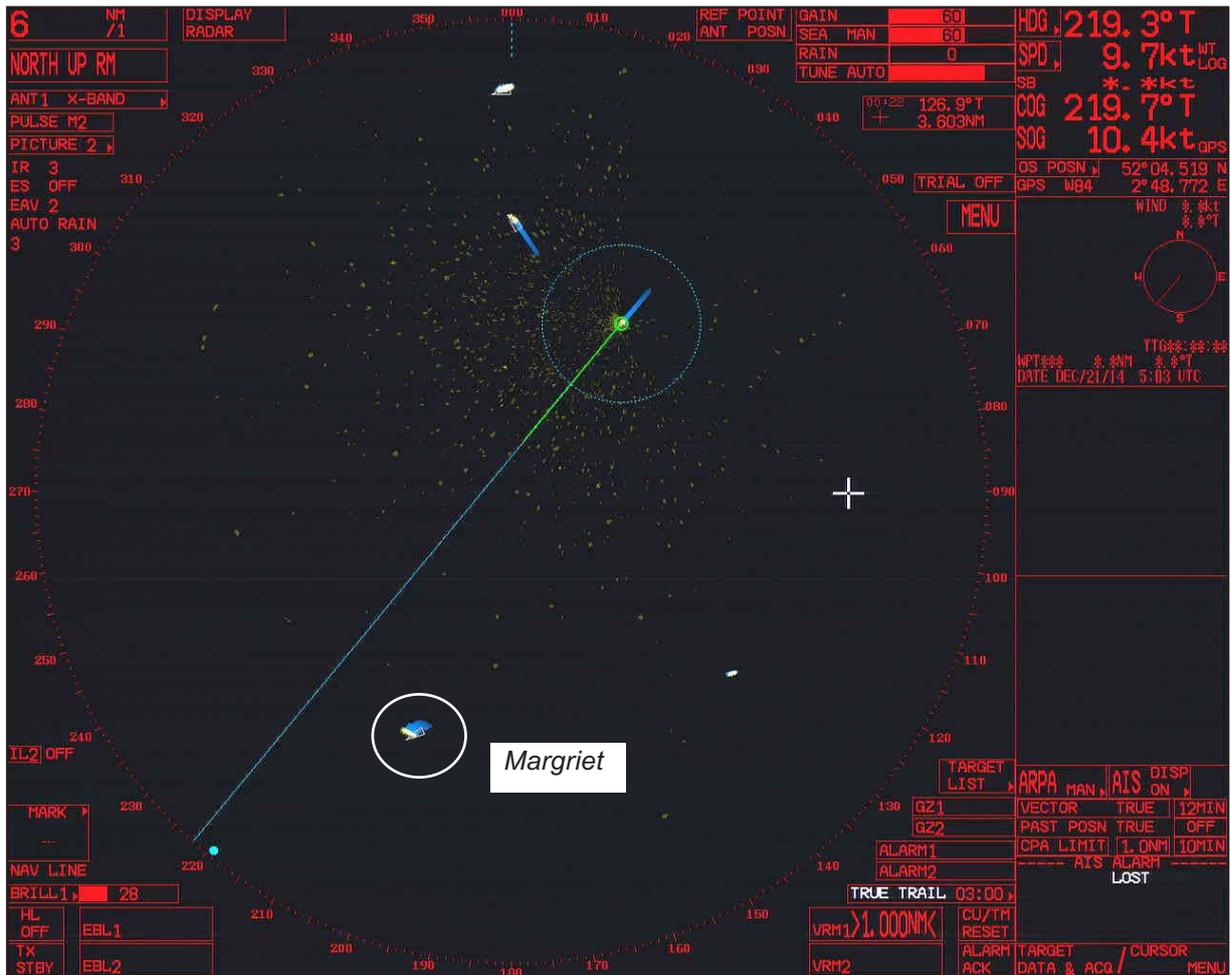
Figure 2: Orakai's X-band radar picture at 0503

Six miles ahead of *Orakai* was the UK registered beam trawler *Margriet* (**Figure 2**). The trawler was towing its fishing gear on a similar heading to the chemical tanker at a speed of approximately 5kts. By 0504, the chief officer and the OS had positively identified the fishing vessel using the automatic identification system (AIS). They had also established that the fishing vessel's closest point of approach (CPA) was in excess of 1nm on the tanker's port side.

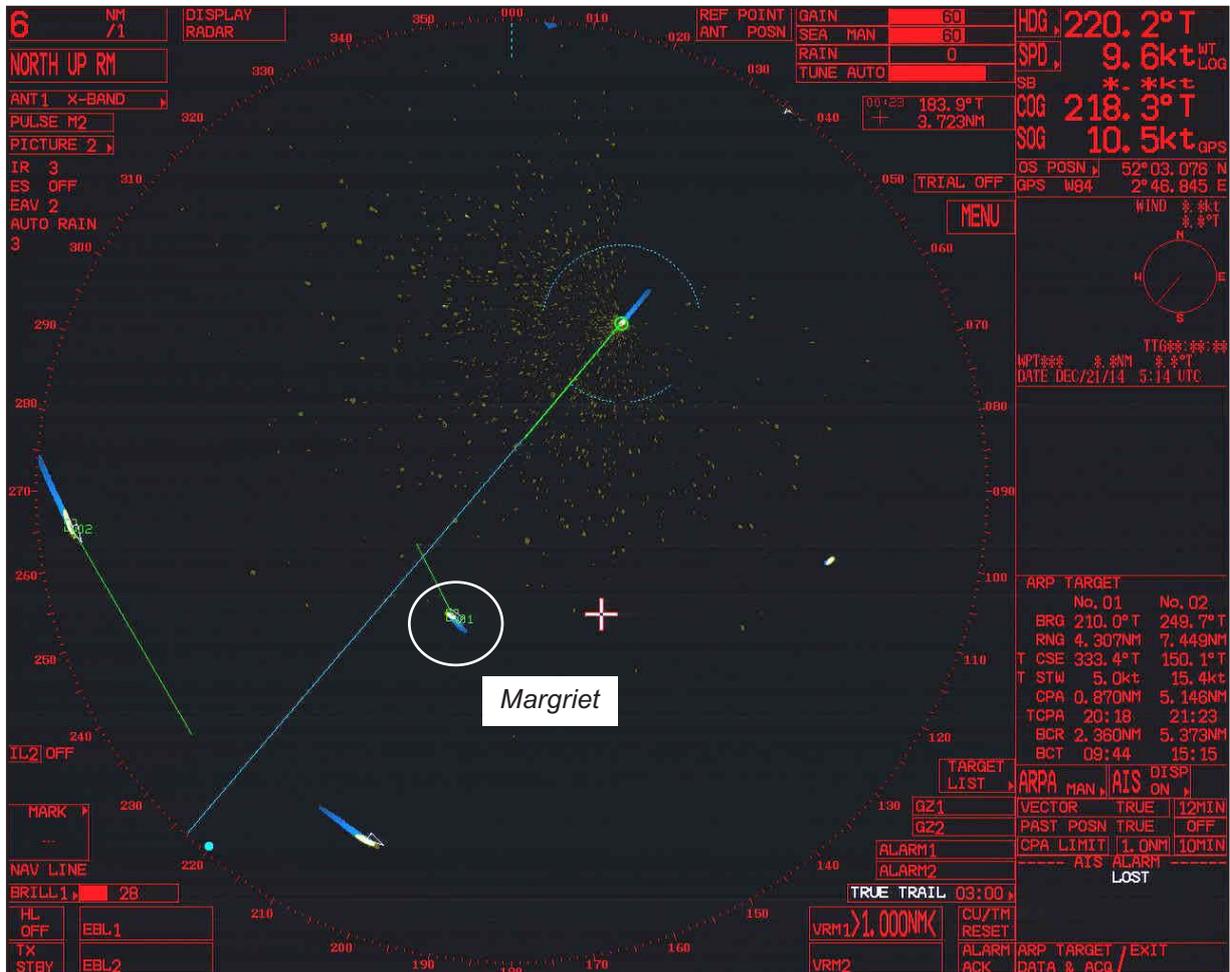
Figure 3: Orakai's X-band radar picture at 0514

At about the same time, *Margriet*'s mate adjusted the heading set on the trawler's autopilot to 333°. *Margriet*'s course alteration was seen by *Orakai*'s OS, and at 0514 he selected the fishing vessel's radar target on the automatic radar and plotting aid (ARPA). He also switched the target's vector from true motion to indicating relative motion. By now, *Margriet* was at a range of 4.3nm and its CPA was 0.9nm on the tanker's starboard side (**Figure 3**).

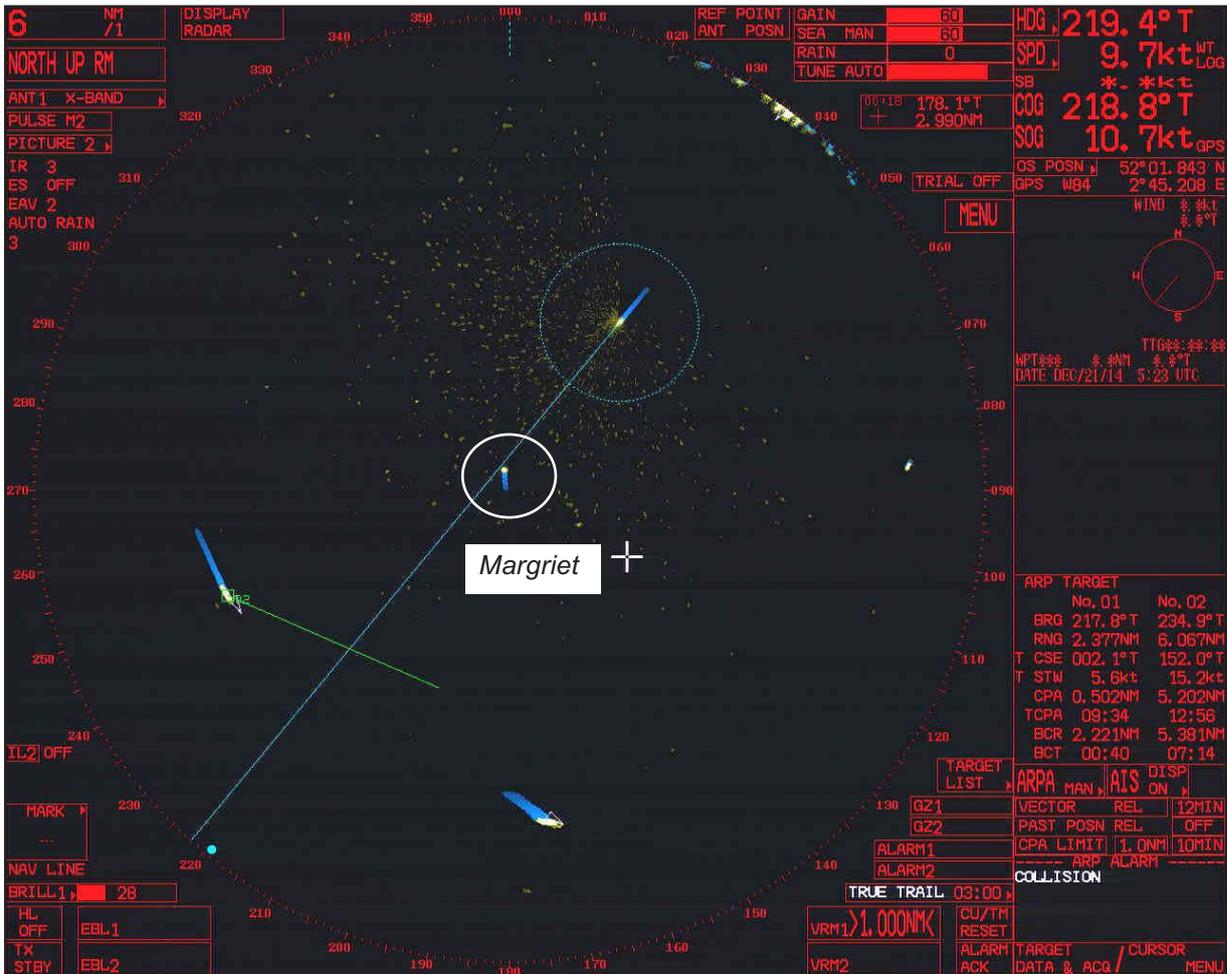
Figure 4: Orakai's X-band radar picture at 0523

At 0520, *Margriet*'s mate adjusted the heading set on the autopilot to north. Three minutes later, the ARPA collision alarm on *Orakai*'s bridge sounded. The distance between the vessels was 2.4nm and the CPA of the fishing vessel had reduced to 0.5nm in 9.5 minutes (**Figure 4**). In response to the collision alarm, the OS adjusted the tanker's heading 5° to port.

However, when the ARPA alarm activated at 0523, *Margriet* had closed to a range of 2.4nm and its CPA had reduced to 0.5nm. This warranted the chief officer's immediate recall to the bridge. Instead, the OS adjusted the tanker's heading by 5°, which had little effect. By the time the OS eventually tried to contact the chief officer, *Margriet* had turned further to starboard and had closed to a range of about 1nm. By this time, the options available to avoid a collision had reduced significantly.

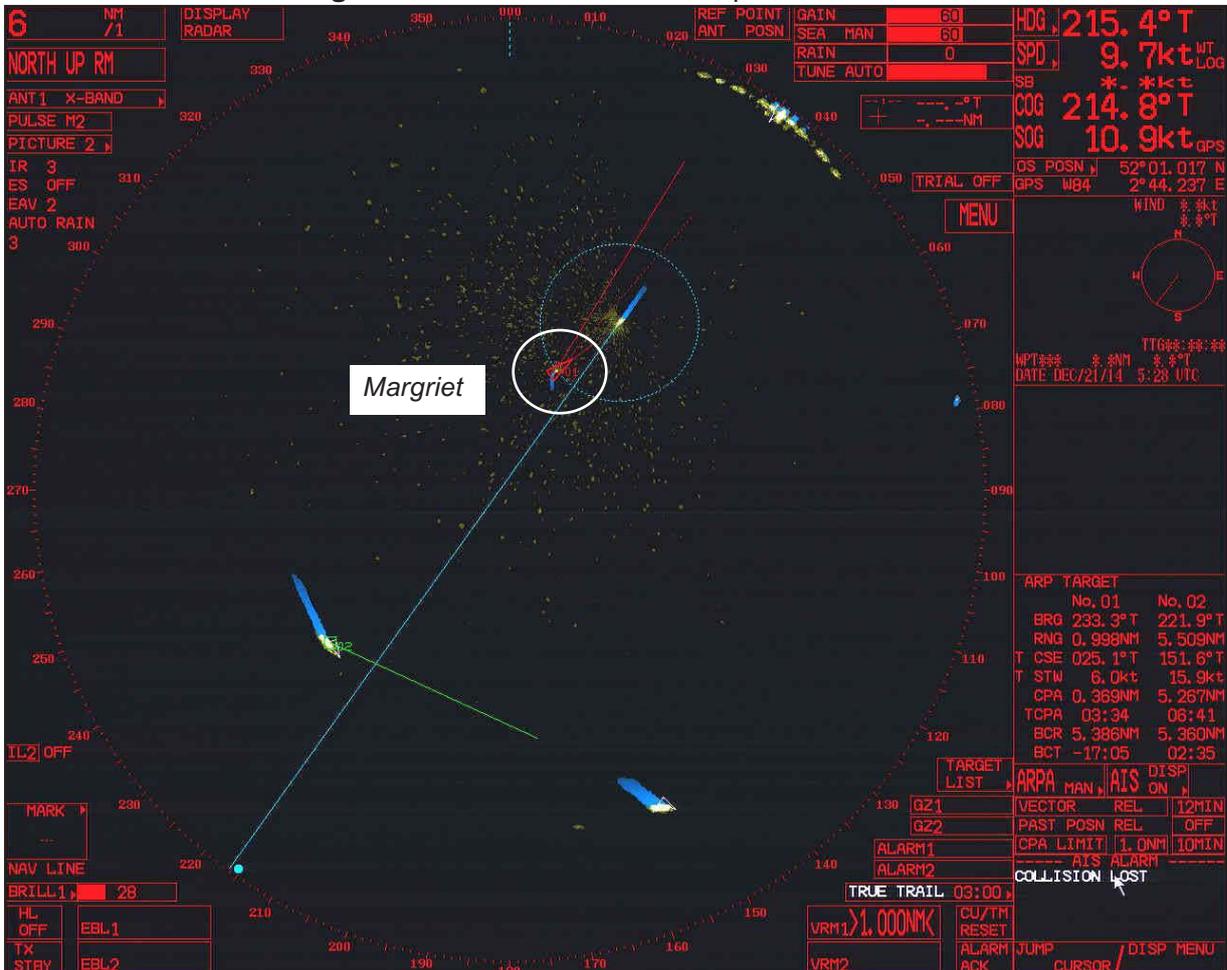
Figure 5: Orakai's X-band radar picture at 0528

Seconds later, *Margriet* reached the end of the track displayed on the electronic chart plotter. The mate adjusted the fishing vessel's heading further to starboard. His intention was to gradually turn the trawler's heading in order to follow the track on the plotter towards the south-east. The trawler was now heading 025° and the CPA with *Orakai* was of 0.37nm in 3.5 minutes' time (**Figure 5**).

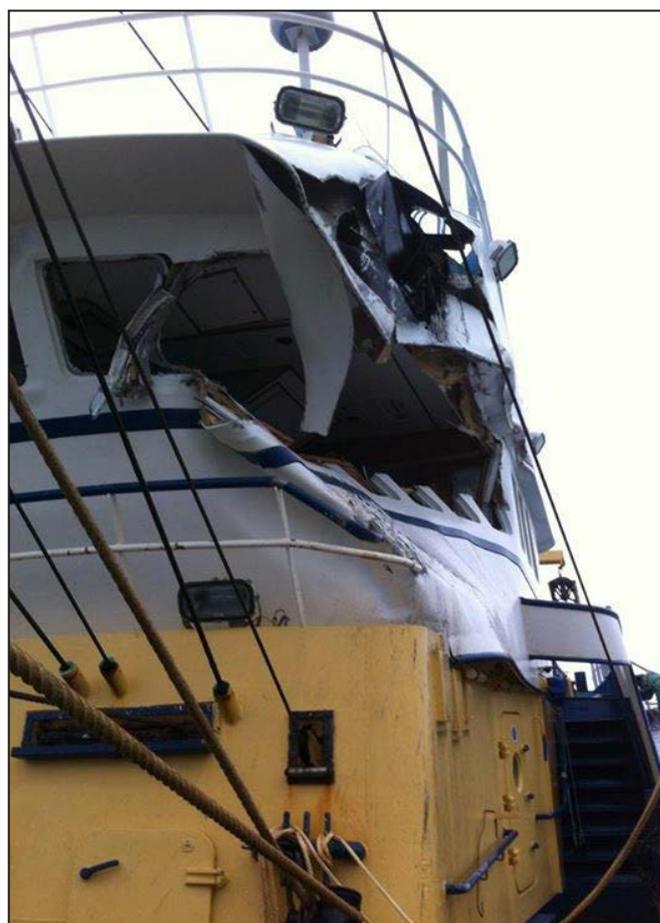
Figure 6: Damage to *Margriet*'s wheelhouse

Margriet was severely damaged. Above the waterline, the wheelhouse structure was badly distorted and buckled (**Figure 6**). The aft gantry was also buckled and the backstay on the port side towing derrick was parted. Below the waterline, the 10mm hull plating in way of the port side wing fuel tank was significantly indented (4500mm x 3600mm) (**Figure 7**). Within the indentation, a vertical gash (1500mm x 600mm) had breached the fuel tank.

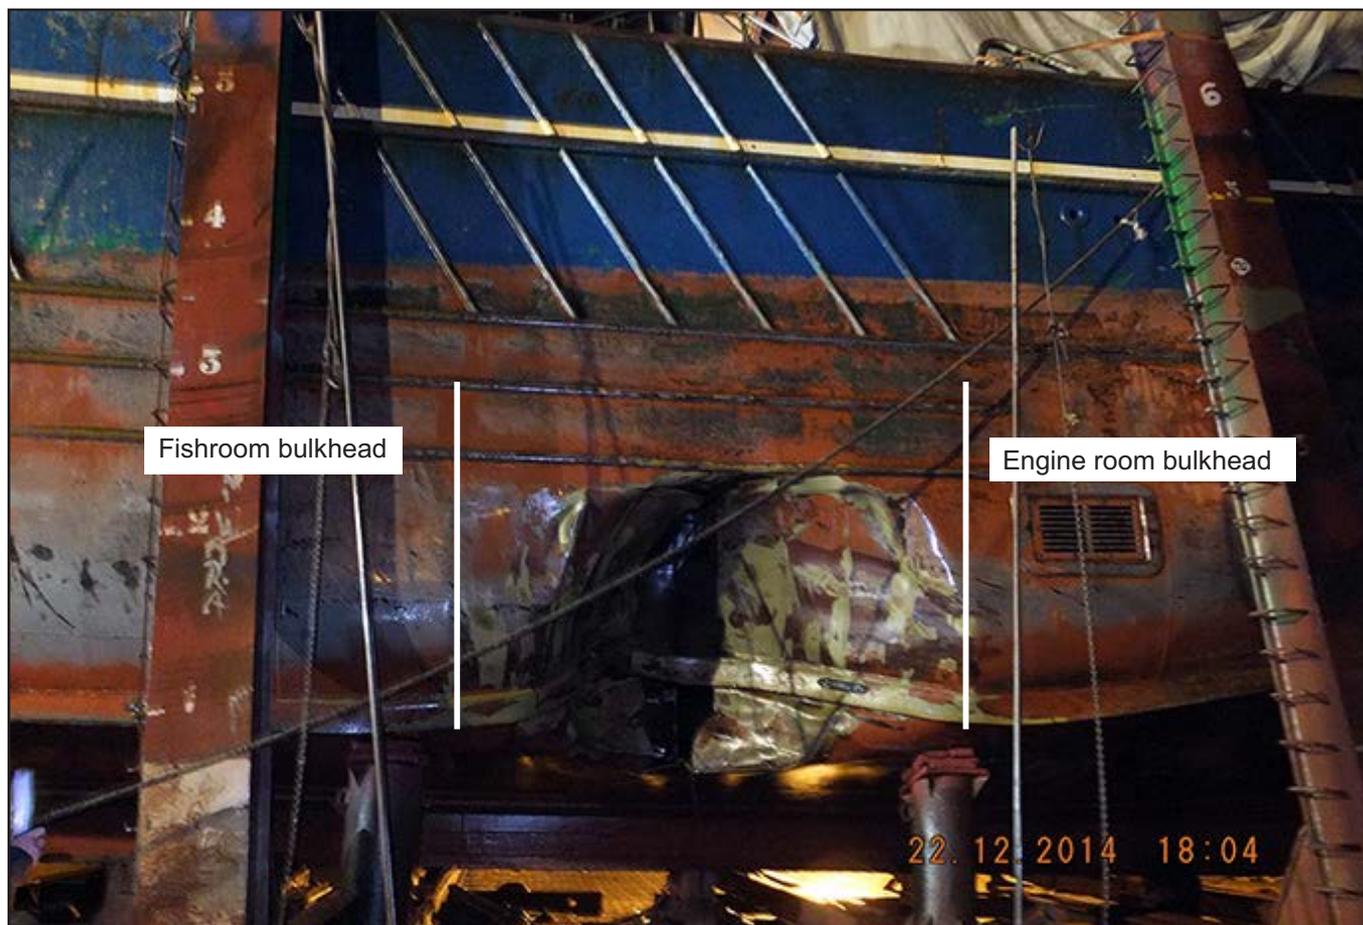
Figure 7: Damage to *Margriet* in way of the port side wing fuel tank

It is extremely fortunate that *Orakai*'s bulbous bow struck *Margriet* in way of the vessel's port wing tank rather than in way of the adjacent engine or fish rooms (**Figure 7**). The UK does not require its fishing vessels to meet damage stability criteria. Therefore, had either the engine or fish rooms been penetrated, it is possible that, given the size of these compartments, *Margriet* would have quickly foundered.
