Rail Accident Report

**Near miss involving track workers near Hest
Bank, Lancashire
22 September 2014**

Report 08/2015
July 2015

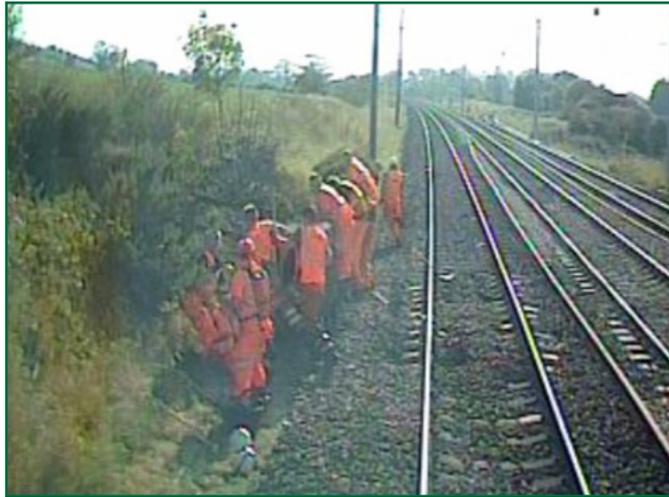
Figure 2: Image of workgroup from forward-facing CCTV camera fitted to train 1M97 (courtesy of FTPE)

- 5 The COSS saw the train approaching on the up main line when it was just over three seconds away and shouted an urgent warning. Staff took rapid evasive action, but some members of the workgroup were on the bridge and were unable to reach the designated position of safety, instead pressing themselves against the bridge parapet (figure 2). The last member of the workgroup was not clear of the line until about one second before the train passed (figures 2 and 9).

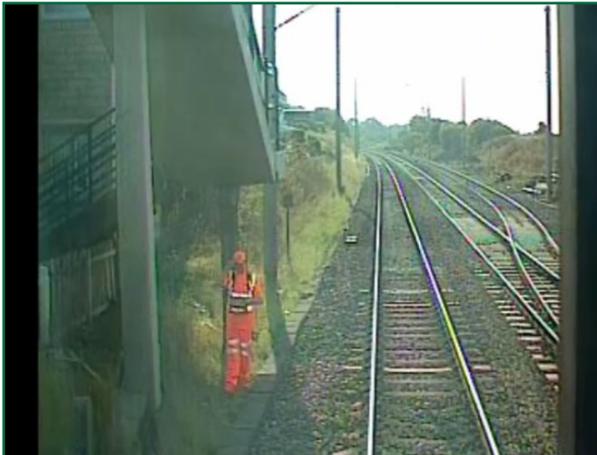
Figure 7: Image of Lookout 1 from forward-facing CCTV camera fitted to train 1M97 (courtesy of FTPE)

- 41 At 14:23:51 hrs⁶, train 1M97 passed Hest Bank level crossing travelling at 101 mph (162 km/h), and then passed Lookout 1 standing beside the up main line approximately 10 metres beyond the crossing. The CCTV recordings from the train shows that he was in position next to the track and facing the train when it passed (figures 7 and 8). It shows him wearing the ZFH lookout unit on a neck strap and holding onto his hard hat to prevent this being blown off by the train. The train driver states that he gave a warning using the train's horn, and that the lookout had acknowledged this by raising his arm as it approached.

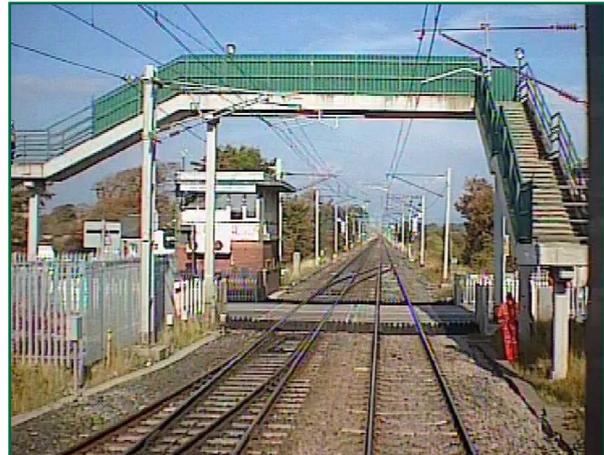
Figure 8: Image of Lookout 1 from rear-facing CCTV camera fitted to train 1M97 (courtesy of FTPE)

- 27 Weather records for Bolton-le-Sands, located between Carnforth and Hest Bank, indicate that conditions were dry and mild (18°C), with a 10 mph southerly wind. The rearward facing CCTV camera on the incident train showed that no haze, glare or other environmental factors were impairing the view of a lookout looking north from Hest Bank level crossing (figure 8).

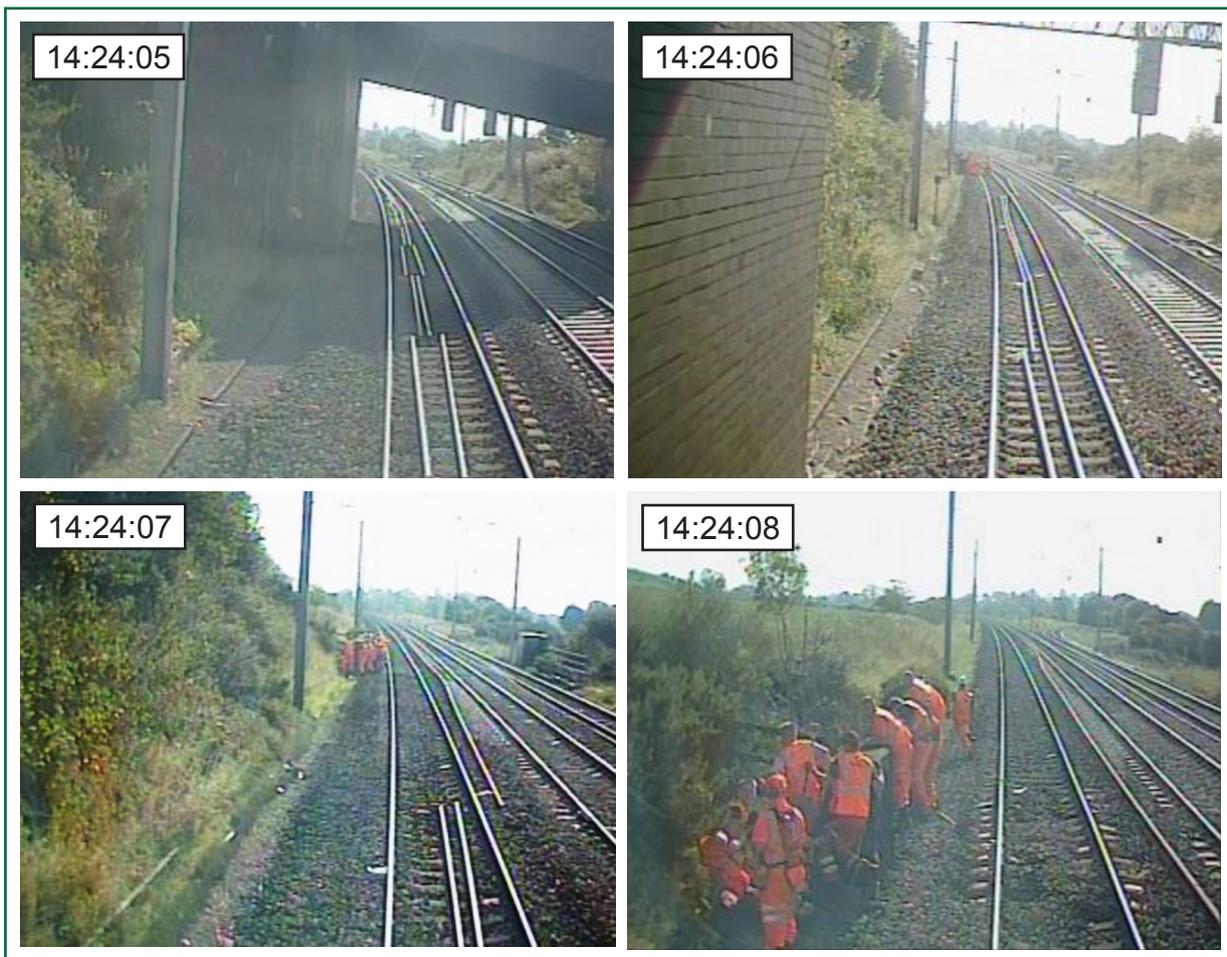
Figure 9: Images of workgroup from forward-facing CCTV camera fitted to train 1M97 while approaching under the A5105 bridge (courtesy of FTPE). Clock times are based on OTDR data.

- 42 Fourteen seconds later, at 14:24:05 hrs, train 1M97 approached the A5105 road bridge (figure 9). The driver states that passing under the bridge, he saw staff working directly in the path of his train and sounded the horn. The COSS, who was placing ballast under the sleepers with a shovel while the cess rail was raised on the jack, saw the train at about the same time and immediately shouted a warning. The train at this point was just over three seconds away. The COSS had not heard the train approaching and the LOWS had not given a warning. The workgroup rapidly evacuated the tracks, dropping tools and leaving the jack in position (figure 10). The jack collapsed under the weight of the passing train (as intended by the jack's design). A witness reports that the train hit a shovel.
