Combined report on the investigations of  
Two fatalities connected with the  
operation of the workboat

***GPS Battler***

off Almeria, Spain

in Marin, Spain

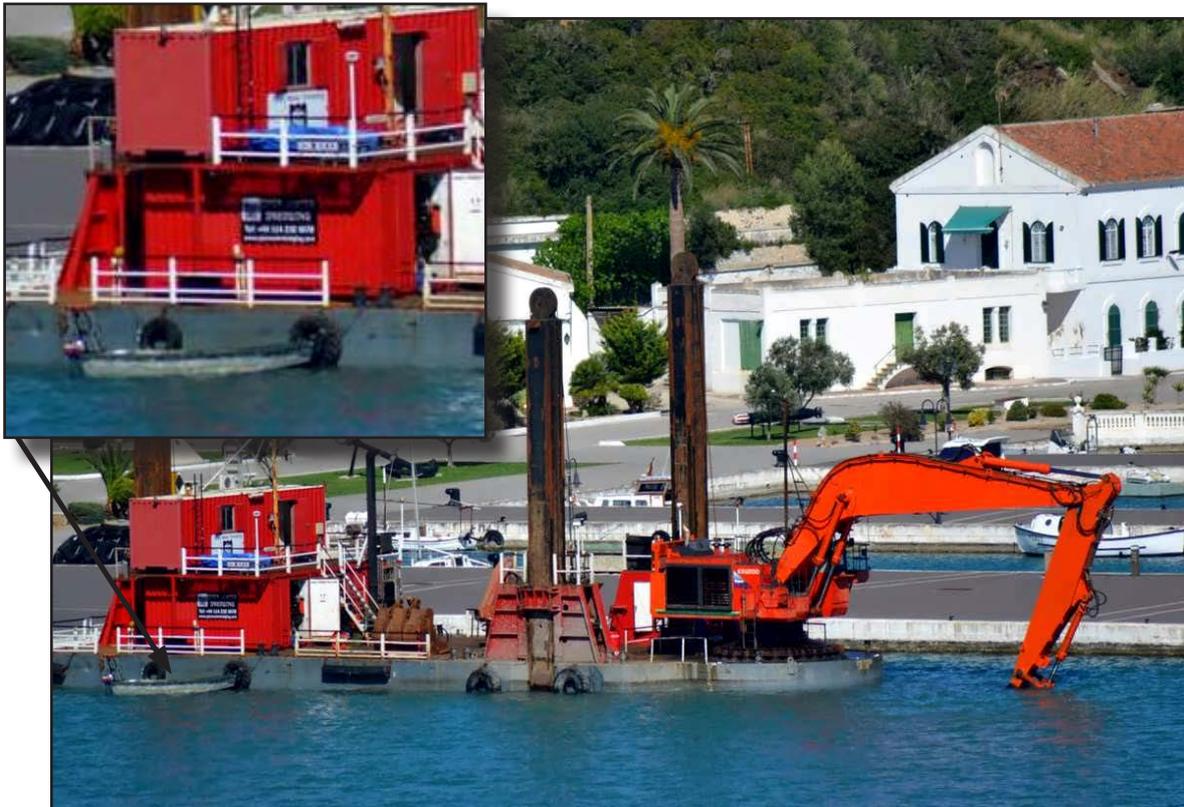
**Figure 5:** Tender alongside *Von Rocks*

The tender was used by the dredger's crew during dredging operations to transfer crew short distances to and from the shore, usually when the dredger was working within harbour limits (**Figures 5 and 6**). It was also used by the dredger's crew to access and maintain some of the dredger's deck equipment. *GPS Battler's* crew had not been authorised to use the tender.

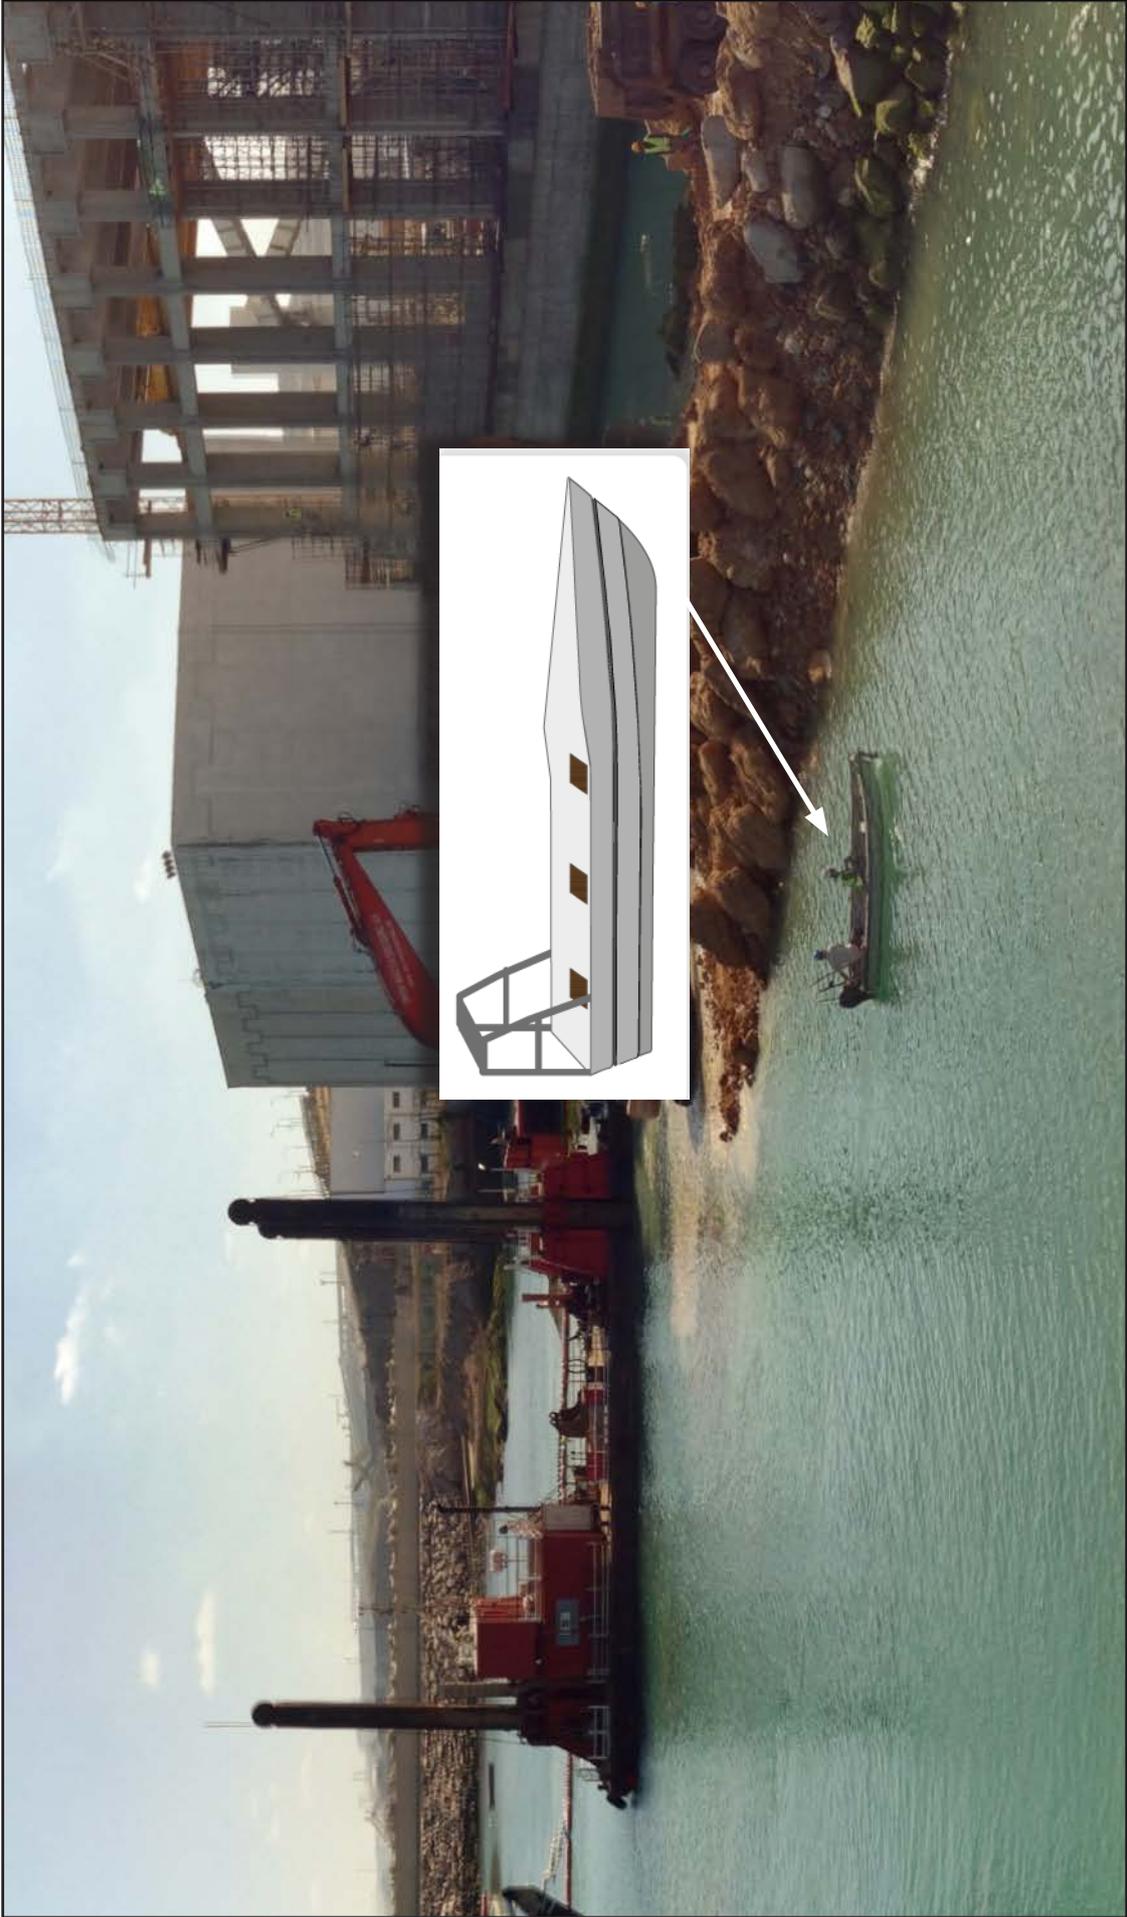
**Figure 6:** Tender during dredging operations

There is no evidence to suggest that *Von Rock's* tender was not fit for purpose for its intended role when operated close to the shore in sheltered waters. However, the tender's swamping off Almeria indicates that the sea conditions prevailing on this occasion exceeded the boat's safe operating limit.

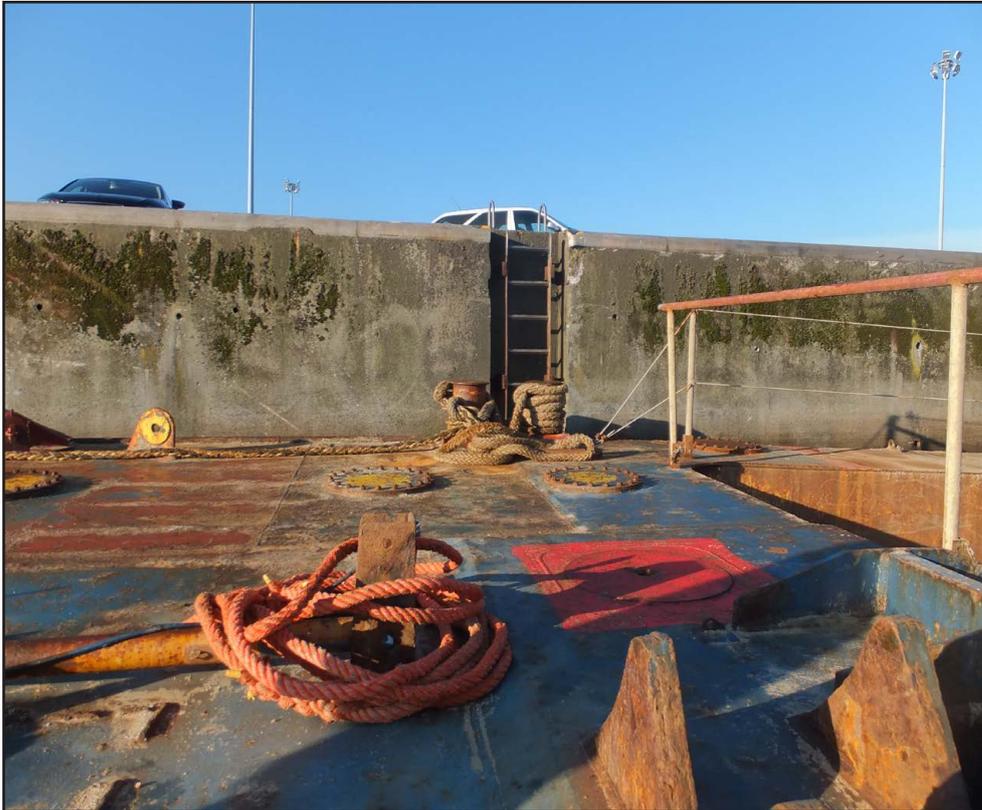
**Figure 8:** Vertical ladder on quay (near low water)

The means of access from the quay to the inner barge depended on the height of tide. The tidal range at spring tides was 3m. Around high water, the levels of the quay edge and the inner barge's deck were sufficiently close to enable a person to step up or down from the quay to the deck (**Figure 13**). Towards low water, the barge's deck was approximately 2.5m below the quay edge and so access was via a fixed vertical ladder fixed to the quay wall (**Figure 8**).

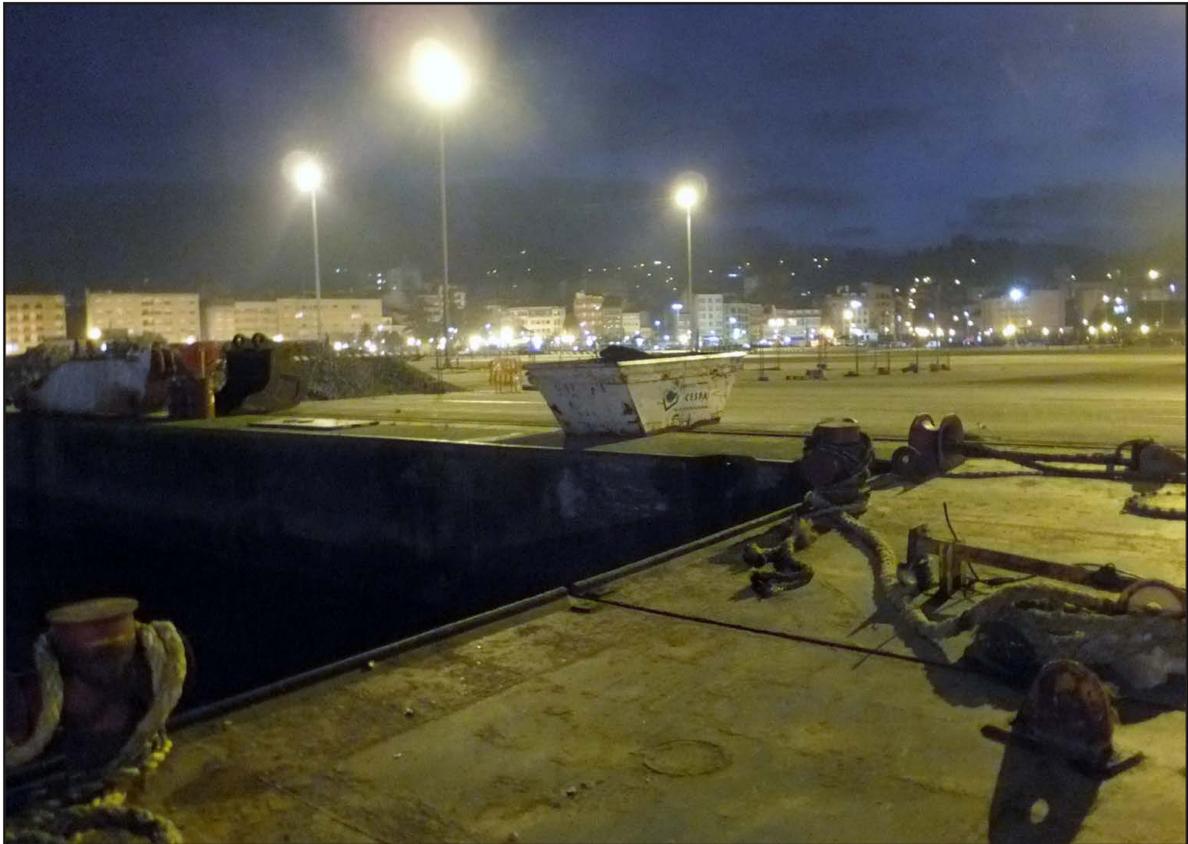
**Figure 9:** Waste skip on the quayside

With the exception of the waste skip (**Figures 9, 10 and 11**), the quay in the vicinity of *GPS Battler* was generally clear of obstructions and trip hazards. The waste skip was approximately 2.5m ahead of the inner barge's bow and was perpendicular to the edge of the quay. The distance from the upper extremity of the skip to the edge of the quay was 0.7m.

It is not known why the mate moved to the front of the skip. The area was well lit and clear of trip hazards. However, as the distance from the leading edge of the skip to the edge of the quay was only 70cm, this was a relatively narrow space for someone of the mate's size to stand without getting very close to the quay edge.

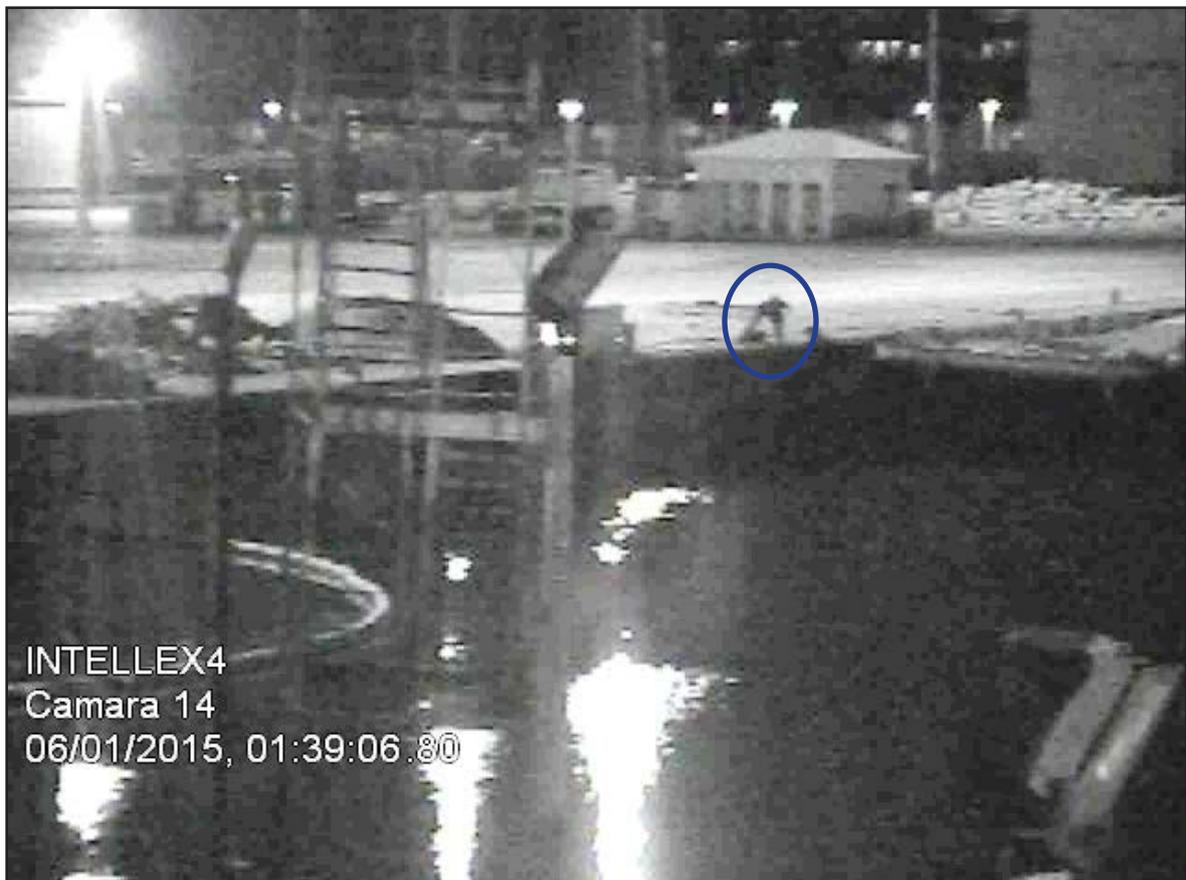
Figure 11: Still from CCTV at 0139 - mate by quay edge

The mate's high blood-alcohol concentration, together with fatigue would have impaired his motor skills and co-ordination, and CCTV footage shows he was unsteady on his feet as he walked from the pedestrian gate towards *GPS Battler*. It is also likely that the alcohol he had consumed would also have caused a loss of understanding and slurred speech. Indeed, the mate's failure to respond when approached by the bosun as he leant against the skip probably indicates that he was in an alcohol-induced stupor. In such a state, it is almost certain that the mate fell into the water because he either stumbled or lost his balance.

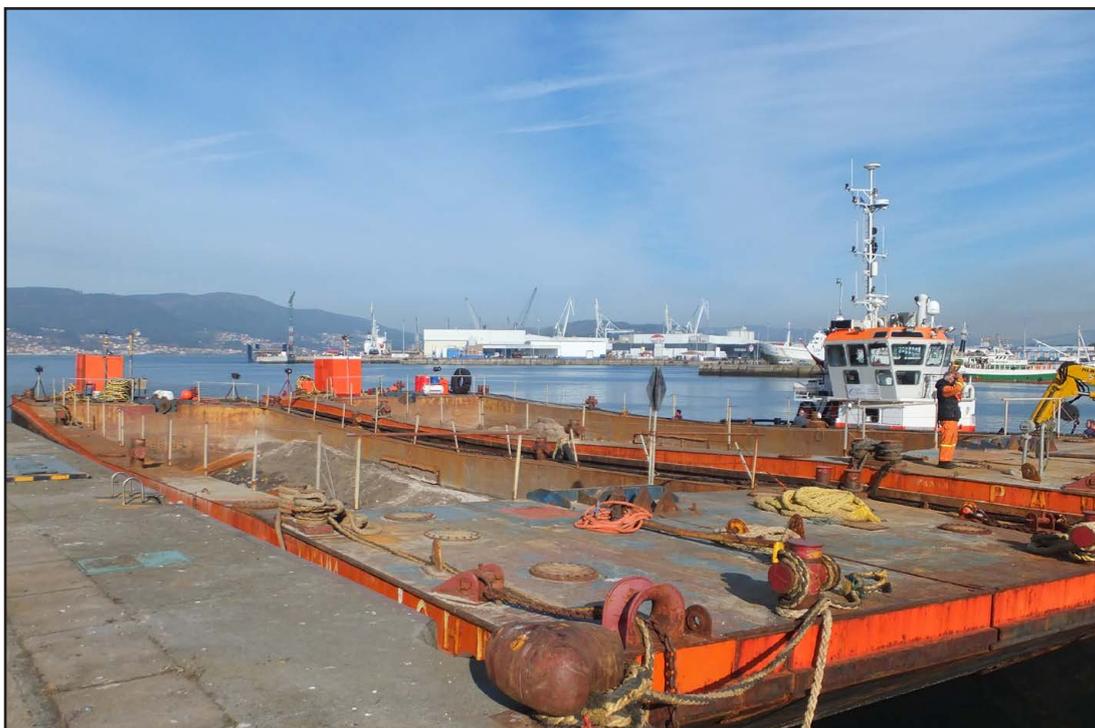
**Figure 13:** Quay and barges (near high water)

To avoid the frequent adjustment of the mooring lines during the rise and fall of the tide, the inner barge's mooring lines had been optimised for low water. As a result, the distance between the inner barge and the quayside varied between approximately 0.25m at low water and 2m at high water when the slack in the mooring lines allowed the barges to drift away from the quay. To keep the inner barge within stepping distance from the quay, it had become established practice to use *GPS Battler's* bow thrust to push the barges against the quay when persons were embarking or disembarking.
