ACCIDENT

Aircraft Type and Registration:	1) Cessna 182F Skylane, G-WARP 2) Grumman AA-5 Traveller, G-BBSA
No & Type of Engines:	1) 1 Continental Motors Corp O-470-R piston engine 2) 1 Lycoming O-320-E2G piston engine
Year of Manufacture:	1) 1963 (Serial no: 182-54633) 2) 1974 (Serial no: AA5-0472)
Date & Time (UTC):	12 June 2015 at 1626 hrs
Location:	Ronaldsway Airport, Isle of Man
Type of Flight:	1) Private 2) Private
Persons on Board:	1) Crew - 1 Passengers - 3 2) Crew - 1 Passengers - 1
Injuries:	1) Crew - None Passengers - None 2) Crew - None Passengers - None
Nature of Damage:	1) G-WARP - Right wingtip and aileron severed 2) G-BBSA - Slight damage to propeller, engine shock-loaded
Commander's Licence:	1) Private Pilot's Licence 2) Private Pilot's Licence
Commander's Age:	1) 67 years 2) 67 years
Commander's Flying Experience:	1) 745 hours (of which 406 were on type) Last 90 days - 11 hours Last 28 days - 4 hours 2) 1,140 hours (of which 638 were on type) Last 90 days - 20 hours Last 28 days - 6 hours

Synopsis

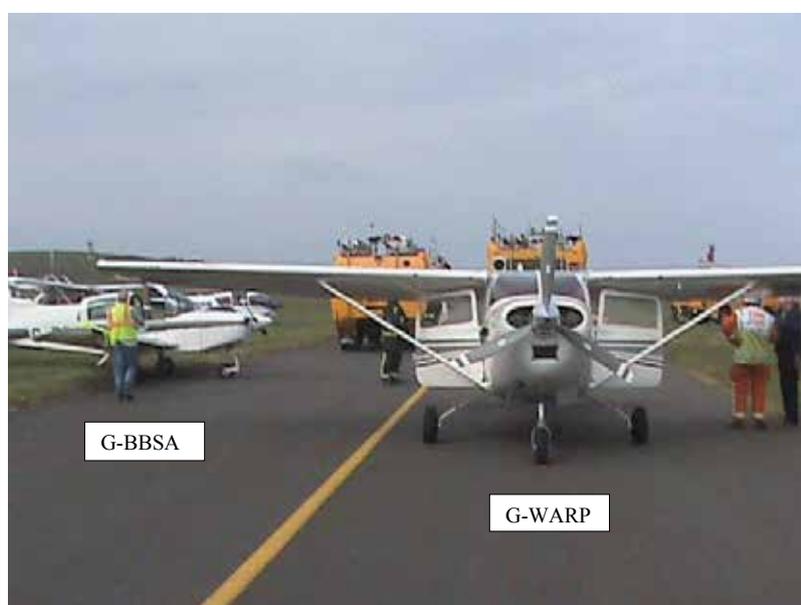
Figure 1

Just prior to the accident, the pilot of G-BBSA pulled the aircraft forward until the nosewheel was on the taxiway and the mainwheels were on the edge of the taxiway, Figure 1. He then started the engine and waited for an opportunity to contact the Tower on the radio to request taxi and departure clearance. He heard an aircraft being given taxi and departure clearance and watched G-WARP as it taxied along Taxiway D, which had been reclassified as an apron, towards him. Initially he thought the right wing on G-WARP would clear his aircraft, but at the last moment realised that it would hit his propeller and therefore attempted to shut the engine down. However the outer section of the wing struck his propeller while the engine was rotating at approximately 1,000 rpm.

Position of G-BBSA and G-WARP after the collision
(Photograph courtesy Ronaldsway Airport)

The occupants of both aircraft were uninjured. Approximately 0.3 m of the outer section of the right wing and aileron on G-WARP had been severed. The propeller on G-BBSA sustained some slight damage and the engine was suspected of having been shock-loaded.
