# AAIB Bulletin 3/2015

## *SPECIAL*

### ACCIDENT

<b>Aircraft Type and Registration:</b>	Hawker Hunter T7, G-BXFI	
<b>No &amp; Type of Engines:</b>	1 x Rolls-Royce Avon Mk 122 turbojet engine	
<b>Year of Manufacture:</b>	1959 (Serial no: 41H-670815)	
<b>Location</b>	Near Shoreham Airport, West Sussex	
<b>Date &amp; Time (UTC):</b>	22 August 2015 at 1222 hrs	
<b>Type of Flight:</b>	Private	
<b>Persons on Board:</b>	Crew - 1	Passengers - None
<b>Injuries:</b>	Crew - 1 (Serious)	Passengers - N/A Other - 11 (Fatal)
<b>Nature of Damage:</b>	Aircraft destroyed	
<b>Commander's Licence:</b>	Airline Transport Pilot's Licence	
<b>Commander's Age:</b>	51 years	
<b>Flying experience:</b>	14,249 hours (of which 40 hours were on type) Last 90 days - 115 hours Last 28 days - 53 hours	
<b>Information Source:</b>	AAIB Field Investigation All times in this bulletin are UTC

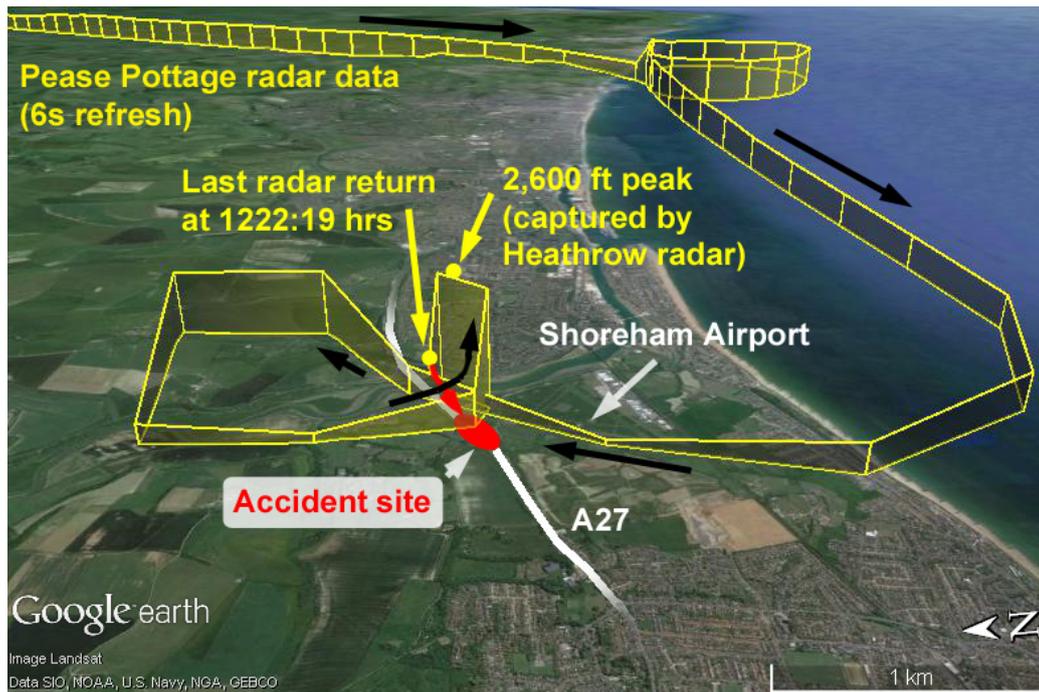
**Figure 1**

Approximate flight path derived from Pease Pottage radar data

Having rolled upright and wings level, the descent was continued to 800 ft amsl and a right turn made to line up with the display line to the west of Runway 02/20 at Shoreham (see Figure 1). The aircraft remained in a gentle right turn with the angle of bank decreasing as it descended to 100 ft amsl and flew along the display line. It commenced a gentle climbing right turn to 1,600 ft amsl, executing a Derry turn<sup>2</sup> to the left and then commenced a descending left turn to 200 ft amsl, approaching the display line at an angle of about 45°. The aircraft then pitched up into a manoeuvre with both a vertical component and roll to the left, becoming almost fully inverted at the apex of the manoeuvre at a height of approximately 2,600 ft amsl. During the descent the aircraft accelerated and the nose was raised but the aircraft did not achieve level flight before it struck the westbound carriageway of the A27 at its junction with Old Shoreham Road.

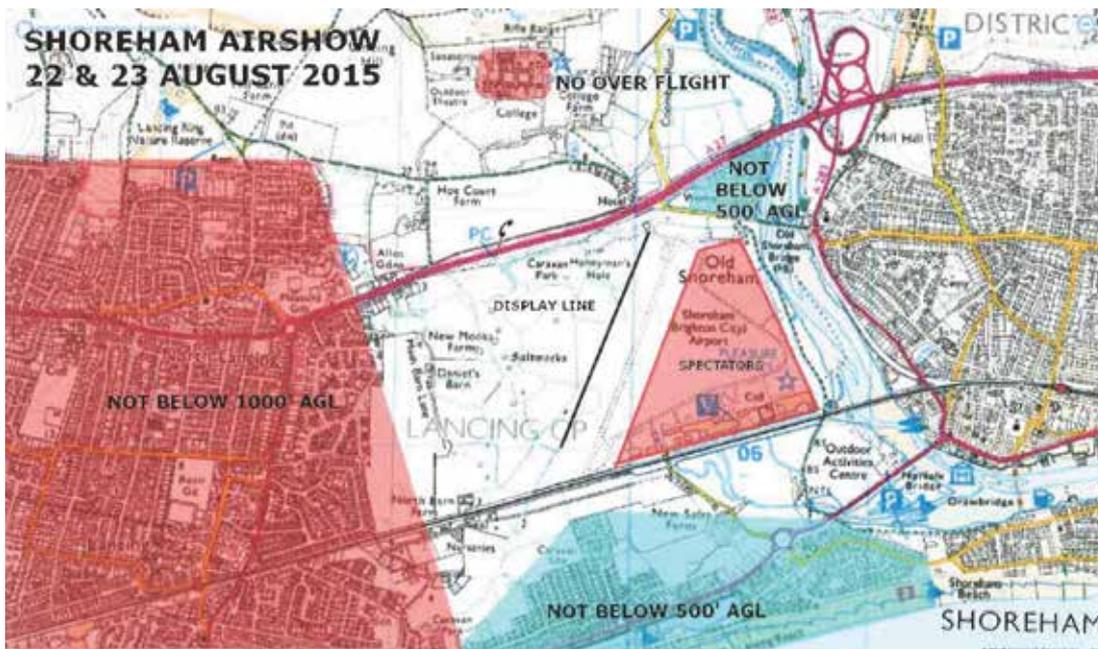
**Figure 2**

The Shoreham Airport display map

A large organised air display was being undertaken with the required minimum separation from the crowd determined according to aircraft speed and the type of display being flown. The relevant display axis for G-BXFI was 230 m from the crowd line, parallel with, and on the other side of, the main runway. The extended centreline of the display axis therefore passed through the junction of the A27 and Old Shoreham Road.

A copy of the of the Shoreham Airport display map is shown at Figure 2 above.

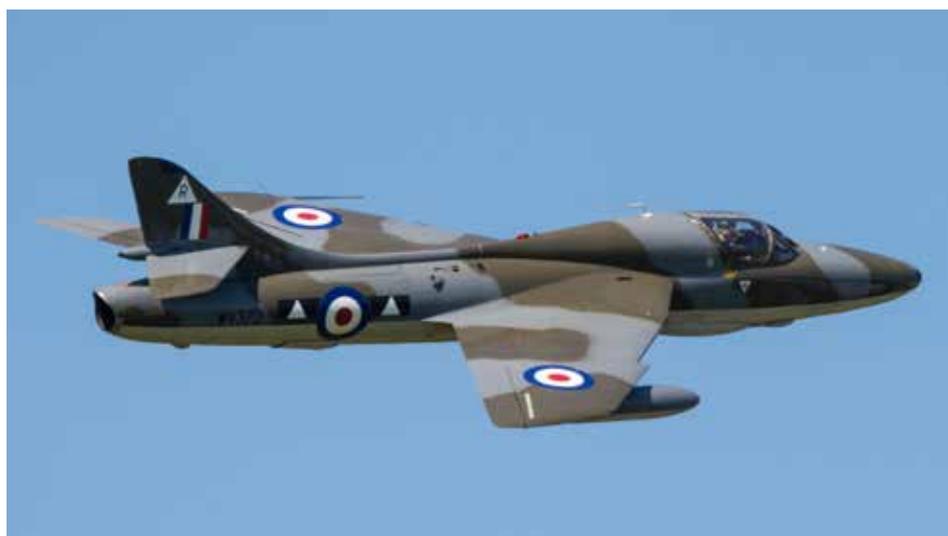
**Figure 3**

Hawker Hunter G-BXFI during the initial 'fly past'.  
(Photo courtesy N Watkin)
