ACCIDENT

Aircraft Type and Registration:	Bolkow BO 207, G-EFTE	
No & Type of Engines:	1 Lycoming O-360-A1A piston engine	
Year of Manufacture:	1961 (Serial no: 218)	
Date & Time (UTC):	6 June 2015 at 13:30 hrs	
Location:	Chichester (Goodwood) Airfield, West Sussex	
Type of Flight:	Private	
Persons on Board:	Crew - 1	Passengers - 1
Injuries:	Crew - None	Passengers - None
Nature of Damage:	Damage to propeller, spinner, cowling and engine shock-loaded	
Commander's Licence:	Private Pilot's Licence	
Commander's Age:	58 years	
Commander's Flying Experience:	825 hours (of which 100+ were on type) Last 90 days - 7 hours Last 28 days - 3 hours	
Information Source:	Aircraft Accident Report Form submitted by the pilot and further enquiries by the AAIB

Synopsis

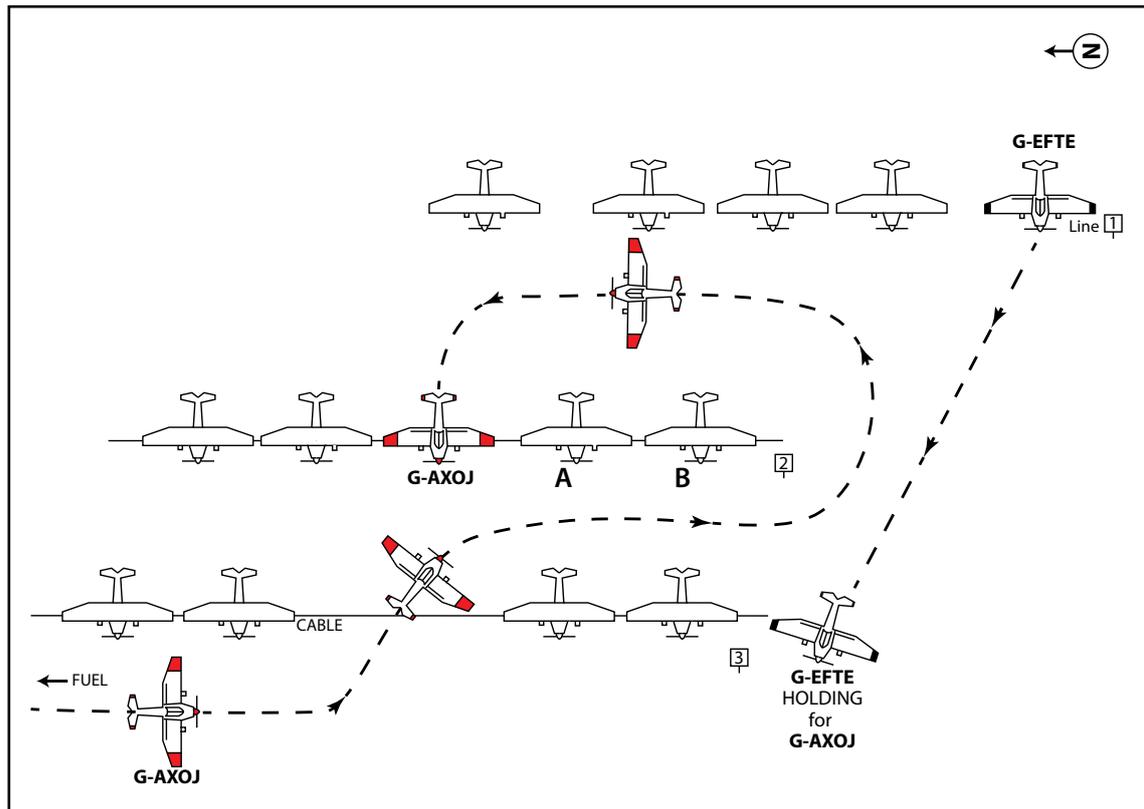
Figure 1

G-EFTE, a Bolkow BO 207 with a tailwheel configuration, was parked on the southern end of parking row 1 at Goodwood Airfield (Figure 1). After pre-flight checks the pilot requested taxi clearance and was told to taxi to the hold of Runway 24. The wind was from 250° at 15 kt. He taxied forwards, into wind, with the stick held full back and as he approached the southern end of parking row 2 he observed a Beagle Pup, registration G-AXOJ, approaching along the taxiway from his right. He stopped the aircraft at the southern end of parking row 3 and expected G-AXOJ to pass in front of him and turn left. However, G-AXOJ turned left through a gap of parked aircraft on row 3 to pass behind G-EFTE (Figure 1). The pilot of G-EFTE then lost sight of G-AXOJ and prepared to move forward but had to hold for another aircraft taxiing in front. As he was about to move forward again, or while starting to move, the tail of his aircraft lifted up and the propeller struck the ground.

Sketch of the parking area and aircraft tracks (not to scale)

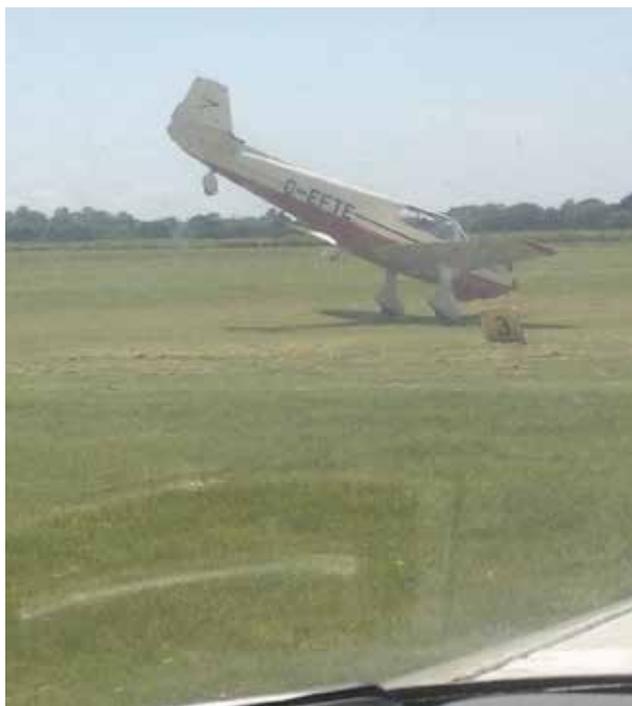
Figure 2

As G-EFTE was about to taxi forwards, or while starting to move forward, the tail of the aircraft lifted up and the propeller struck the ground. Another aircraft, G-AXOJ, was nearby and its propwash may have affected G-EFTE but there were conflicting witness accounts on whether this occurred.

An eye witness to the event was a pilot conducting pre-flight checks while sitting in the left front seat of a Piper PA-28 parked on row 2 in position A or B as shown in Figure 1. She observed G-EFTE taxi in front of her aircraft and stop next to the row 3 sign. She then saw G-AXOJ taxi through a gap of parked aircraft on row 3 and taxi towards her in front of row 2. G-AXOJ then stopped in front of her aircraft and she believed the pilot was looking for somewhere to park. The aircraft then taxied behind G-EFTE and at some point "put on a fair bit of power", and as they did this the tail of G-EFTE began to lift into the air. She reported that the pilot of G-AXOJ did not appear to look at G-EFTE and taxied away to park. She took a photograph of G-EFTE resting on its propeller, before the fire service arrived (Figure 2).

Photograph of G-EFTE taken by the eyewitness in the parked Piper PA-28

It was not possible, from the conflicting accounts, to determine the cause of G-EFTE tipping onto its propeller. However, regardless of the cause, the accident serves as a useful reminder of being careful when adding power while taxiing near other aircraft, especially near tailwheel aircraft or other 'taildragger' types.
