ACCIDENT

Aircraft Type and Registration:	North American T-28A Trojan, N14113	
No & Type of Engines:	1 Wright 1820-768 radial piston engine	
Year of Manufacture:	1951 (Serial no: 81-1)	
Date & Time (UTC):	30 April 2015 at 1111 hrs	
Location:	Duxford Airfield, Cambridgeshire	
Type of Flight:	Private	
Persons on Board:	Crew - 1	Passengers - None
Injuries:	Crew - None	Passengers - N/A
Nature of Damage:	Nose landing gear failure, engine shock-loaded, propeller blade tips bent	
Commander's Licence:	Airline Transport Pilot's Licence	
Commander's Age:	70 years	
Commander's Flying Experience:	17,915 hours (of which 160 were on type) Last 90 days - 2 hours Last 28 days - 1 hour	
Information Source:	Aircraft Accident Report Form submitted by the pilot and additional inquiries made by the AAIB

Synopsis

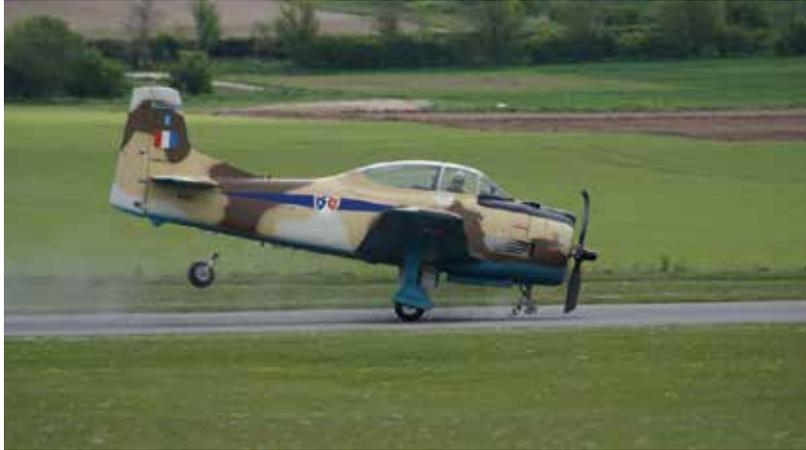
The aircraft was on its takeoff run for an air test after annual maintenance and, as it accelerated through 80 kt IAS, the pilot became aware of a pronounced and severe lateral vibration through the airframe. The pilot immediately closed the throttle and the nose of the aircraft simultaneously dropped as the nosewheel and yoke detached. The propeller struck the runway and stopped; the aircraft continued an estimated 150 yards before coming to a stop on the runway, resting on its main landing gear and the remains of the NLG strut. The pilot made the aircraft safe and exited without further incident. Figure 1 shows the nosewheel and yoke detaching during the takeoff run.

Nosewheel and yoke detachment during the takeoff run
(Picture courtesy of Mr Brian Marshall)
