ACCIDENT

Aircraft Type and Registration:	Dassault Falcon 20D, G-FRAK
No & Type of Engines:	2 x General Electric CO CF700-2D-2
Year of Manufacture:	1969
Date & Time (UTC):	25 April 2015 at 1650 hrs
Location:	English Channel, approximately 20 nm south of Portland Bill
Type of Flight:	Special operations, target towing
Persons on Board:	Crew - 3 Passengers - None
Injuries:	Crew - None Passengers - N/A
Nature of Damage:	Wing leading edge torn and dented, winch carrier damaged, target lost at sea
Commander's Licence:	Air Transport Pilot's Licence
Commander's Age:	64
Commander's Flying Experience:	12,700 hours (of which 9,000 were on type) Last 90 day - 121 hours Last 28 days - 32 hours
Information Source:	AAIB Field Investigation

Synopsis

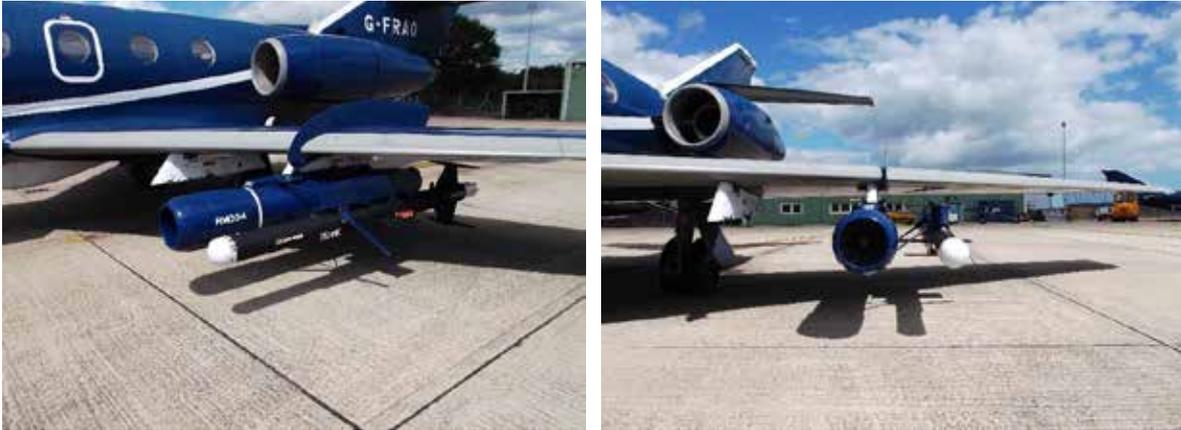
Figure 3

The aircraft was fitted with a Meggitt RM30/ASL target winch, sometimes referred to as a reeling machine, which was mounted on a pylon under the left wing, at around mid-semi-span, Figure 3. There is a carrier, sometimes called a launcher, attached to the outboard side of the winch by a series of struts, under which the target is stowed.

Images of winch, target, launcher and pylon

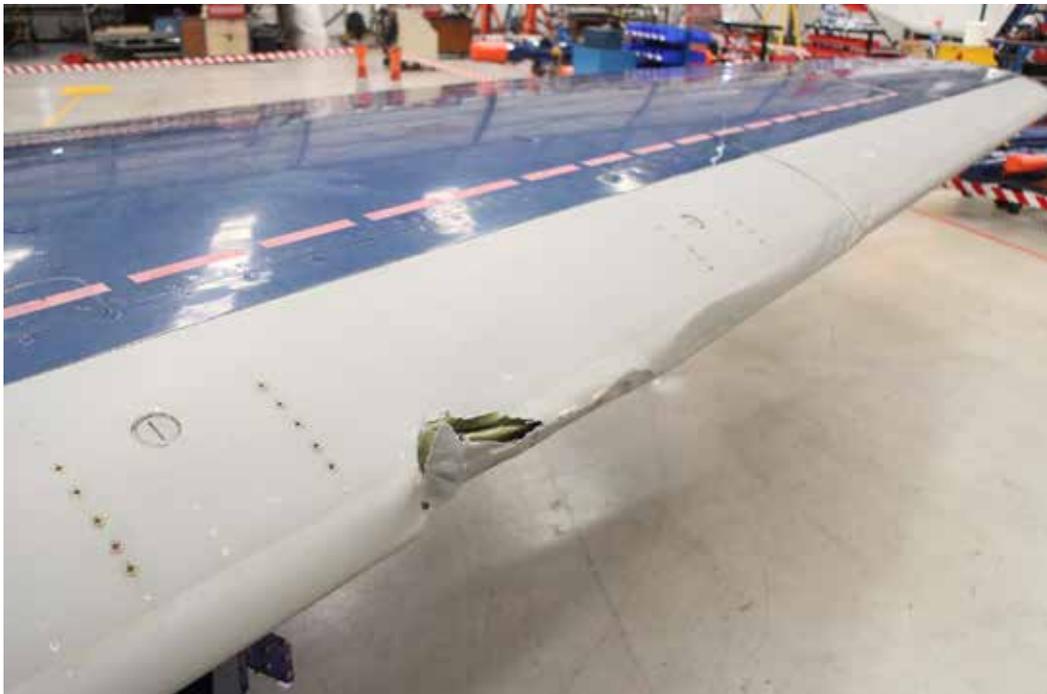
Figure 4

There was damage to the droop leading edge on the left wing and the struts between the target winch and the launcher. There was also deformation to the pylon where it attached to the wing spar, Figure 4.

Image showing damage to leading edge

The video evidence clearly showed a significant increase in cable speed with approximately 40 m of cable left to recover, and the vent doors could be seen approximately half-open.

The limit switches for the vent doors OPEN and doors CLOSED were tested. The CLOSED switch was found to have a variable, high impedance and failed open circuit once during testing. An open circuit prevents the servo motor from operating in the closed direction. If the servo motor was not at the closed limit then an open circuit on the CLOSED switch would have prevented the vent doors from closing and the spool would speed up.

The target accelerated during the latter stages of its recovery, causing it to strike the aircraft. The acceleration was probably due to an overspeed of the target winch as a result of the failure of the vent door CLOSED limit switch preventing the vent doors from closing when commanded. The turbine would then have spooled up, increasing the torque and resulting in the winch accelerating.

Because the vent door limit switches are on condition items, the winch manufacturer issued a Service Bulletin 094 on 13 May 2015 recommending:

- Replacing the cable harness (which includes the two vent door limit switches) every 10 years.
- Performing a ground test on the winch doors every 20 missions.
- The TTO should check, during recovery, the length display for the 'tens' changing from once per second to the 'units' changing to about once per second, after transition to SLOW.

- Painted markings on the vent doors to enhance visual cues for movement.
- Changed its recovery procedure so that the Pilot Monitoring is seated on the same side as the active winch. His task from 1,000 m of cable remaining, is to observe the vent doors for correct movement.

- Changed its recovery procedure so that the TTO selects slow with 130 m of cable remaining to be reeled in, rather than at 60 m. This gives the crew more time to detect an erroneous speed condition, and the system more time to detect an overspeed condition.
- Tested the vent door limit switches and introduced recurrent testing every 4 hours of winch running.
- Commenced a door limit switch replacement programme.

It is recommended that the European Aviation Safety Agency, require that Meggitt Defense Systems Inc review the design, maintenance and operation of the RM30 and similar winches to reduce the possibility of an uncommanded target acceleration during recovery.
