Report on the investigation of
the capsizing and foundering of

FV Stella Maris

14 miles east of Sunderland

28 July 2014

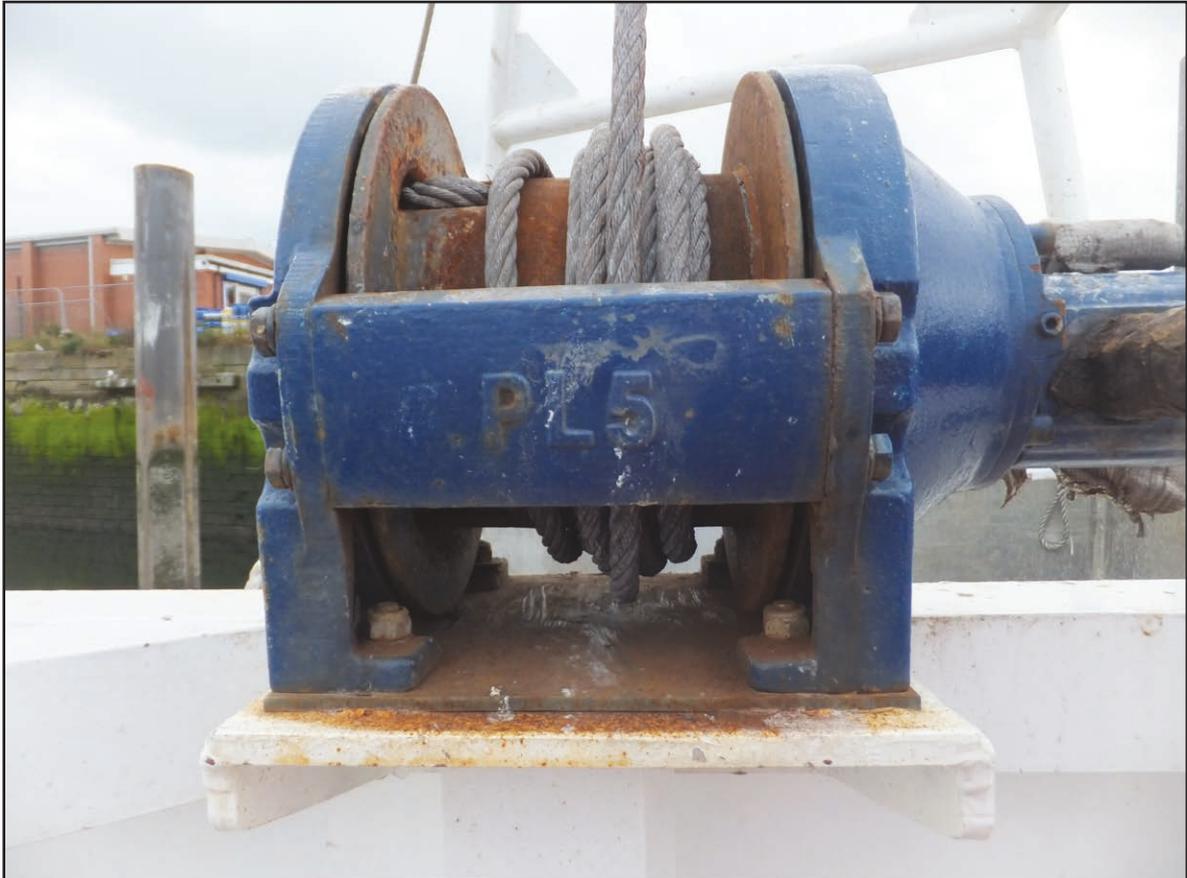
Figure 4: Gilson winch showing build up of wire

The gilson winch, which had a 2.8t first layer pull capacity, hoisted the heavy cod end from the sea until it was almost above the transom bulwark. As successive layers of wire built up on the winch, its pulling capability reduced (**Figure 4**). The skipper realised that the weight was too great to be safely lifted at about the same time as the winch's pressure relief valve lifted, due to the excessive load, preventing further hoisting of the cod end.

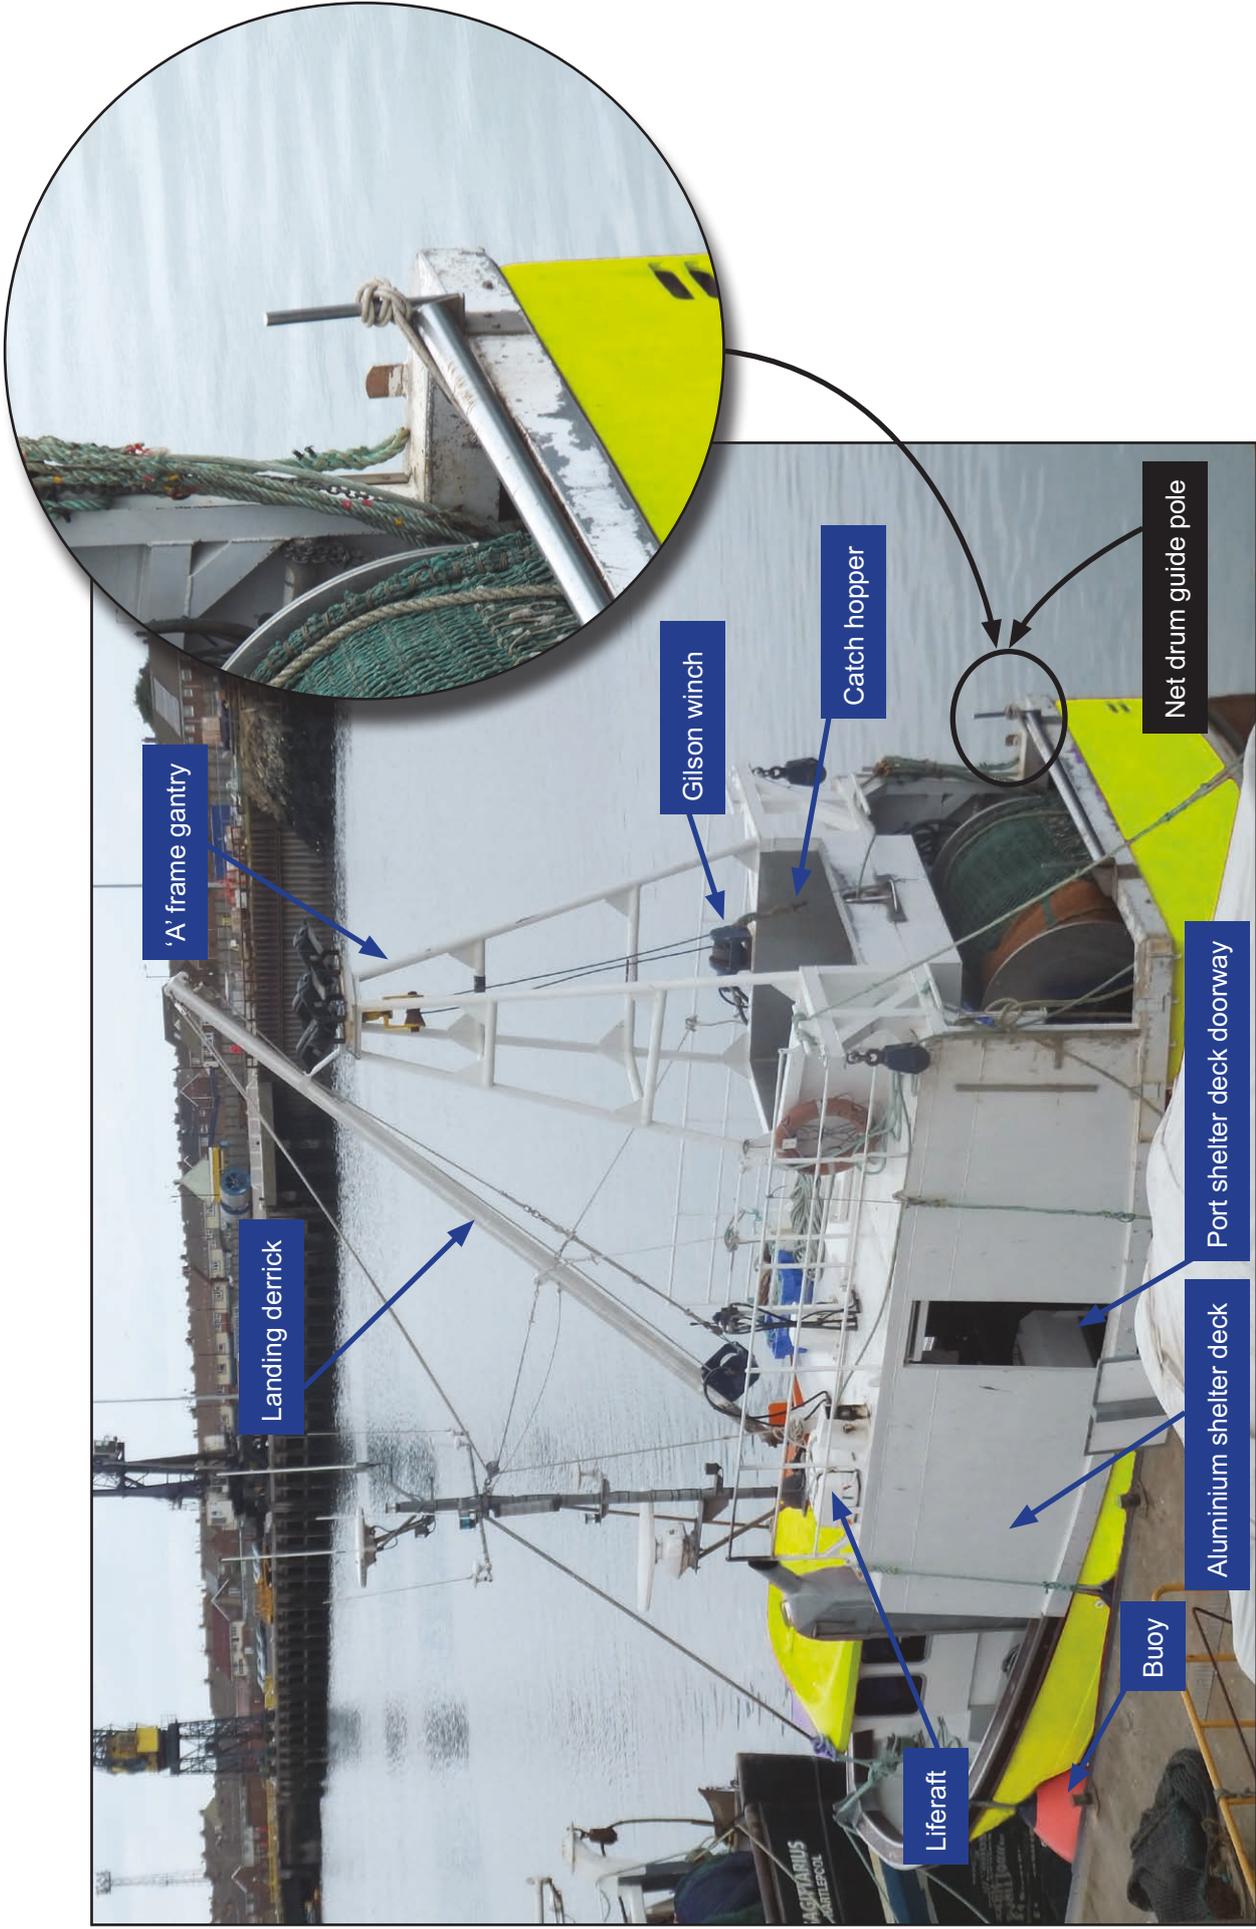
Figure 5: Pertinent fabrications and equipment

At this stage, the starboard freeing ports were submerged, causing the deck to flood and the list to increase, until the starboard quarter bulwark was also submerged. The skipper then ran forward with the intention of fetching the saw stored by the wheelhouse door to cut the net free from the guide pole, while the deckhand, aware that the vessel was on the verge of capsizing, ran forward on the port side to escape the shelter deck by the midships door (**Figure 5**).

- Removal of the starboard side gilson derrick (**Figure 10**), and thus the need to lay broadside on to wind and seas when lifting the cod end on board. This was replaced with an “A” frame gantry aft (**Figure 5**) with a lifting point that was at least 1m higher than the original derrick. This enabled the cod end to be lifted over the stern as the vessel made way slowly ahead.

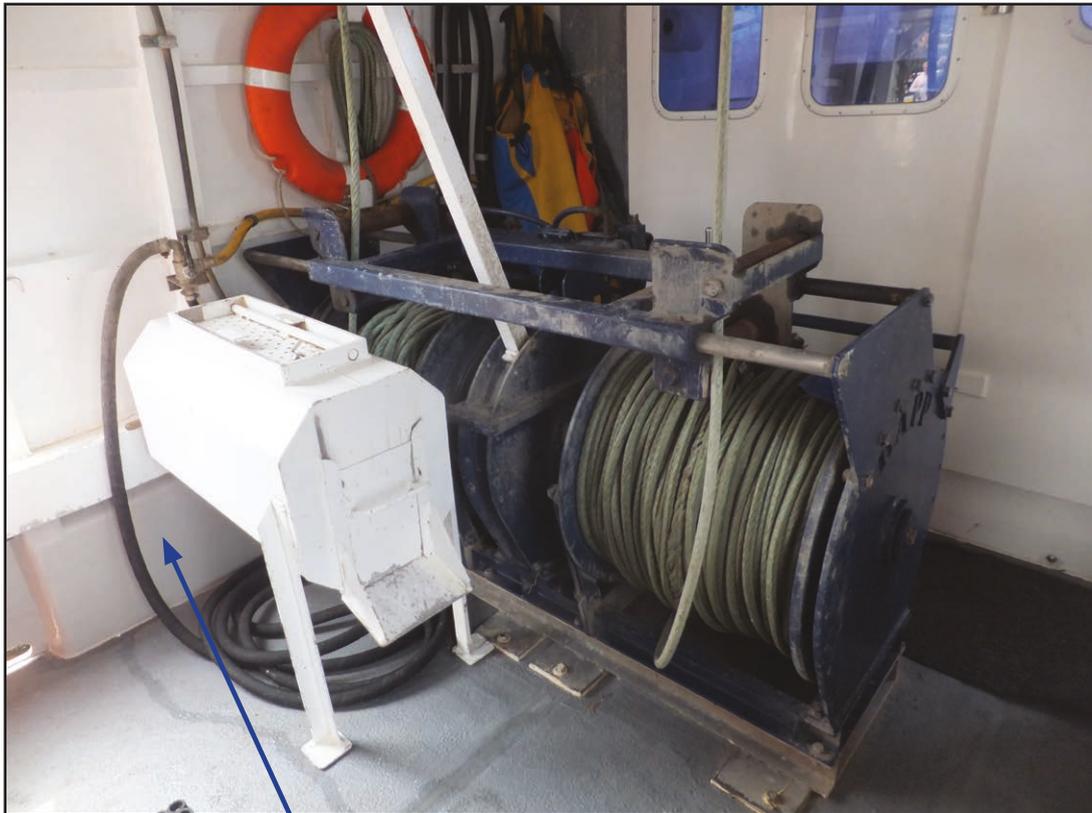
Figure 11: Position of port side engine room air intakes between bulwark frames

As built, *Stella Maris* (**Figure 10**) was arranged as a conventional small stern trawler, with the wheelhouse forward and the working deck aft of the wheelhouse. The hull and deckhouse were constructed of GRP, the gutting shelter was GRP sheathed 25mm thick plywood and all other original fabrications (gallows, gilson derrick, gantry and landing derrick) were made of steel. The air vents for the engine room were built into the bulwarks athwartships of the trawl winch (**Figure 11**) and terminated below top rail height.

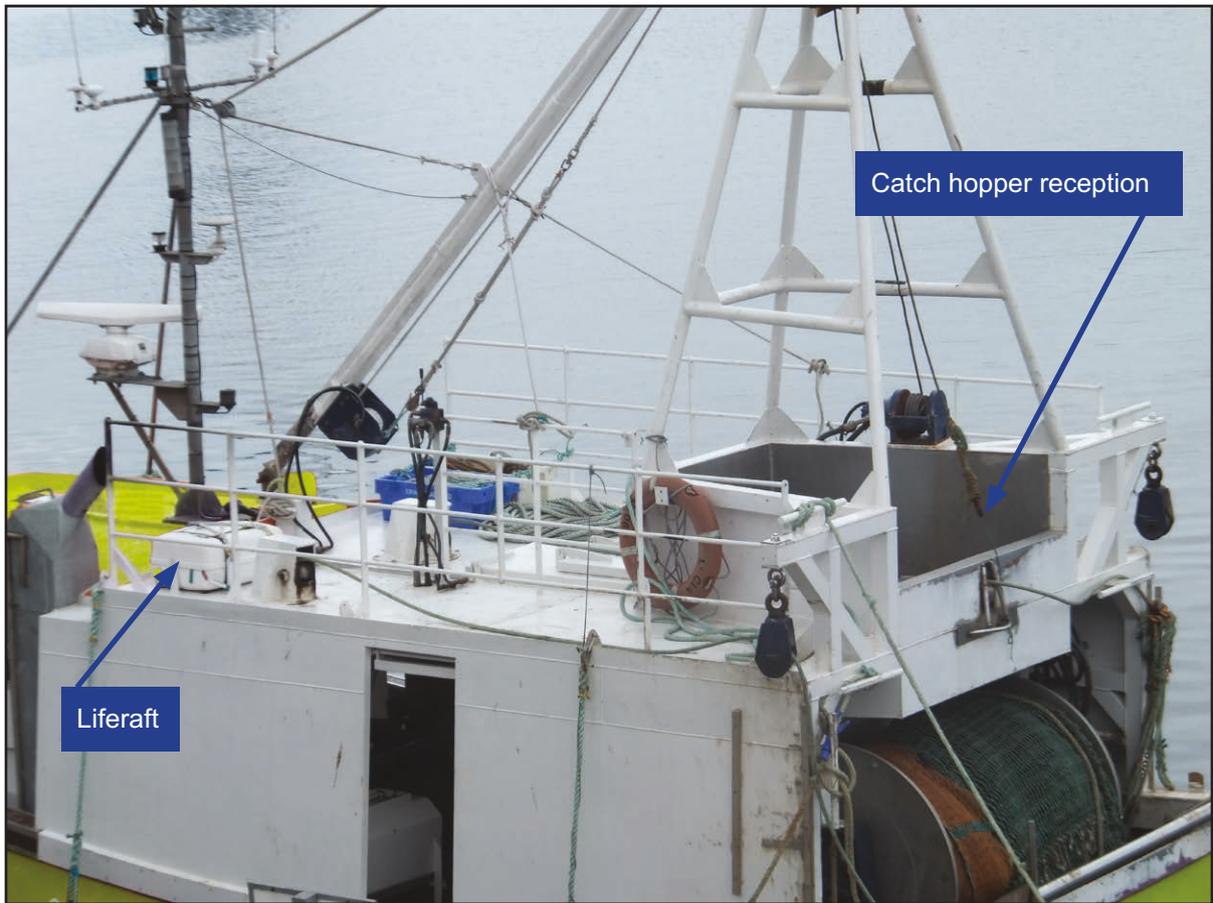
Figure 12: Position of catch hopper below gantry

- Replacement of the original net drum with a lighter unit, further reducing top weight.
- Installation of a catch hopper (**Figure 12**) below the “A” frame gantry, enabling deposited catch to gravity feed onto a sorting table for processing (**Figure 13**). This removed the previous requirement of manually shovelling the fish from the deck, which was labour intensive and damaged the catch. The catch hopper also enabled faster processing, allowing the fish to be put on ice earlier, further improving their quality.

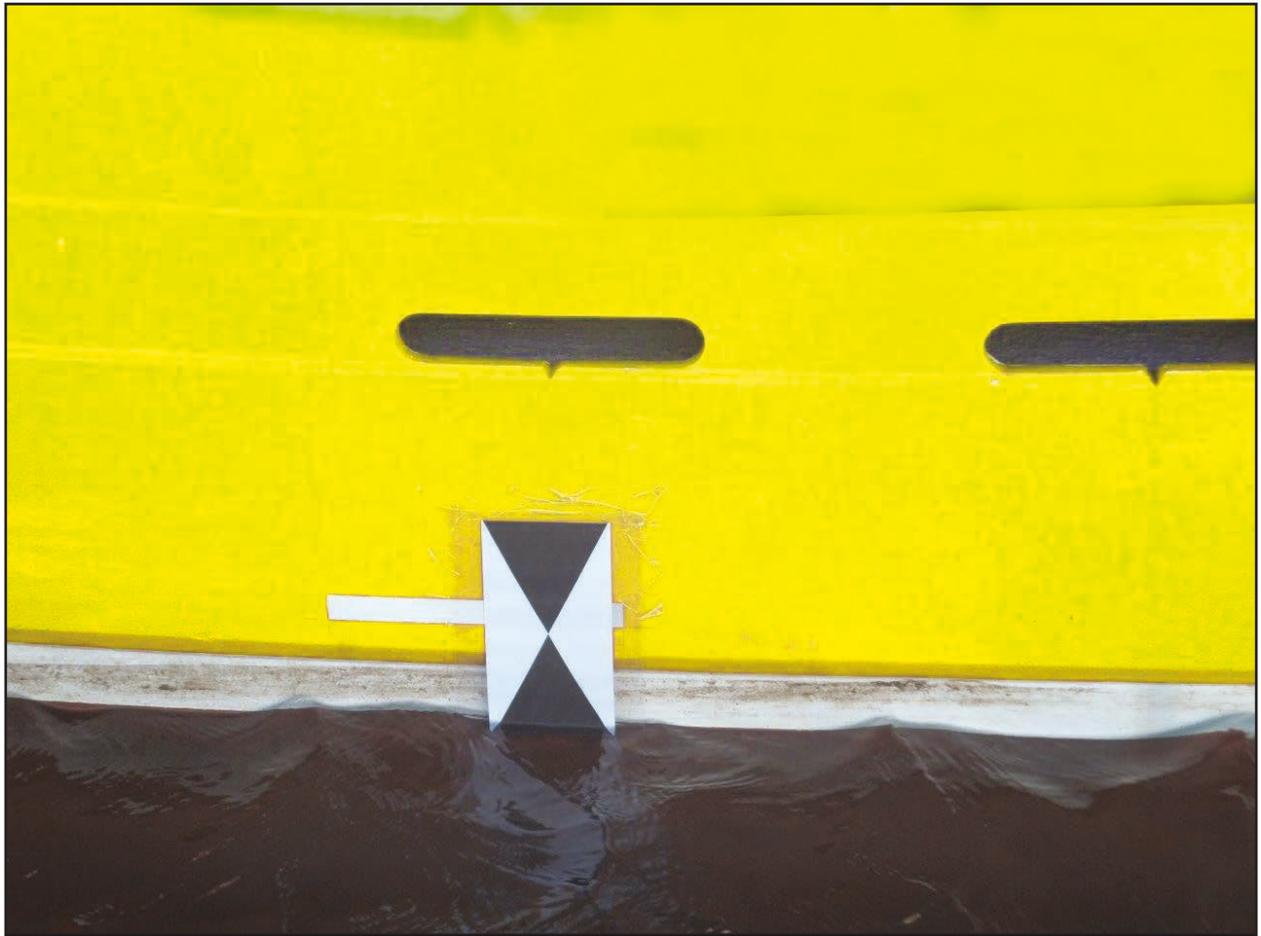
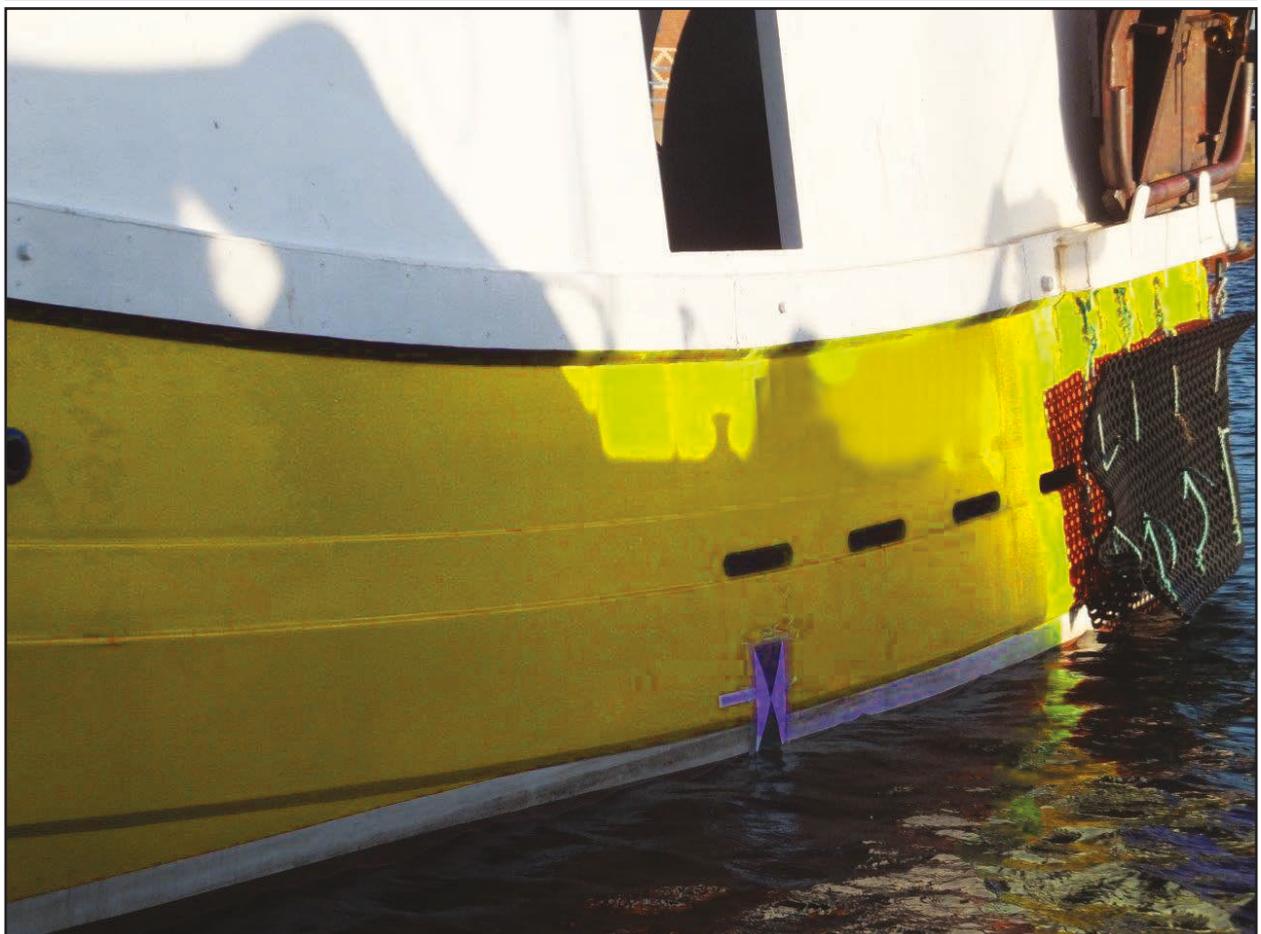
Figure 16: Wolfson guidance mark in place

3. The Wolfson guidance mark (section 1.9) was temporarily applied, indicating the vessel was on the dividing line between green and amber safety zones in the depart port condition.

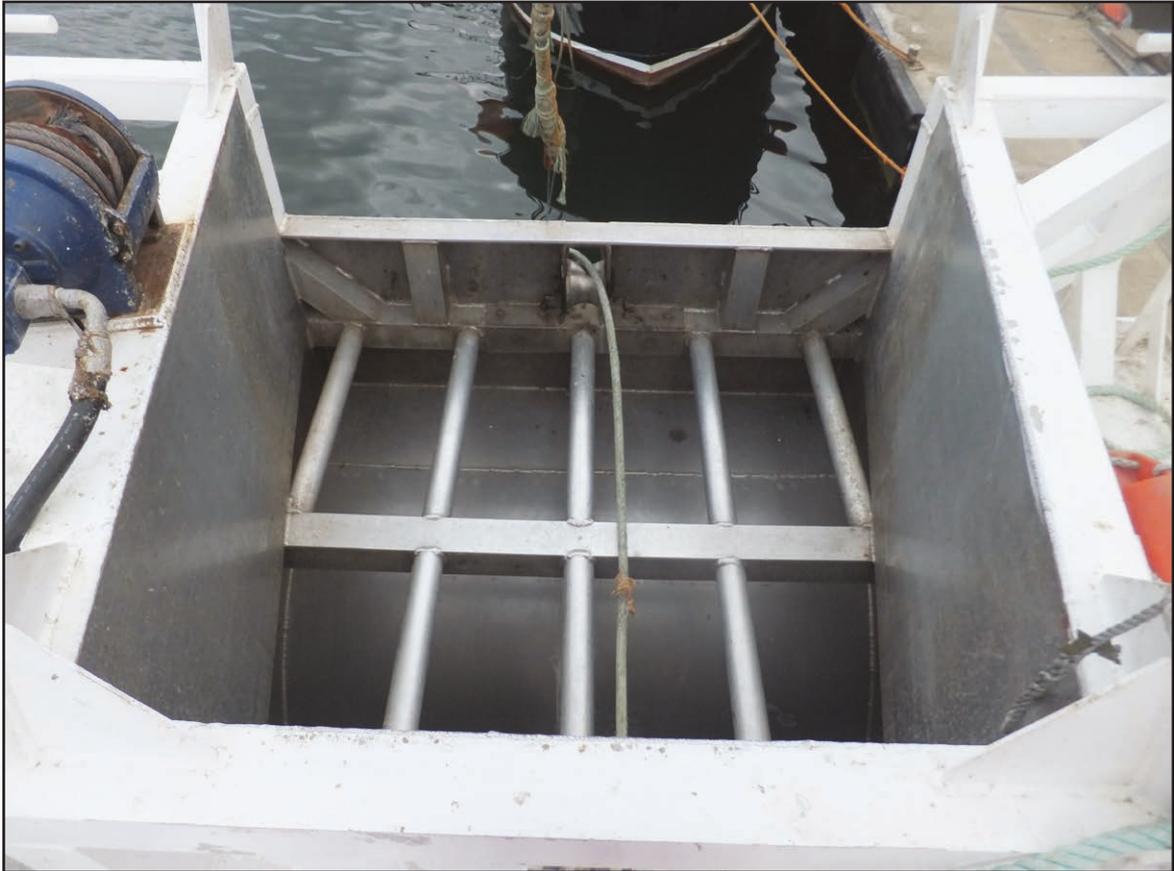
Figure 17: Catch hopper seen from above

Following modification, the catch was stowed in a gravity feeding hopper at a height of between 1 and 2m above deck level and, although this greatly reduced the manual effort and improved catch quality, the vessel's stability would have been greatly impaired while the weight was in the hopper (although the hopper had a capacity of 1.1t, it is understood that it was not loaded to more than half of its capacity by the operators of *Stella Maris*.)
