ACCIDENT

Aircraft Type and Registration:	Beech 95-B55 Baron, G-RICK	
No & Type of Engines:	2 Continental Motors Corp IO-470-L piston engines	
Year of Manufacture:	1972 (Serial no: TC-1472)	
Date & Time (UTC):	3 May 2015 at 1113 hrs	
Location:	West of Abernyste, near Dundee, Scotland	
Type of Flight:	Private	
Persons on Board:	Crew - 1	Passengers - 1
Injuries:	Crew - 1 (Fatal)	Passengers - 1 (Fatal)
Nature of Damage:	Aircraft destroyed	
Commander's Licence:	Airline Transport Pilot's Licence	
Commander's Age:	37 years	
Commander's Flying Experience:	3,900 hours (of which 100 were on type) Last 90 days - 60 hours Last 28 days - 33 hours	
Information Source:	AAIB Field Investigation

Synopsis

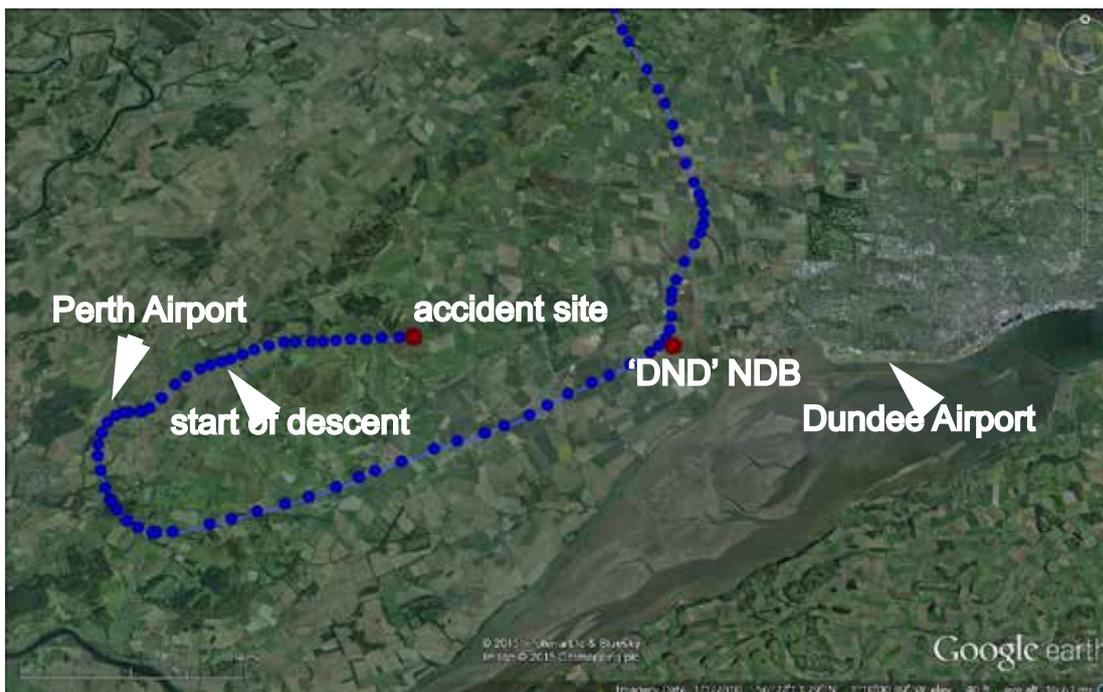
Figure 1 shows the last 8 minutes of recorded ground track as G-RICK tracked south towards the 'DND' beacon, before turning right to follow the procedural pattern for the Dundee ILS/DME approach to Runway 09. The outbound leg was extended, beyond the procedure, to a distance of 11 nm from the DME. The final descent commenced when the aircraft was 6.7 nm from the 'DND' beacon (9.4 nm from the DME), on an easterly track back towards the 'DND'.

Final 8 minutes of G-RICK's ground track recorded by the GPSMAP 696

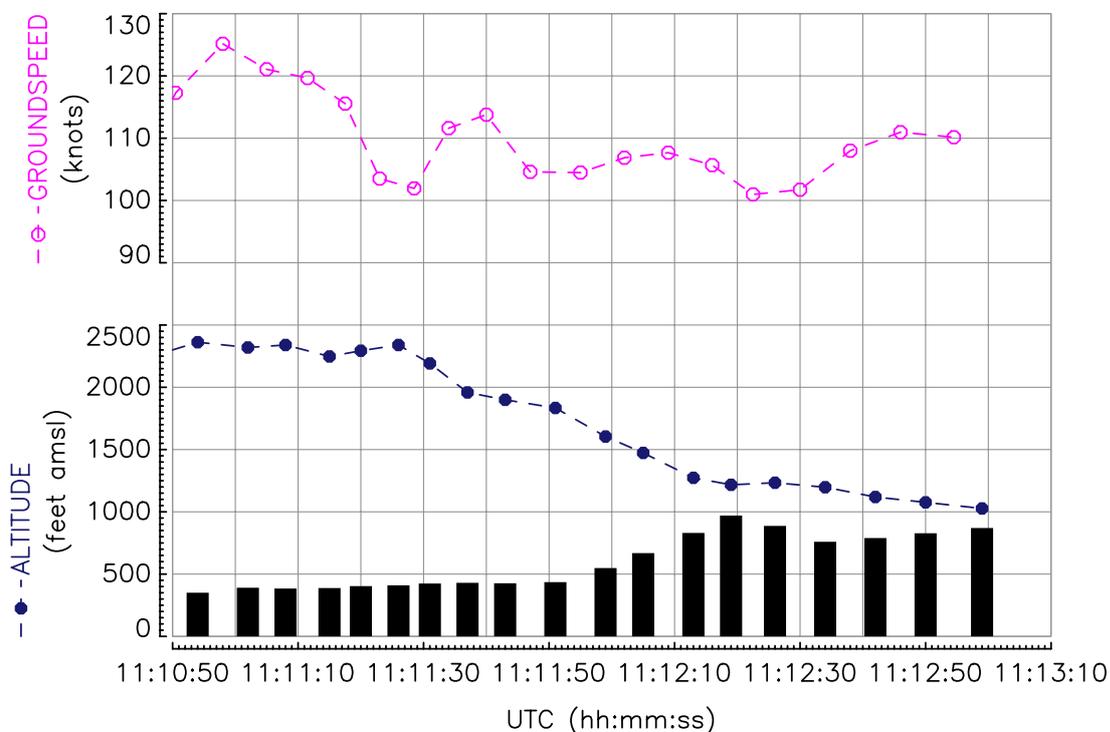
The altitude and ground profile on the approach toward Dundee are shown in Figure 2 (starting just after passing Perth Airport). Also plotted in Figure 2 is G-RICK's groundspeed, which was between 100 and 110 kt during the final descent.

Altitude recorded by the GPSMAP 696 (with ground elevation indicated by black bars) and calculated groundspeed (averaged between points)

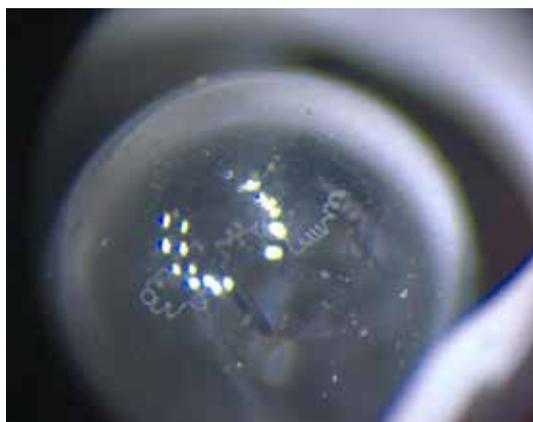
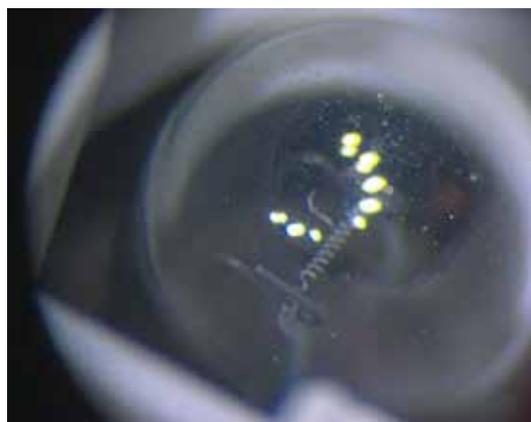
Figure 5

The navigation and radio equipment was severely damaged by the impact forces and it was not possible to determine their settings. However, examination of the HSI source annunciator bulb filaments under a microscope showed that the GPS filament had characteristic plastic deformation, indicating that it was illuminated at the time of impact (Figure 5). This indicated that GPS-derived navigation data was being displayed on the HSI at the time of the accident.

HSI source annunciator lightbulbs,
showing plastic deformation of the GPS bulb filament

to the 'DND' NDB. The GPS annunciator bulb confirmed that the HSI was being fed by the GPS rather than the ILS and the pilot's "FOUR MILE" R/T call, made when the aircraft was approximately 7 nm from the runway threshold, indicates that he had lost situational awareness⁸.

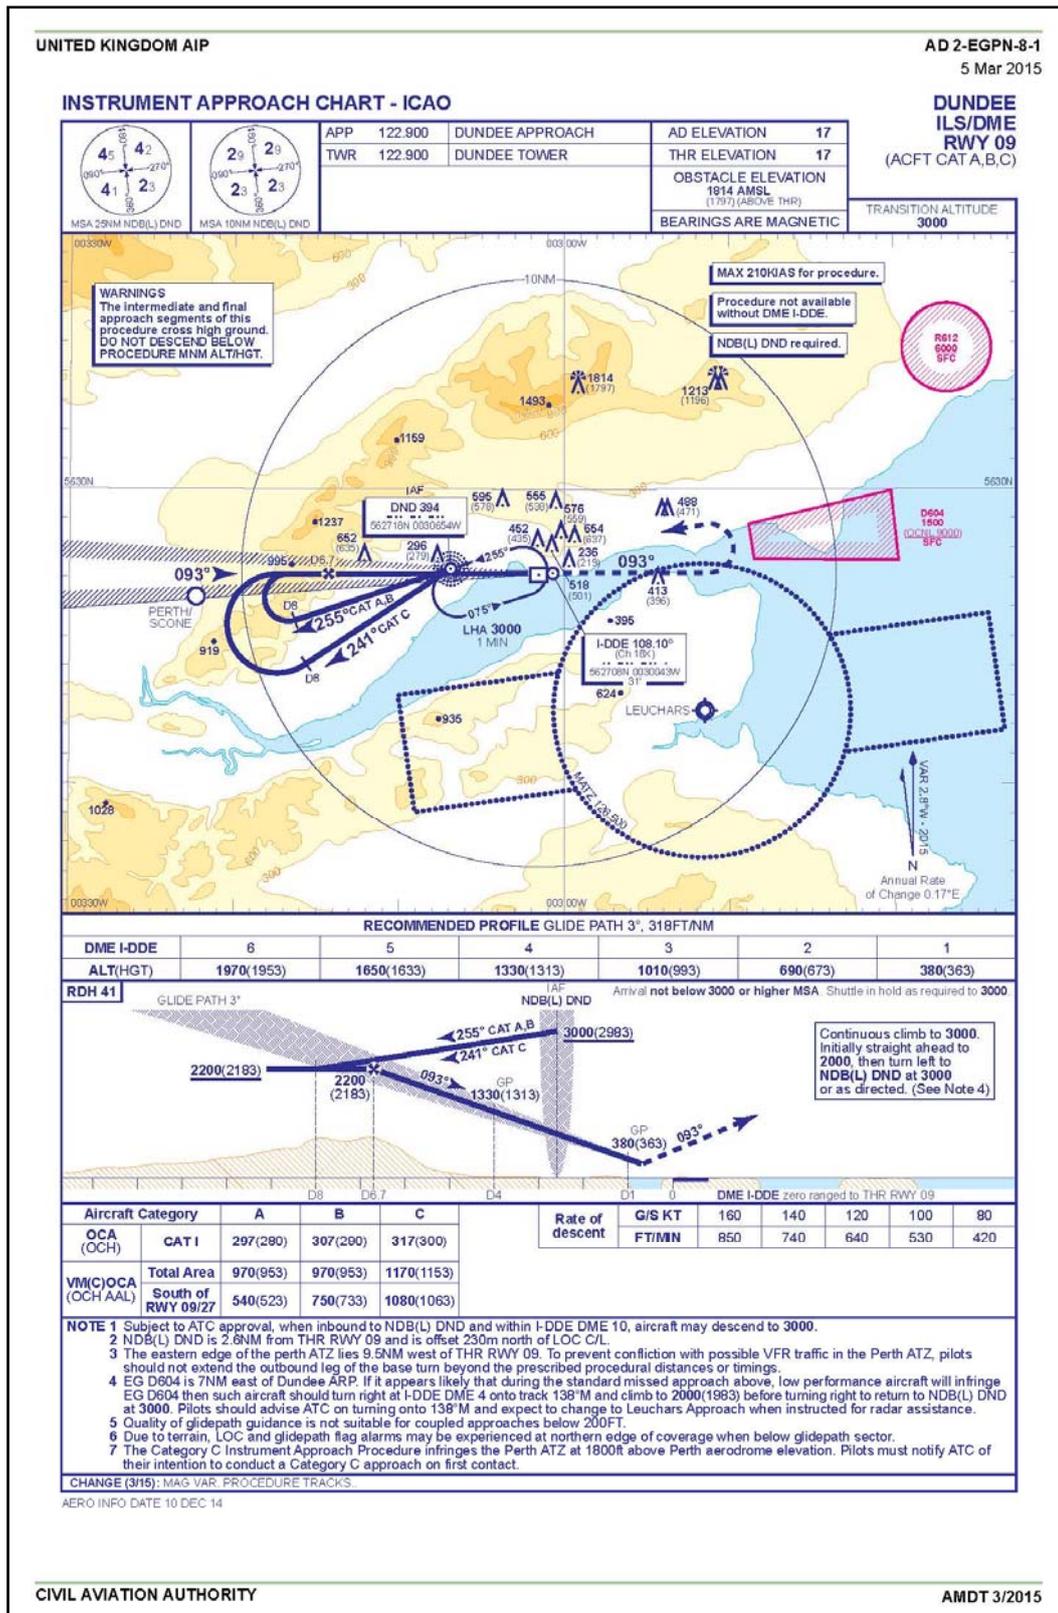
Figure 6

The published procedure (Figure 6) required the aircraft to fly over the 'DND' beacon at an altitude of 3,000 ft, then turn onto an outbound track (255° for this category of aircraft) and descend to 2,200 ft amsl. At a distance of 8 nm from the DME, pilots should commence a level right turn and use ILS guidance to intercept the localiser. Pilots should continue to fly level until they intercept the glidepath. As a cross-check, the approach chart indicates that glidepath interception at 2,200 ft should occur when the aircraft is 6.7 nm from the DME. The pilot should then follow the localiser and glidepath guidance down to the decision altitude. There are additional advisory heights on the approach chart at each nautical mile from touchdown.

Dundee ILS/DME RWY 09 approach, dated 5 March 2015

With no glideslope guidance, the pilot may have reverted to a Localiser/DME approach. This required a descent to start at 6.7 nm from the DME. However, the pilot commenced his descent at 9.4 nm from the DME; 6.7 nm from the 'DND'. This was probably the GPS distance displayed on the GNS 530W. If the pilot was flying the Localiser/DME approach profile to the 'DND'; he should have been at a height of 1,330 ft amsl at a distance of 4 nm, but the accident occurred with the aircraft at 900 ft amsl. The reason why the aircraft was so low is not clear. However, hill effect⁹ and turbulent conditions may have been contributory factors.
