**SERIOUS INCIDENT**

<b>Aircraft Type and Registration:</b>	Gulfstream G200, EC-KRN
<b>No &amp; Type of Engines:</b>	2 Pratt & Whitney PW306A turbofan engines
<b>Year of Manufacture:</b>	2008 (Serial no: 188)
<b>Date &amp; Time (UTC):</b>	14 January 2015 at 2127 hrs
<b>Location:</b>	London Luton Airport
<b>Type of Flight:</b>	Commercial Air Transport (Passenger)
<b>Persons on Board:</b>	Crew - 3                      Passengers - 3
<b>Injuries:</b>	Crew - None                      Passengers - None
<b>Nature of Damage:</b>	Damage to four mainwheels and tyres
<b>Commander's Licence:</b>	Airline Transport Pilot's Licence
<b>Commander's Age:</b>	40 years
<b>Commander's Flying Experience:</b>	3,169 hours (of which 2,010 were on type) Last 90 days - 65 hours Last 28 days - 33 hours
<b>Information Source:</b>	Aircraft Accident Report Form submitted by the pilot and further enquiries by the AAIB

**Synopsis**

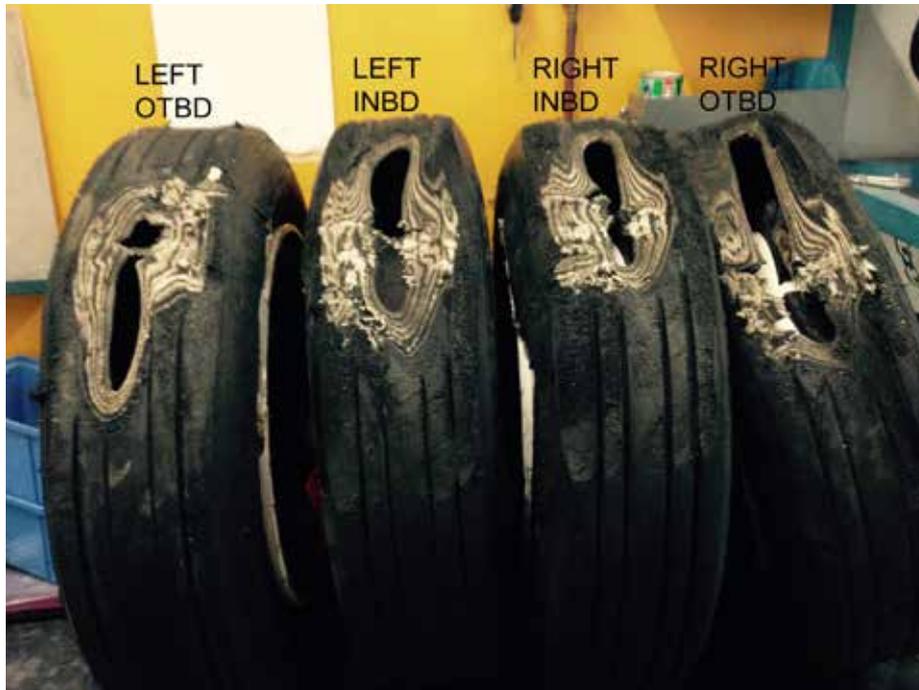
The aircraft was not examined by the AAIB but photographs taken by the operator revealed that all four tyres had flat spots which had worn through the tyre and carcass (Figure 2). The damage to the left tyres and the right inboard tyre appeared to be similar, while the damage to the right outboard tyre covered a more elongated area. All four wheels had suffered rim damage, but the most substantial rim damage was to the right outboard wheel (Figure 3).

**Figure 2**  
Damage to tyres

Within a second of touchdown there was a loud bang which was most likely one of the tyres bursting. The right outboard tyre and wheel had suffered the most damage so it was probably this tyre that burst first. The commander perceived that a second tyre burst on the right side a couple of seconds later but there was no associated sound on the CVR for this. The first tyre burst probably caused its wheel speed to drop below 30% of the aircraft's groundspeed so the 'locked wheel' condition was detected, which explains the triggering of the ANTI SKID OFF light. This would have resulted in a loss of brake pressure not only to the wheel with the burst tyre but also to its adjacent wheel. The remaining brake effectiveness would therefore have been 50% of normal braking effectiveness. This loss of braking, combined with the wet runway surface, was probably the reason why the flight crew were reporting braking difficulties on the CVR and it is what prompted them to select the emergency braking system<sup>5</sup>. Eight seconds after the emergency brake system was selected there were three loud short-duration sounds, within about seven seconds of each other. These were probably the sounds of the three remaining tyres bursting as a result of flat spots incurred during skidding. Without the protection of anti-skid very little brake pedal application is required to skid a tyre. These three tyres suffered less damage and made less noise when they burst than when the first tyre burst, probably because the aircraft had decelerated by this time and therefore there was less energy in the tyres.

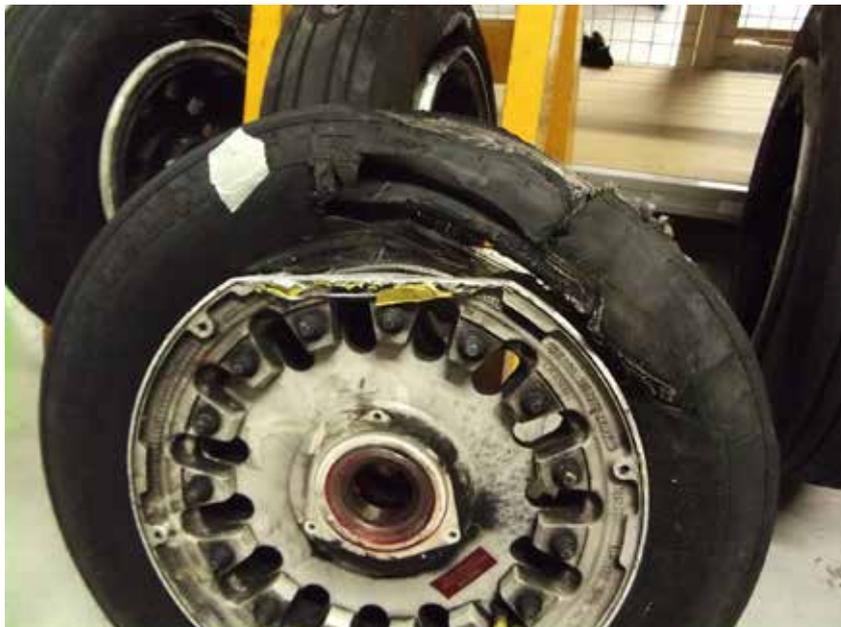
**Figure 3**  
Right outboard wheel rim damage
