## ACCIDENT

<b>Aircraft Type and Registration:</b>	Piper PA-28-140 Cherokee, G-BHXK	
<b>No &amp; Type of Engines:</b>	1 Lycoming O-320-E2A piston engine	
<b>Year of Manufacture:</b>	1965 (Serial no: 28-21106)	
<b>Date &amp; Time (UTC):</b>	4 April 2015 at 1030 hrs	
<b>Location:</b>	Near Loch Etive, Oban, Argyll and Bute	
<b>Type of Flight:</b>	Private	
<b>Persons on Board:</b>	Crew - 1	Passengers - 1
<b>Injuries:</b>	Crew - 1 (Fatal)	Passengers - 1 (Fatal)
<b>Nature of Damage:</b>	Aircraft destroyed	
<b>Commander's Licence:</b>	Private Pilot's Licence	
<b>Commander's Age:</b>	28 years	
<b>Commander's Flying Experience:</b>	150 hours <sup>1</sup> (of which 100 were on type) Last 90 days - 62 hours Last 28 days - 19 hours	
<b>Information Source:</b>	AAIB Field Investigation

## Synopsis

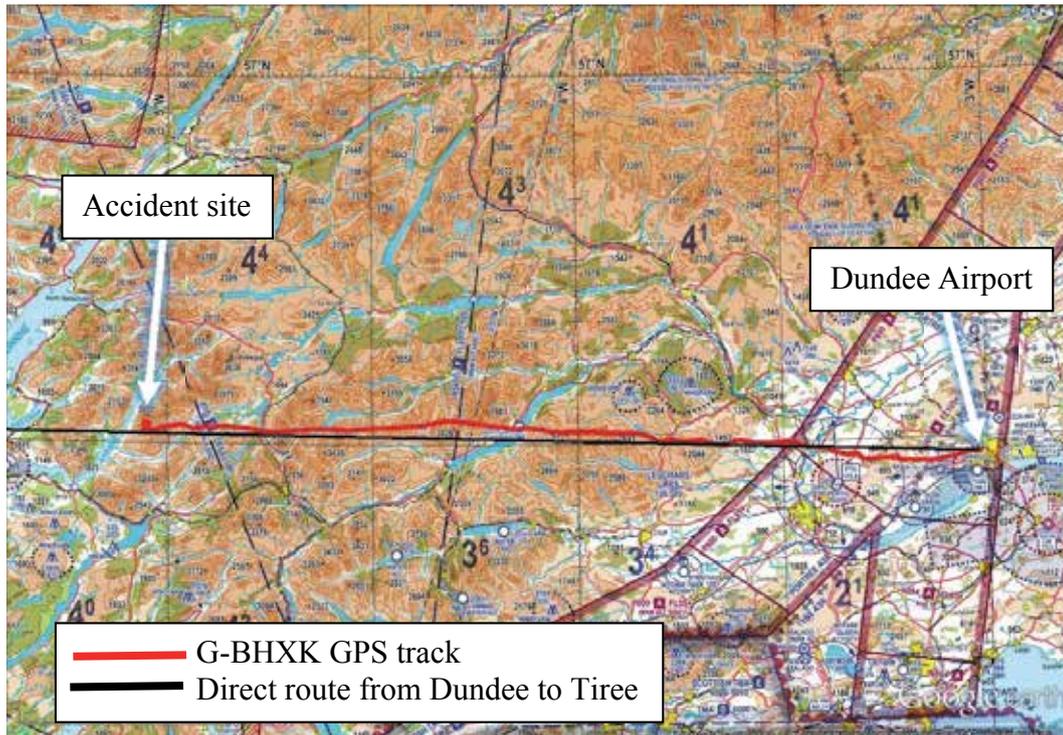
**Figure 1**

The aircraft continued on its westerly track (Figure 1), maintaining the same altitude on the regional QNH of 1023 HPa.

1:500,000 chart showing MSA, G-BHXX track (red) and direct route to Tiree from Dundee (black)

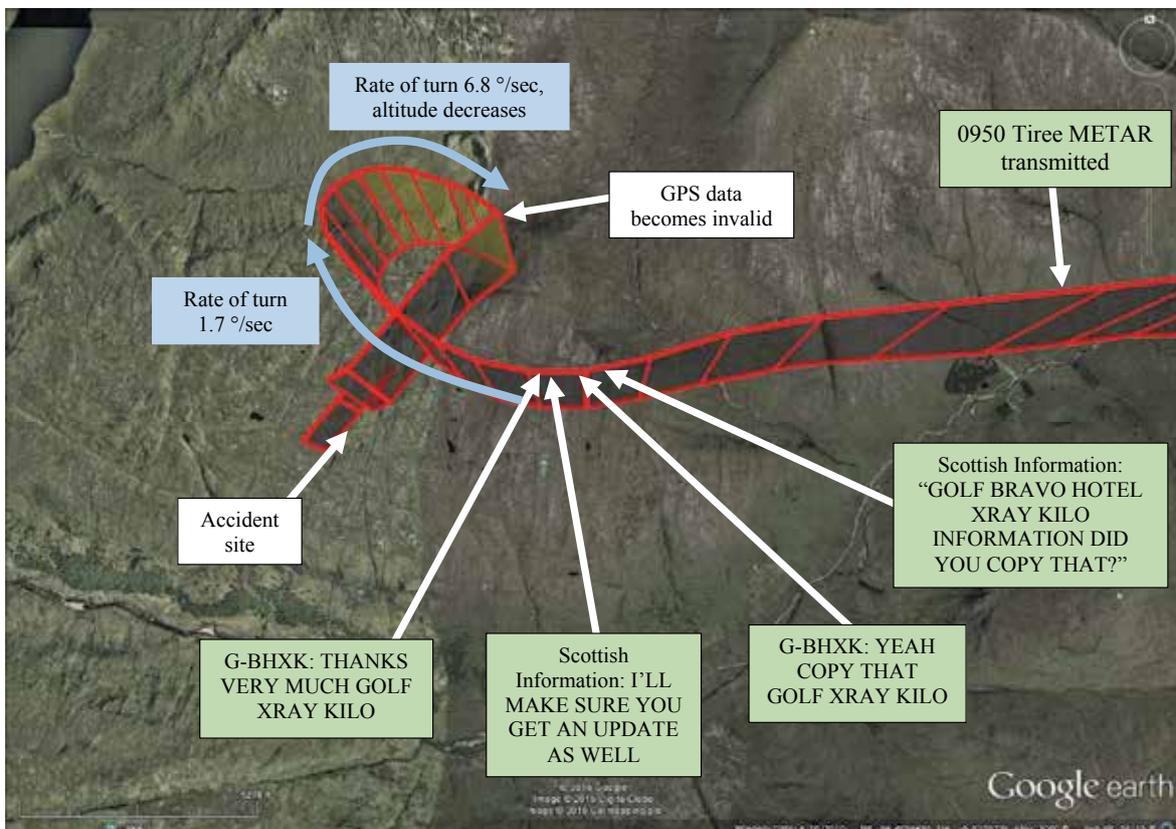
**Figure 2**

Final stage of the G-BHXX GPS track

G-BHXX replied at 1028:28 hrs “YEAH COPY THAT GOLF XRAY KILO”. At the same time that this transmission was made, the aircraft heading began to slowly increase at an approximately constant rate over the next 38 seconds, from 252°T to 317°T, (1.7°/second). During this time, the recorded altitude remained constant at 6,500 ft but the derived groundspeed reduced from 98 kt to 71 kt.

At 1029:08 hrs, the rate of turn and groundspeed began to increase and the altitude decreased, with the final valid GPS position recorded 21 seconds later. At this point, the aircraft’s heading was 123°T, representing an average rate of turn over the 21 seconds of 6.8 °/second. After 1029:08 hrs, the recorded GPS position and altitude became erratic and unreliable. In previous accidents investigated by the AAIB, when an aircraft enters a tight turn it can lead to obscuration of the GPS antenna by the aircraft structure. This can have an effect on the positional accuracy and, considering the increased rate of turn encountered by G-BHXX, this is likely to have been the case.
