ACCIDENT

Aircraft Type and Registration:	Agusta Bell 206B Jet Ranger II, G-SUEX	
No & Type of Engines:	1 Allison 250-C20B turboshaft engine	
Year of Manufacture:	1978 (Serial no: 8567)	
Date & Time (UTC):	16 September 2014 at 1241 hrs	
Location:	Flamborough Head, Yorkshire	
Type of Flight:	Public Transport (Helicopter)	
Persons on Board:	Crew - 1	Passengers - 1
Injuries:	Crew - 1 (Fatal)	Passengers - 1 (Fatal)
Nature of Damage:	Destroyed	
Commander's Licence:	Commercial Pilot's Licence (Helicopter)	
Commander's Age:	58 years	
Commander's Flying Experience:	Estimated 4,000 hours (of which n/k were on type) Last 90 days - n/k hours Last 28 days - n/k hours	
Information Source:	AAIB Field Investigation

Synopsis

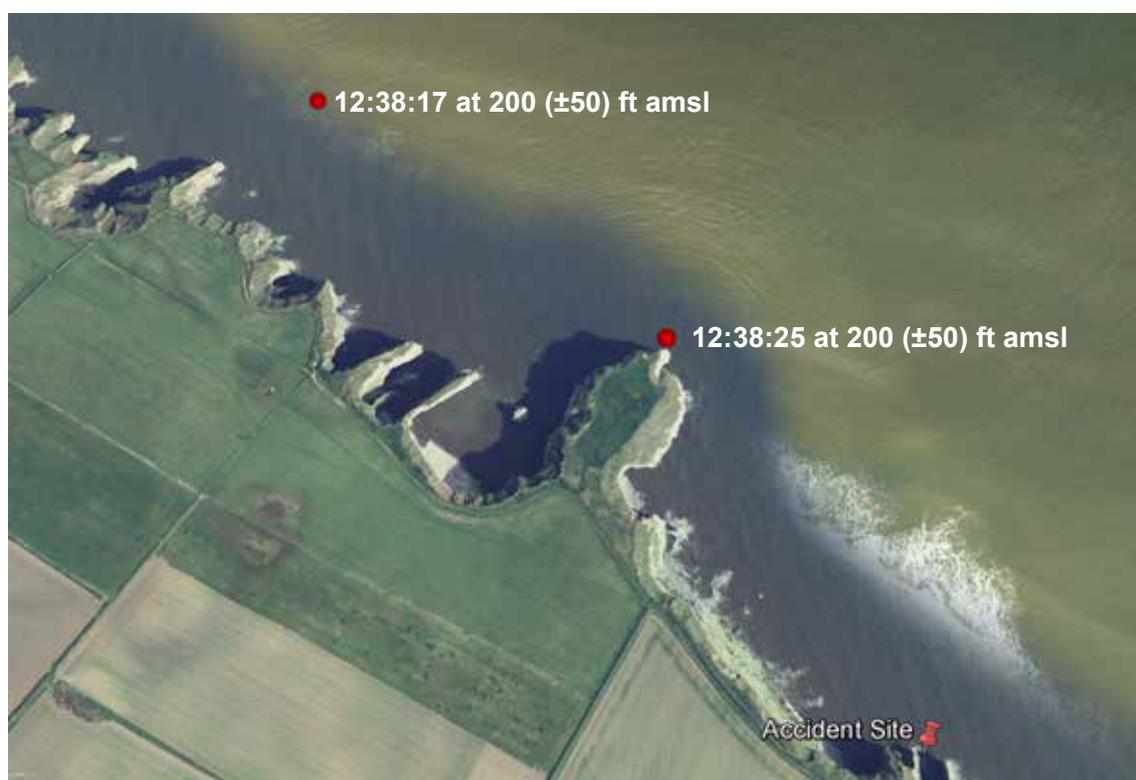
Figure 4

The final two contacts were from the Claxby SSR (Figure 4) at 1238:17 hrs and 1238:25 hrs, when the helicopter was within 800 m of the accident site. The reported Mode C altitude, corrected for QNH, was 200 ft amsl for both contacts and the groundspeed was calculated to be about 90 kt. However, as this was based on just two points, whose positional accuracy is unknown, it is approximate.

Claxby SSR contacts near the accident site

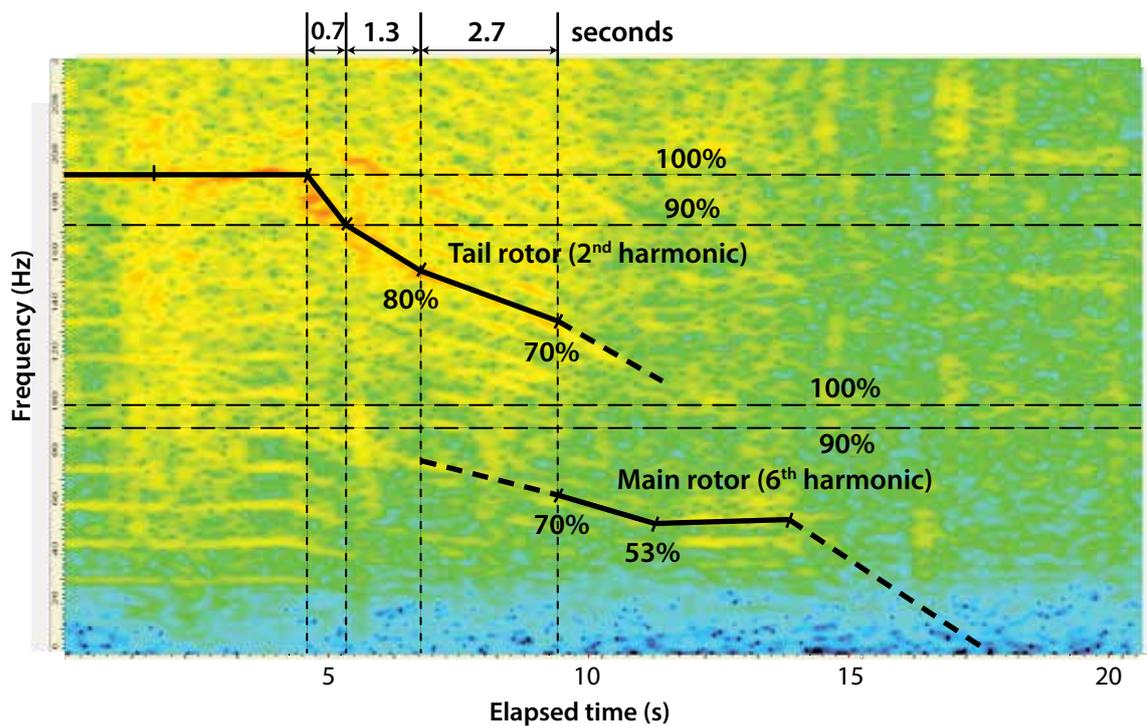
A witness, who was approximately 800 m to the south of the accident site, had inadvertently activated the video recording feature on their camera while it was in their pocket. It was subsequently possible to isolate the audio of the helicopter's rotor system from the recording and conduct frequency analysis (Figure 5). Of note, no loud, sharp noises, such as bangs, were found on the audio. Also, the higher frequencies generated by the engine were beyond the frequency range of the audio recording.

Frequency analysis of witness audio recording showing main and tail rotor rpm decay

'The analysis shows that the recording of MR RPM decay is not compatible with a typical autorotation manoeuvre, while there is better correlation with a piloting technique intended to maintain altitude.'

The audio analysis showed a significant and sustained reduction in the rotor rpm, inconsistent with entry into normal autorotation³. The single strike mark near the foot of the cliff and the nature of the damage to the rotor drive train were indicative of very low energy in the rotor system at impact. Also, the injuries identified at the post-mortem examination were consistent with a vertical impact of greater than 80 g, suggesting an unarrested descent.

This report included a graphical display of the main and tail rotor rpm decay, based on the frequency analysis of the witness audio recording (see Figure 5 on page 55). Figure 5 was incorrectly labelled. Reference to the tail rotor should have been to the main rotor, and vice versa. The time axis labels and harmonic references were also incorrect. However, the supporting text, analysis and conclusions were unaffected by these labelling errors.

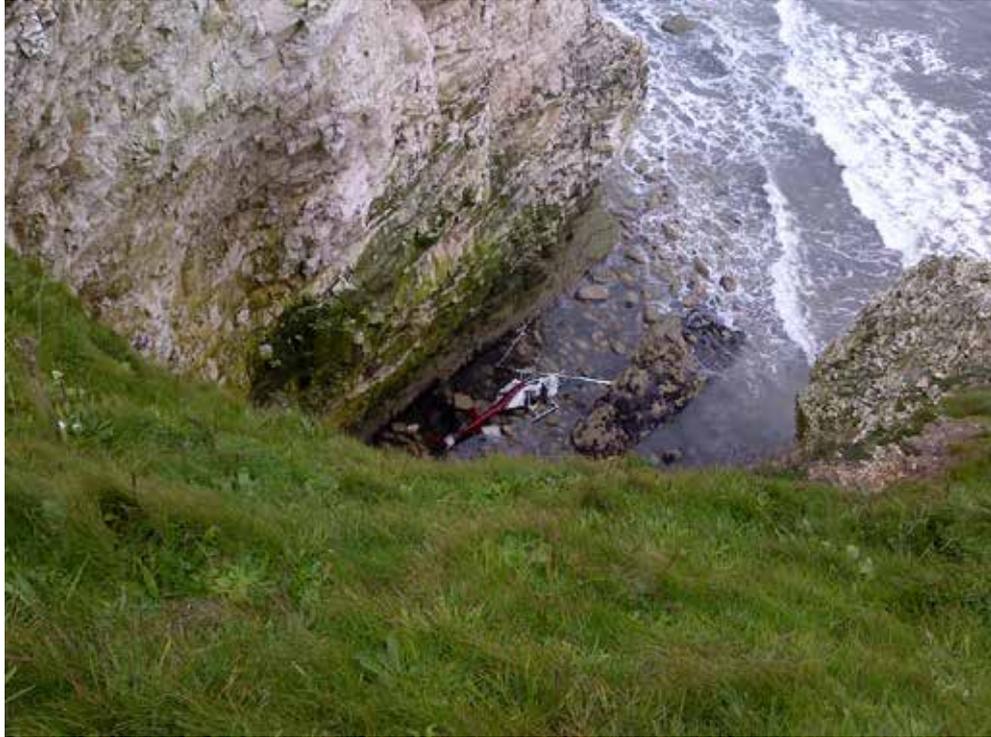
Figure 6

The accident site was located in the inter-tidal zone at the base of a gully in the cliffs at Flamborough Head. A photograph taken shortly after the accident showed the helicopter lying on its left side, partly submerged in the sea (Figure 6). It had sustained damage from the impact but appeared whole. The tide was ebbing and the emergency services were able to recover the deceased occupants at low tide. A significant quantity of jet fuel was reported in the sea around the wreckage.

Showing helicopter lying at the base of the cliffs shortly after the accident
(Courtesy Trevor Norton)

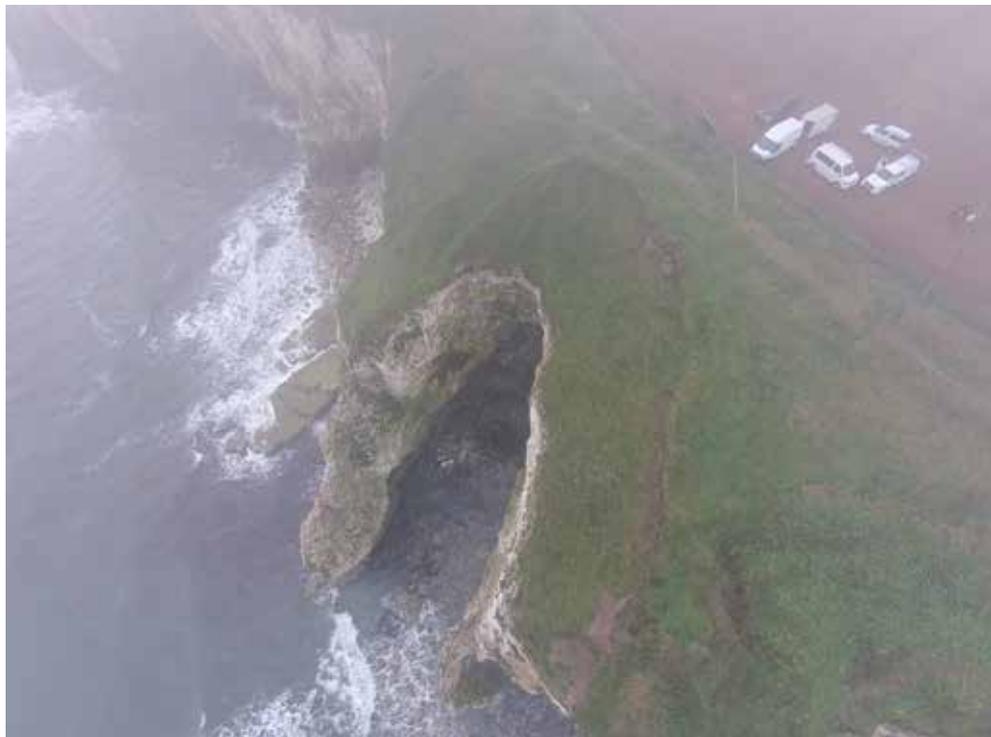
Figure 7

The cliff face above the accident site was largely undercut and the top edge of the cliff was unstable, making access difficult (Figure 7). The wreckage was initially accessible for a short period either side of low tide, by abseiling down the cliff to an adjacent beach and walking around an outcrop. An assessment of the wreckage was made and photographs were taken but no attempt at recovery was made, due to the incoming tide. It was evident that, due to the action of the waves, the wreckage had been moved and was broken into smaller pieces. When the weather and sea conditions became less favourable, this route was no longer available.

General view of the accident site

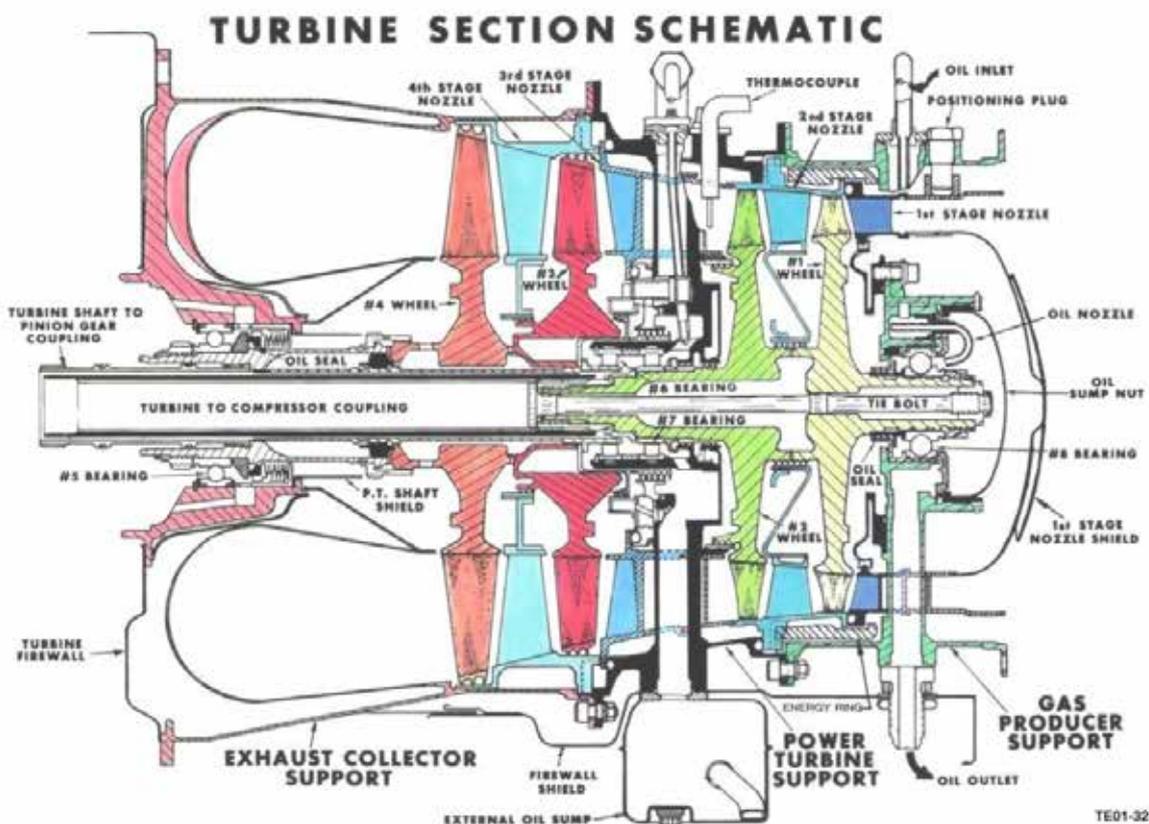
Figure 9

When the turbine assembly was dismantled, the No 5 and No 8 bearings (Figure 9) were found to have suffered severe thermal distress (see Figure 10). The No 6 and No 7 bearings had also suffered damage. The No 5 bearing and No 8 bearings are ball bearings and provide axial and radial location for the turbine assembly. Damage to the turbine rotors and adjacent components indicated they had come into contact with each other.

General arrangement of turbine assembly and bearings

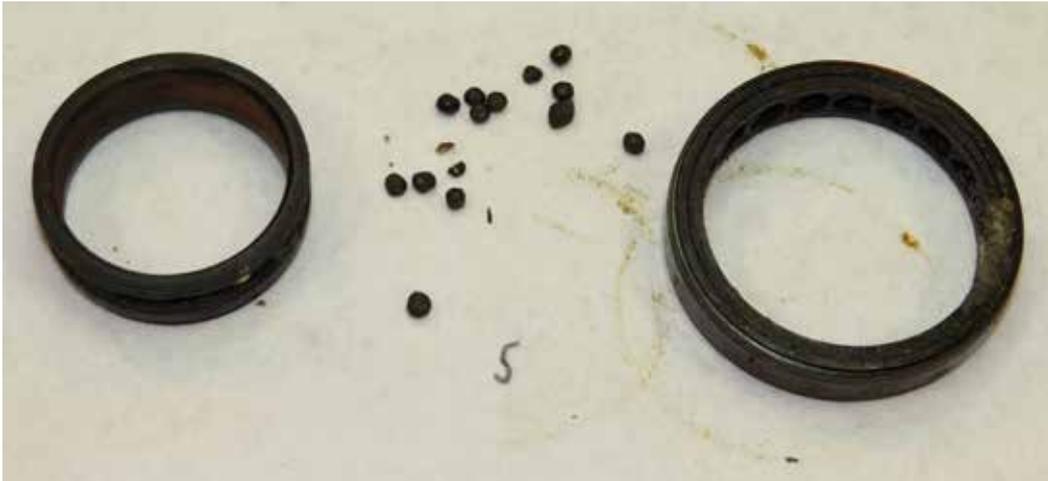
Figure 10

Example of bearing damage, in this case No 5 bearing

The No 5 and No 8 turbine thrust bearings exhibited severe thermal distress which had led to the bearings ceasing to position the turbine rotors axially and radially. The No 6 bearing also exhibited damage which indicated it had ceased to position the power turbine rotor radially.

The No 8 bearing exhibited an approximately 0.75 inch long circumferential fatigue crack in the outer ring, originating at the corner of the key slot, which did not extend into the bearing raceway. This was typical of a crack caused by the outer raceway trying to rotate against its key due to friction within the bearing. The bearing was comprised of the material types specified by the engineering drawing but it was not possible to determine the original hardness or microstructure of the part due to the severe thermal distress.

'The primary failed component was unable to be identified due to the advanced stage of distress to many of the turbine bearings, as well as the engine's exposure to seawater.'
