ACCIDENT

| Aircraft Type and Registration: | YAK-52, G-CDJJ | |
| Date & Time (UTC): | 18 June 2015 at 1553 hrs | |
| Location: | North Weald Airfield, Essex | |

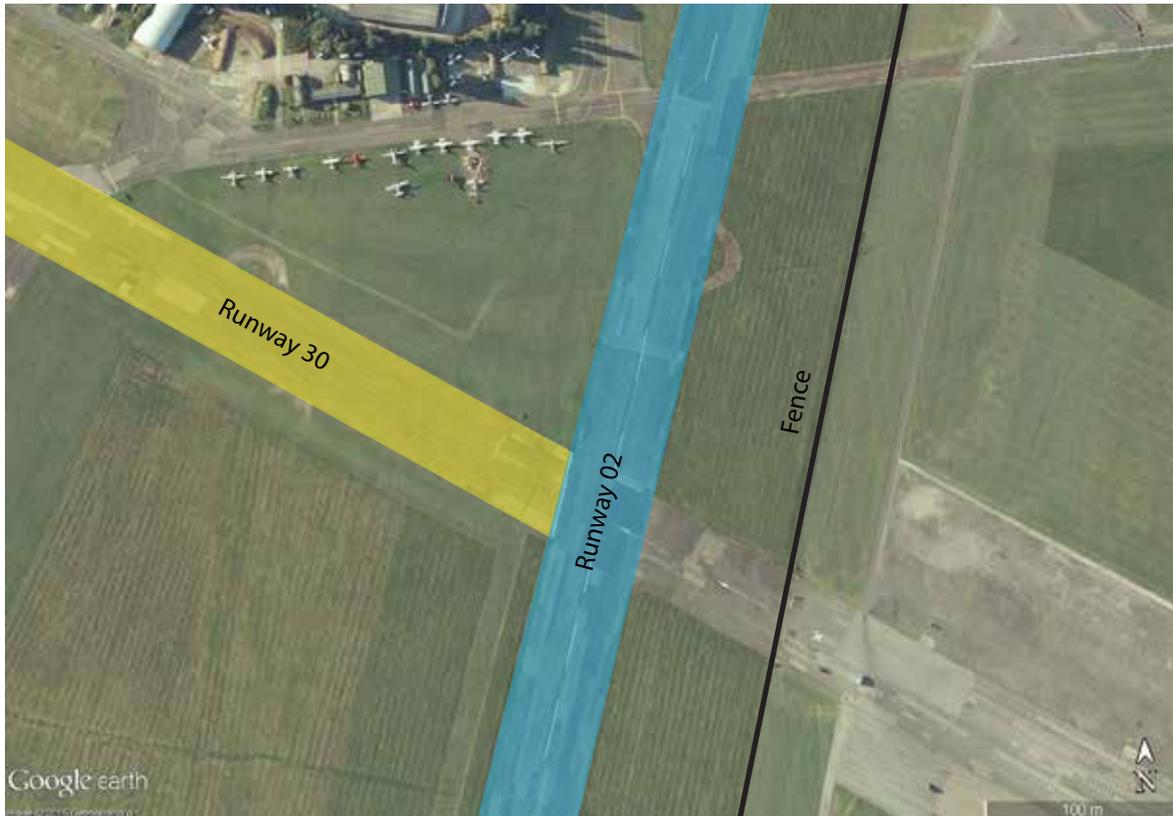
Figure 1

Runway 30 is an unlicensed paved runway formed from part of a larger disused runway (see Figure 1). Another paved runway, orientated 02/20, intersects the disused part of Runway 30, adjacent to the displaced threshold of the used part, and should not be used for landing. A 150 cm high fence parallels Runway 02 and lies in the undershoot of Runway 30, about 138 m before the Runway 30 displaced threshold.

Overview of North Weald runway layout and fence location

The airfield operator has repainted the lead-in lines to the displaced threshold on Runway 30 and is planning to repaint the runway closed X markings on the disused paved surface outside the airfield boundary.
