**Mooring line failure resulting in serious injury to a
deck officer on board
Zarga
alongside South Hook LNG terminal,
Milford Haven
on 2 March 2015**

MAIB SAFETY BULLETIN 1/2016

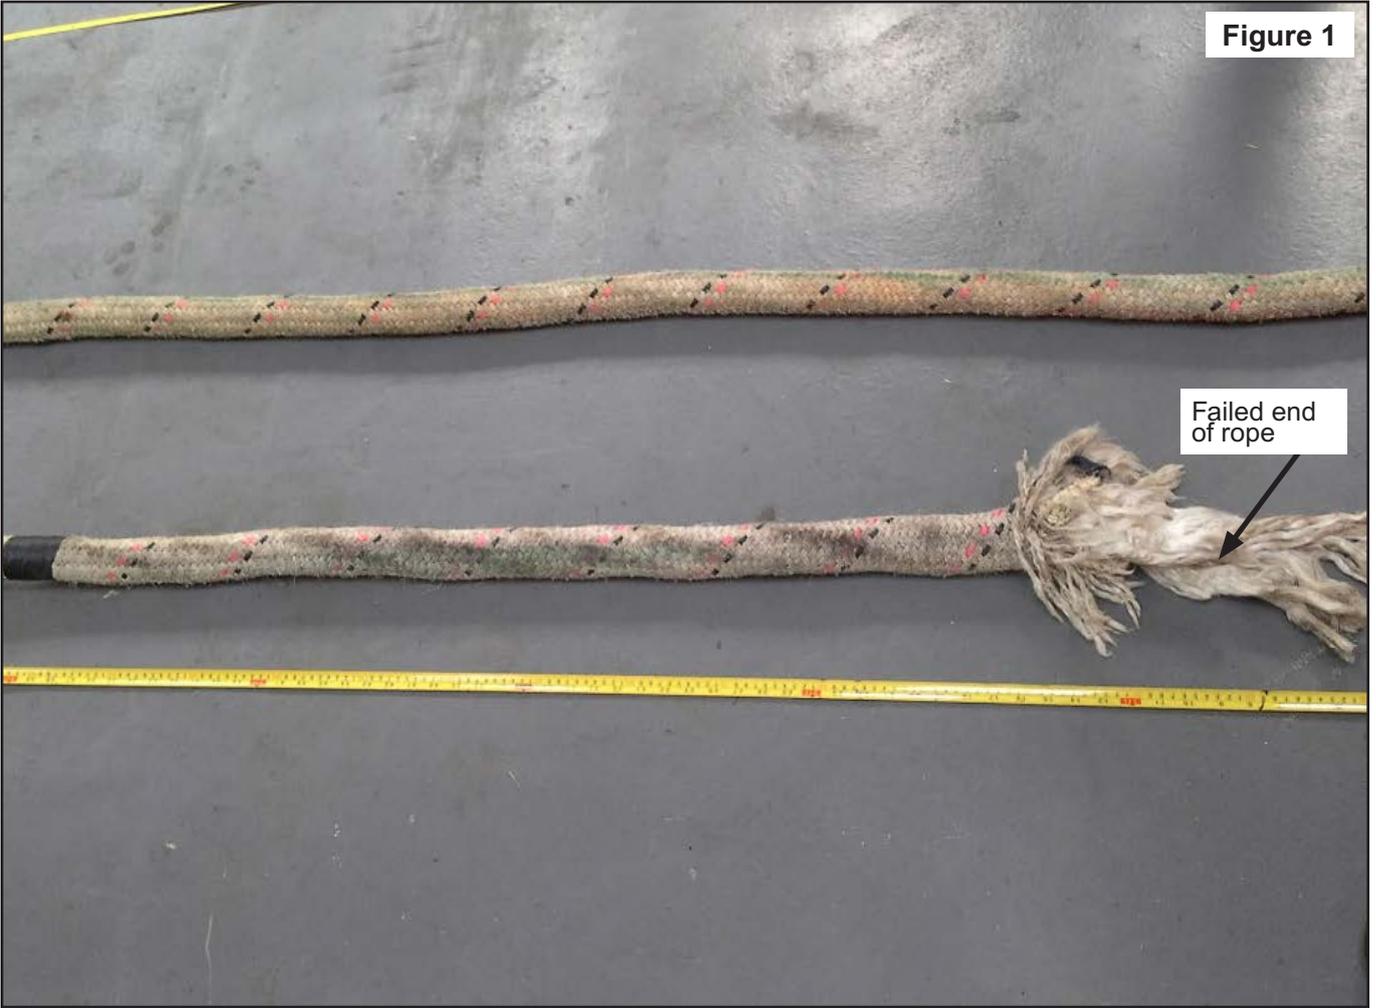
Figure 1

The rope failed at an indicative load of 24 tonnes. Subsequent non-destructive assessment of the rope by an industry expert did not identify any defects that would indicate that it had been used or operated incorrectly (**Figure 1**).

Failed end of rope

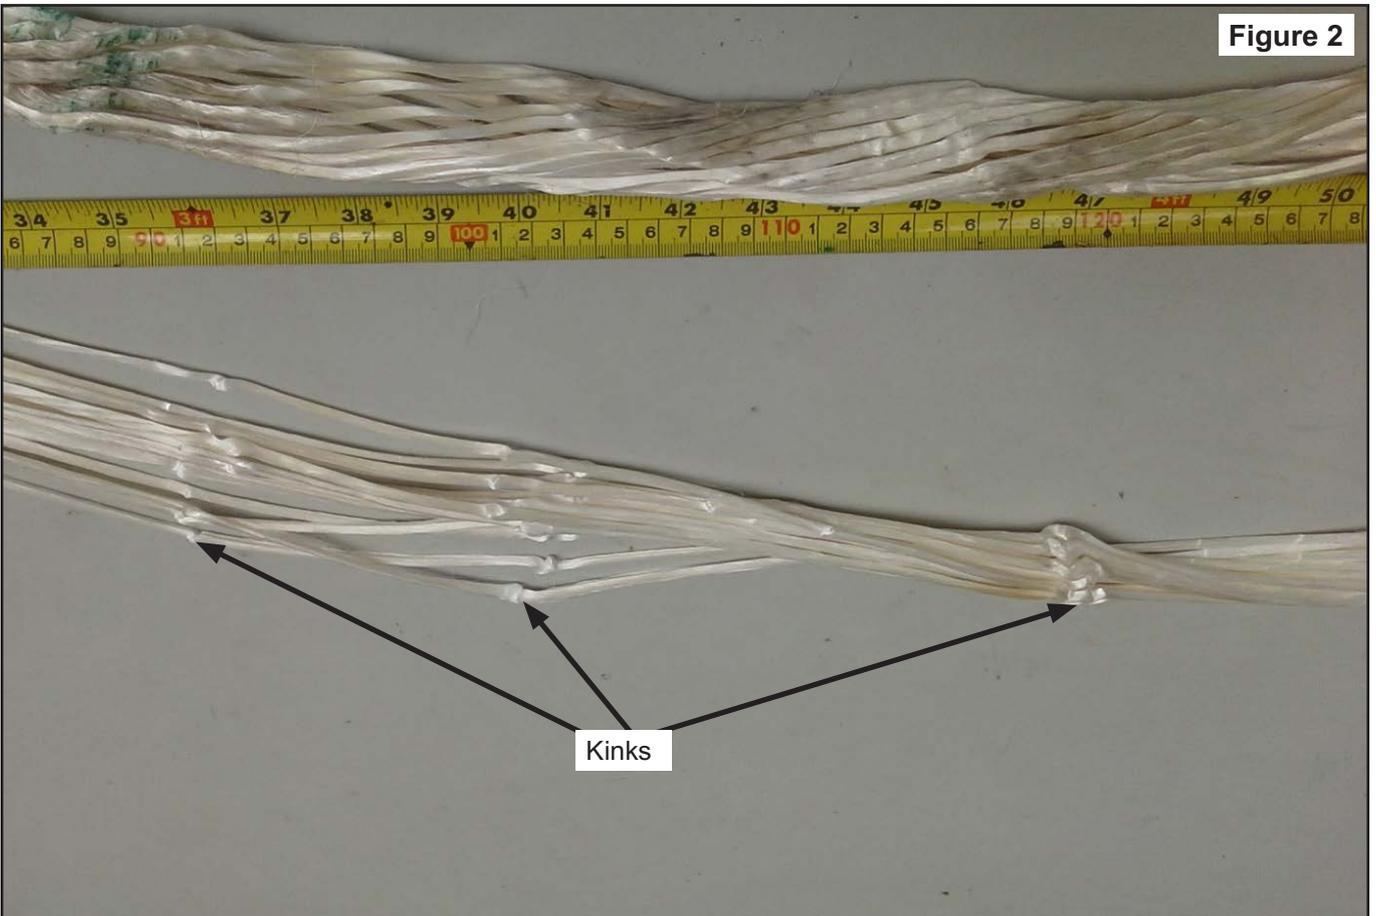
Figure 2

When the close-fitting jacket was removed from the rope at each side of the failure point, the rope yarns in all three strands exhibited moderate to severe kinking. The Z-shaped kinks were visually apparent and were found at close intervals with, for example, 22 occurring over a length of 2.78m (**Figure 2**).

Kinks

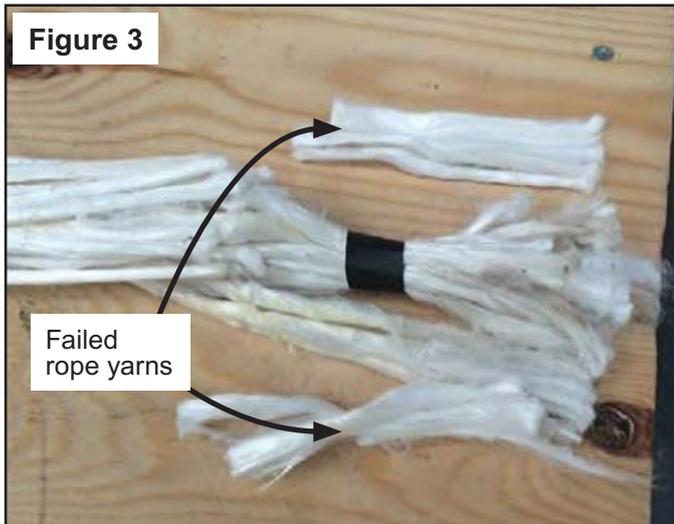
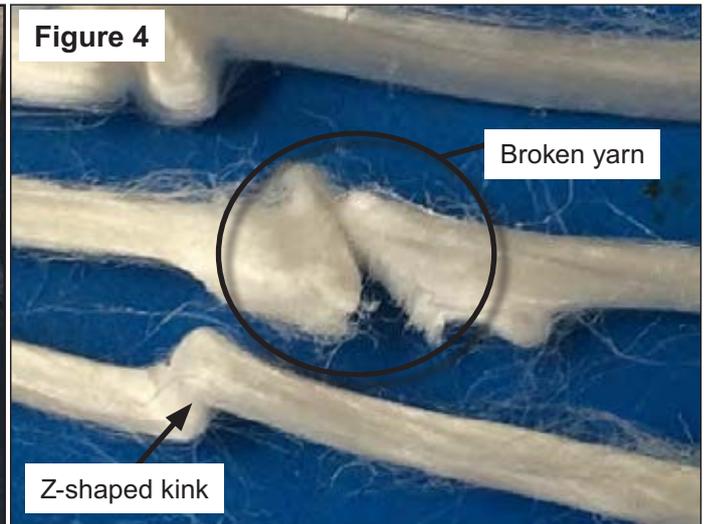
During the rope's dissection, 12 of the 96 rope yarns were found to have separated. The rope yarns were found to have failed at kink points and had separated as if they had been cut with a sharp knife at 45 degrees (**Figures 3 and 4**).

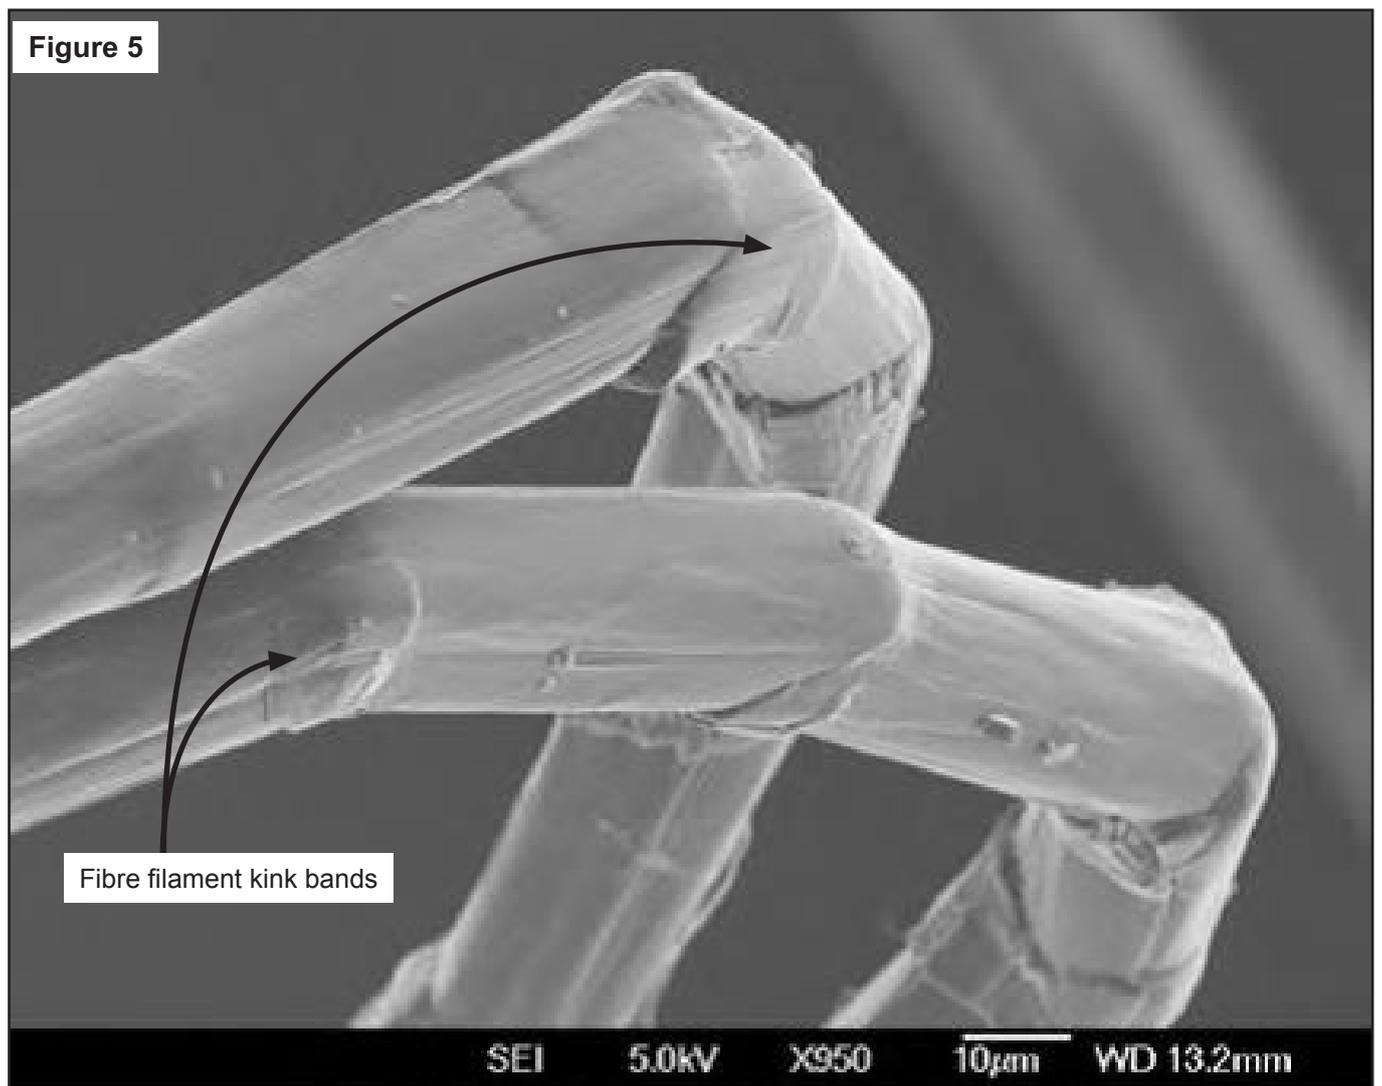
Following the identification of the kinking and failed rope yarns, a number of additional sections of the rope were inspected. Further rope yarn failures and damage to the rope yarns at filament level were seen (**Figure 5**). The damage identified was consistent with axial compression fatigue.

Operating ropes around tight bend radii can exacerbate axial compression fatigue and also cause internal abrasion damage. In this case, the failed mooring rope had been run from its winch drum to the LNG terminal hook via a deck roller bollard and a ship's side roller fairlead. The diameters of the rollers for both the deck bollard and deck fairlead were less than the minimum recommended by the rope manufacturer for its 44mm HMPE jacketed ropes.

Close-fitting jacketed synthetic fibre ropes with low twist constructions are more prone to failure under normal operating conditions than other mooring rope constructions. This is especially the case where the diameter to diameter (D:d) ratio between a ship's deck fittings and its mooring ropes, is less than that recommended by the rope's manufacturer. The nature of the close-fitting jacket precludes visual inspection of the rope's core for signs of degradation. Operators of vessels using close-fitting jacketed synthetic fibre mooring ropes are strongly advised to contact the rope's manufacturer/supplier to:

- Confirm or otherwise that the rope is suitable for its intended use and envisaged operating conditions including, specifically, that it is compatible with the vessel's deck fittings, and,
- Ensure that an appropriate regime exists to monitor the condition of the ropes in use so as to maintain a high level of confidence that they can be replaced before they become materially weakened or degraded.
