ACCIDENT

Aircraft Type and Registration:	Aeronca C3, G-AEFT	
No & Type of Engines:	1 J.A.Prestwich J99 piston engine	
Year of Manufacture:	1936 (Serial no: A-610)	
Date & Time (UTC):	14 October 2015 at 1510 hrs	
Location:	Near Polzeath, Cornwall	
Type of Flight:	Private	
Persons on Board:	Crew - 1	Passengers - None
Injuries:	Crew - None	Passengers - N/A
Nature of Damage:	Propeller detached	
Commander's Licence:	Airline Transport Pilot's Licence	
Commander's Age:	46 years	
Commander's Flying Experience:	10,030 hours (of which 275 were on type) Last 90 days - 58 hours Last 28 days - 16 hours	
Information Source:	Aircraft Accident Report Form submitted by the pilot and additional enquiries by the AAIB

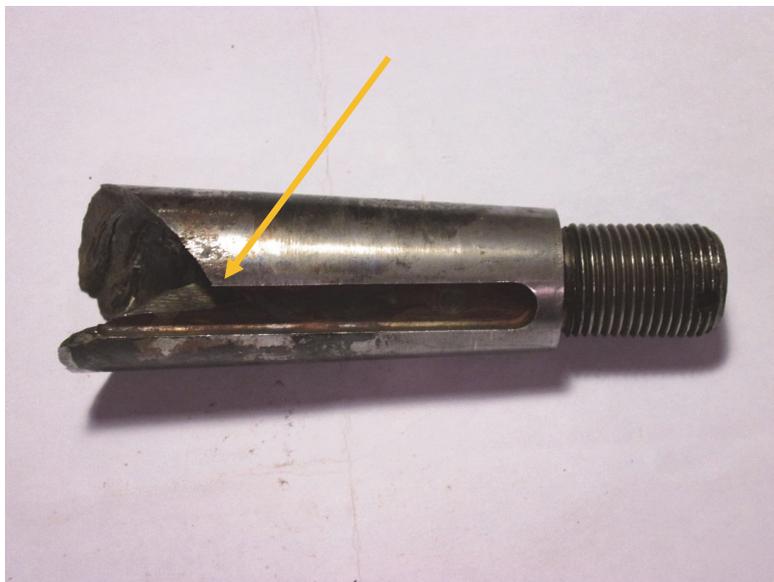
Figure 1

it had detached because the tapered end of the crankshaft on which it was mounted, had fractured (Figure 1). He also recognised that the fracture was almost identical to one he had seen in an AAIB Bulletin concerning another JAP J99-engined aircraft in 2012 (G-EBJI, Bulletin 10/2012).

Failed crankshaft showing corrosion pitting in the area of the fatigue crack origin (arrowed).

Comparison of the photographs from G-EBJI and G-AEFT showed remarkable similarity and both were clearly high-cycle fatigue failures. Both fatigue origins were towards the aft end of the keyway slot, although it could be seen that the origin on 'FT' also appeared to coincide with a degree of corrosion pitting.

However, as a result of this second occurrence, in which corrosion pitting may have contributed to the problem and a visual inspection had apparently been insufficient to detect the onset of cracking, the LAA have issued Airworthiness Information Leaflets (AIL) No. MOD/ENG/JAP/001 for the JAP engine, and MOD/ENG/AER/001 for the Aeronca version, effectively mandating the following for all engines before further flight:

- Removal of the propeller.
- Removal of the Woodruff key.
- Inspection, using a 10x magnifying glass, of the tapered end for corrosion or obvious cracking, particularly around the edges and corners of the keyway. If cracks or corrosion pits are found, the crankshaft must be scrapped.
- If the findings from the step above are negative, then the area around the keyway should be subjected to a Dye Penetrant inspection technique. If no cracks are found, then the propeller can be refitted and remain in service
- The above work and subsequent refitting of the propeller should be completed to the satisfaction of a suitably qualified LAA Inspector, who should then raise worksheets and sign the log book to confirm compliance with the AIL.

The inspection is to be repeated every 25 flying hours or 3 calendar years, whichever occurs first. A copy of Aeronca memorandum M-36 was attached to the AILs for information.
