ACCIDENT

Aircraft Type and Registration:	Mooney M20K 231, G-BYEE	
No & Type of Engines:	1 Teledyne Continental TSIO-360-LB1 piston engine	
Year of Manufacture:	1980 (Serial no: 25-0282)	
Date & Time (UTC):	4 October 2015 at 1130 hrs	
Location:	Caernarfon Airport, Gwynedd	
Type of Flight:	Private	
Persons on Board:	Crew - 1	Passengers - 2
Injuries:	Crew - None	Passengers - None
Nature of Damage:	Severe damage to left wing and minor damage to propeller	
Commander's Licence:	Private Pilot's Licence	
Commander's Age:	70 years	
Commander's Flying Experience:	896 hours (of which 449 were on type) Last 90 days - 11 hours Last 28 days - 4 hours	
Information Source:	Aircraft Accident Report Form submitted by the pilot and enquiries by the AAIB

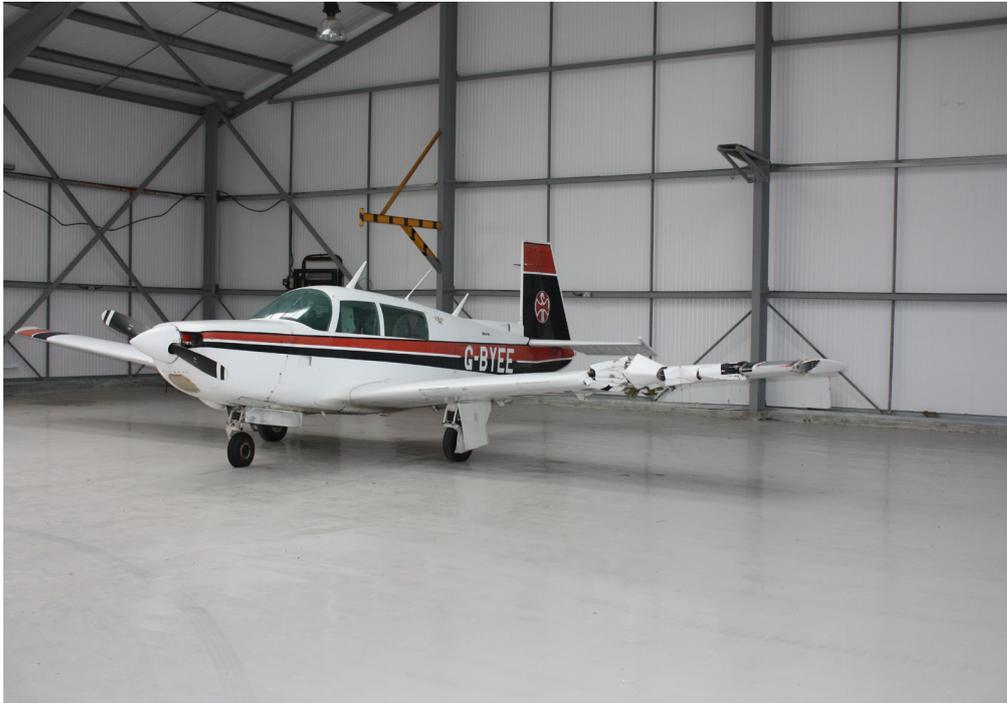
Figure 1

The aircraft, now with all three wheels on the grass, continued to deviate from the runway. The pilot saw a vehicle ahead of him, parked on a disused taxiway and this was the focus of his attention when the left wing struck a fence post, 46 m from the runway centreline, which he had not noticed. The collision caused the aircraft to turn abruptly, further to the left, and it continued its landing roll.

The pilot refrained from trying to brake the aircraft sharply, as it was travelling over an unknown surface. It crossed a disused, intersecting runway and he then regained full control, steering the aircraft back towards Runway 07, leaving the parked vehicle to his left. He did not appreciate the extent of the damage to the left wing until he had taxied the aircraft to the parking area and shut it down. There was also damage to one propeller blade, possibly caused by a loose stone during the landing.

G-BYEE showing the severely damaged left wing
