## ACCIDENT

<b>Aircraft Type and Registration:</b>	RL7A XP Sherwood Ranger, G-CHHD	
<b>No &amp; Type of Engines:</b>	1 Jabiru 2200A piston engine	
<b>Year of Manufacture:</b>	2012 (Serial no: LAA 237A-15054)	
<b>Date &amp; Time (UTC):</b>	16 August 2015 at 1605 hrs	
<b>Location:</b>	Druridge Bay Airfield, Northumberland	
<b>Type of Flight:</b>	Private	
<b>Persons on Board:</b>	Crew - 1	Passengers - None
<b>Injuries:</b>	Crew - 1 (Minor)	Passengers - N/A
<b>Nature of Damage:</b>	Damage to propeller, engine cowlings and wings; engine shock-loaded	
<b>Commander's Licence:</b>	National Private Pilot's Licence	
<b>Commander's Age:</b>	70 years	
<b>Commander's Flying Experience:</b>	855 hours (of which 16 were on type) Last 90 days - 12 hours Last 28 days - 12 hours	
<b>Information Source:</b>	Aircraft Accident Report Form submitted by the pilot

During a takeoff run, the right main wheel failed and the aircraft nosed over. The failure was probably the result of insufficient torque being applied to the wheel's attachment nuts during original assembly.

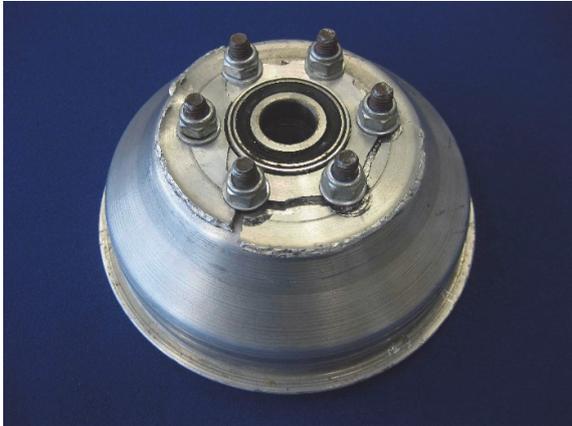
**Figure 1***Photo: LAA*

The right wheel was constructed from two aluminium halves which were bolted together. It was found that the outer half had failed circumferentially, which had allowed the outer rim to separate.

G-CHHD right main wheel

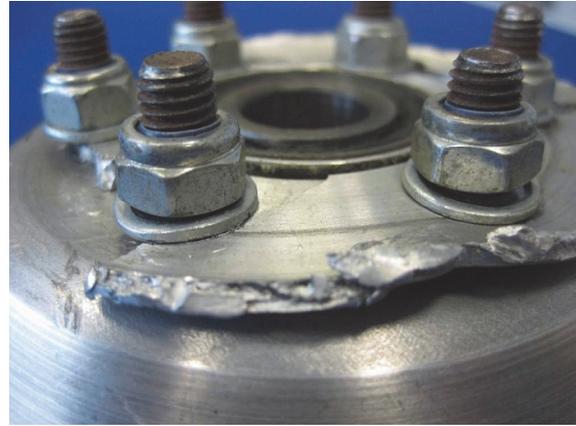
**Figure 2***Photo: LAA*

G-CHHD right main wheel - detail

The LAA's examination revealed that two of the six attachment bolts were not fully tightened down, which left a gap of around 1.5 mm (see Figure 2), with another bolt noted as being loose. Corrosion products were observed near one of the loose bolts (see Figure 3), with evidence pointing to fretting that occurred as a result of relative movement between the two halves in service.

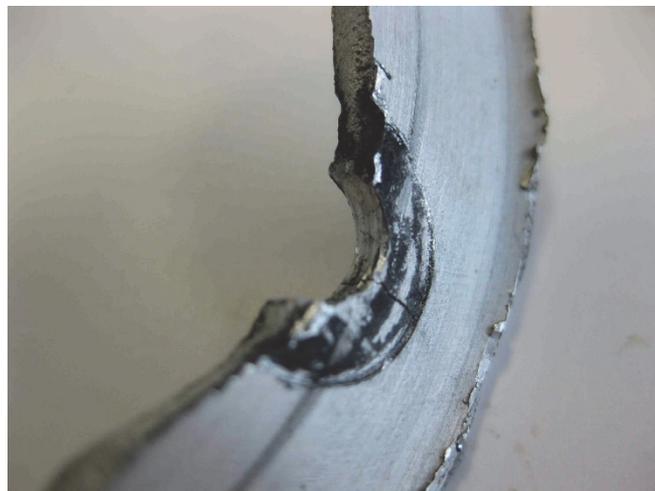
*Photo: LAA***Figure 3**

Showing corrosion products and radial crack

A radial crack is visible in Figure 3, which would have occurred during the circumferential progression of what was determined to be a low-cycle fatigue crack. The remainder of the failure was attributed to overload. It was concluded that the failure probably resulted from insufficient torque being applied to the attachment nuts during the initial assembly. (Note: this aircraft was constructed by a previous owner).
