ACCIDENT

Aircraft Type and Registration:	Vans RV-9A, G-XSAM	
No & Type of Engines:	1 Wilksch WAM-120 piston engine	
Year of Manufacture:	2008 (Serial no: PFA 320-13797)	
Date & Time (UTC):	18 September 2015 at 1830 hrs	
Location:	Old Sarum Airfield, Wiltshire	
Type of Flight:	Private	
Persons on Board:	Crew - 1	Passengers - 1
Injuries:	Crew - None	Passengers - None
Nature of Damage:	Damage to propeller, nose and nose landing gear	
Commander's Licence:	Commercial Pilot's Licence	
Commander's Age:	35 years	
Commander's Flying Experience:	3,046 hours (of which 2 were on type) Last 90 days - 78 hours Last 28 days - 23 hours	
Information Source:	Aircraft Accident Report Form submitted by the pilot

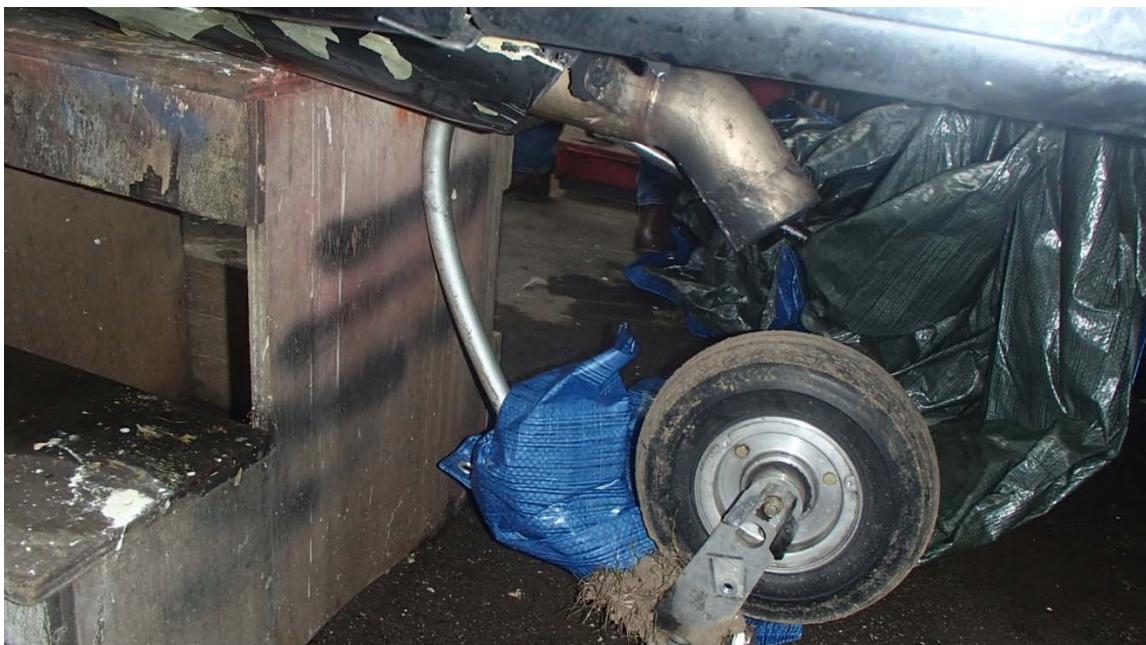
Figure 1

Examination of the aircraft showed that the nose landing gear leg had folded backwards and there was distortion of the nosewheel fork relative to the leg. Previous experience of collapses on this type of nose gear suggests that this kind of damage is typical when the

nose landing gear is subjected to high loads which can cause the nosewheel fork to bend and dig into the ground – the resulting drag on grass runways then typically causes the leg itself to collapse backwards in bending near its mounts (Figure 1).

Nose landing gear of G-XSAM showing distortion of nosewheel fork and tubular leg

'Problems have been experienced with the RV-9A noseleg, especially when operating off grass, with instances of the nosewheel bending back and the strut digging into the ground, causing a rapid stop and further damage. In order to avoid this risk, it is important to maintain the correct nosewheel tyre pressure, and to trim the spat to ensure generous clearance between the tyre and the wheel aperture in the spat (circa half an inch). It is also important to maintain suitable preload on the nosewheel axle bearings, torquing up the axle nut gently as required in the absence of a conventional spacer between the bearings. It is also important to land the aircraft on the mainwheels first and hold the nosewheel off the ground during the initial part of the landing roll, rather than landing on all three wheels together which encourages wheelbarrowing and overloading the nosewheel.'
