## ACCIDENT

<b>Aircraft Type and Registration:</b>	Jabiru UL, G-RYAL
<b>No &amp; Type of Engines:</b>	1 Jabiru 2200A piston engine
<b>Year of Manufacture:</b>	2000 (Serial no: PFA 274A-13365)
<b>Date &amp; Time (UTC):</b>	31 October 2015 at 1200 hrs
<b>Location:</b>	Sandtoft Airfield, North Lincolnshire
<b>Type of Flight:</b>	Private
<b>Persons on Board:</b>	Crew - 1                      Passengers - 1
<b>Injuries:</b>	Crew - 1 (Serious)      Passengers - 1 (Serious)
<b>Nature of Damage:</b>	Aircraft destroyed
<b>Commander's Licence:</b>	National Private Pilot's Licence
<b>Commander's Age:</b>	85 years
<b>Commander's Flying Experience:</b>	440 hours (of which 9 were on type) Last 90 days - 10 hours Last 28 days - 4 hours
<b>Information Source:</b>	Aircraft Accident Report Form submitted by the pilot

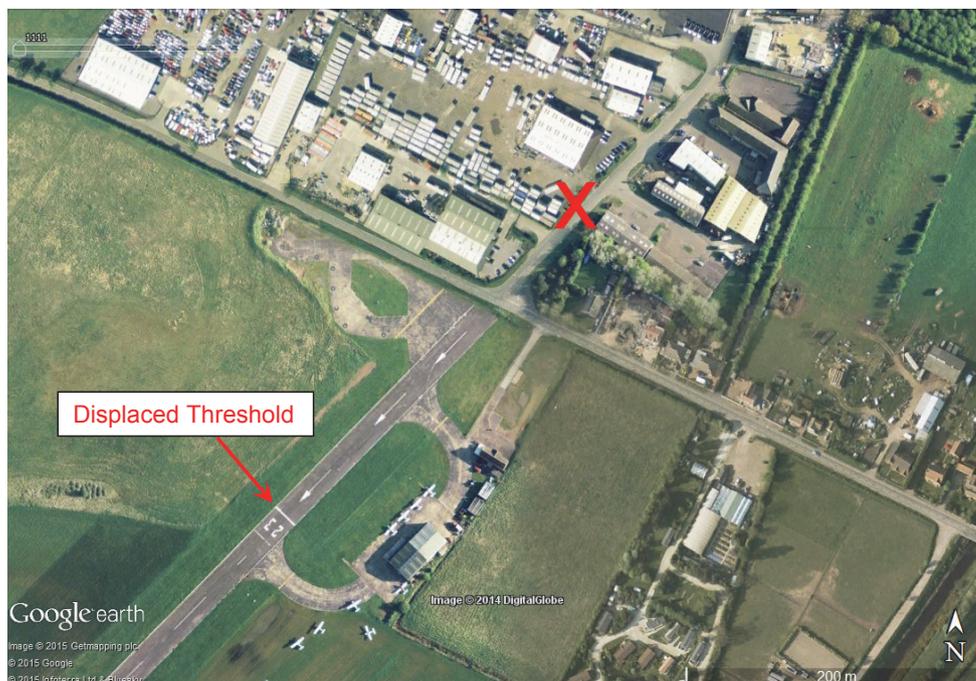
**Figure 1**

The pilot commenced his approach to Runway 23 and was targeting an approach speed of 57 kt with full flap. Runway 23 has a 190 m displaced threshold but he was aiming to land at the beginning of the paved surface (Figure 1). He "got a bit low" during the approach and

Sandtoft Runway 23. Location of the lamp post struck by the aircraft marked with an 'x' (Image courtesy Google Earth)

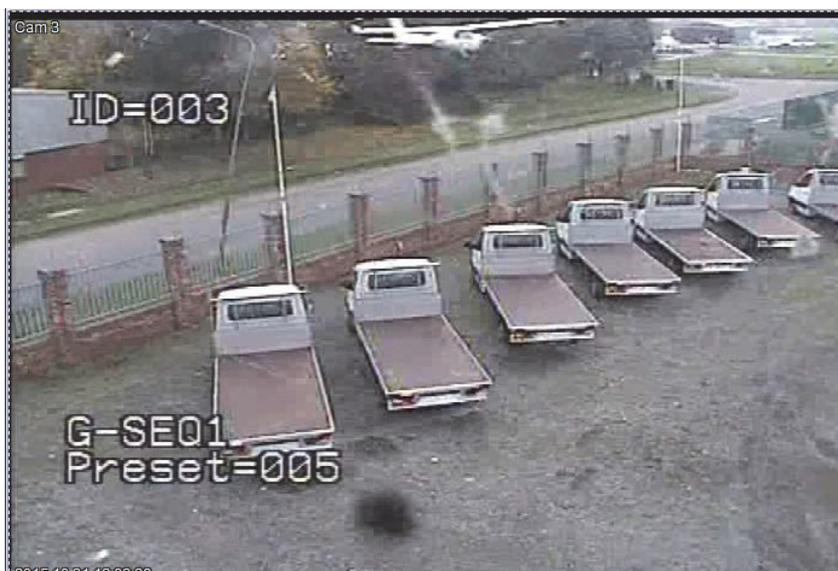
**Figure 2**

at one point added power to climb, then he heard his passenger saying “there’s a lighting column”, or words to that effect, and a second later he felt an impact. CCTV captured the moment when the aircraft’s tailplane struck a lamp post (Figure 2). The aircraft then pitched nose-down, hit a road and slid about 35 m before coming to rest against the airfield perimeter fence. Both the pilot and his passenger were seriously injured and were assisted by emergency services.

CCTV snapshot of the moment after the aircraft's tailplane hit the lamp post
