ACCIDENT

Aircraft Type and Registration:	Pegasus Quik, G-XJJM
No & Type of Engines:	1 Rotax 912ULS piston engine
Year of Manufacture:	2007 (Serial no: 8306)
Date & Time (UTC):	23 July 2015 at 1747 hrs
Location:	Hall Lane Farm, Burtonwood, Cheshire
Type of Flight:	Training
Persons on Board:	Crew - 1 Passengers - None
Injuries:	Crew - 1 (Serious) Passengers - N/A
Nature of Damage	Aircraft damaged beyond economic repair
Commander's Licence:	Student
Commander's Age:	27 years
Commander's Flying Experience:	45 hours (all of which were on type) Last 90 days - 4 hours Last 28 days - 3 hours
Information Source:	Enquires by the AAIB

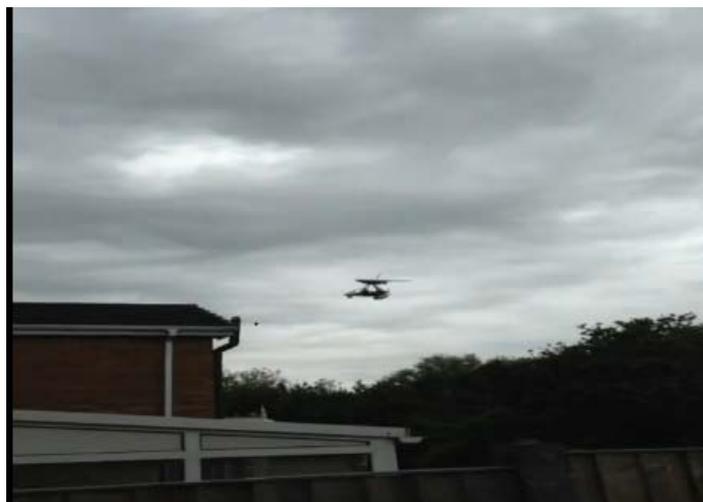
Figure 1

A witness who lived in the southern part of Newton-le-Willows saw the aircraft manoeuvring close to the houses. He said that many people had come out of their homes to watch the microlight, which he captured on video as it flew south along the route of the canal, which the AAIB estimated was approximately 75 m (260 ft) from where the video was taken. A still from the video is shown at Figure 1. The witness noted that the engine noise was heard to change as the aircraft manoeuvred and the aircraft crashed shortly after the video was recorded. The AAIB estimated that the accident site was approximately 440 m south of where the video was taken and from GPS data it was established that the aircraft would have taken 10 seconds to fly this distance.

Still taken from the video clip provided by a witness
