Collision between the fishing vessels *Silver Dee* (B310) and *Good Intent* (SY79) resulting in the foundering of *Silver Dee* Irish Sea 29 July 2015

SUMMARY

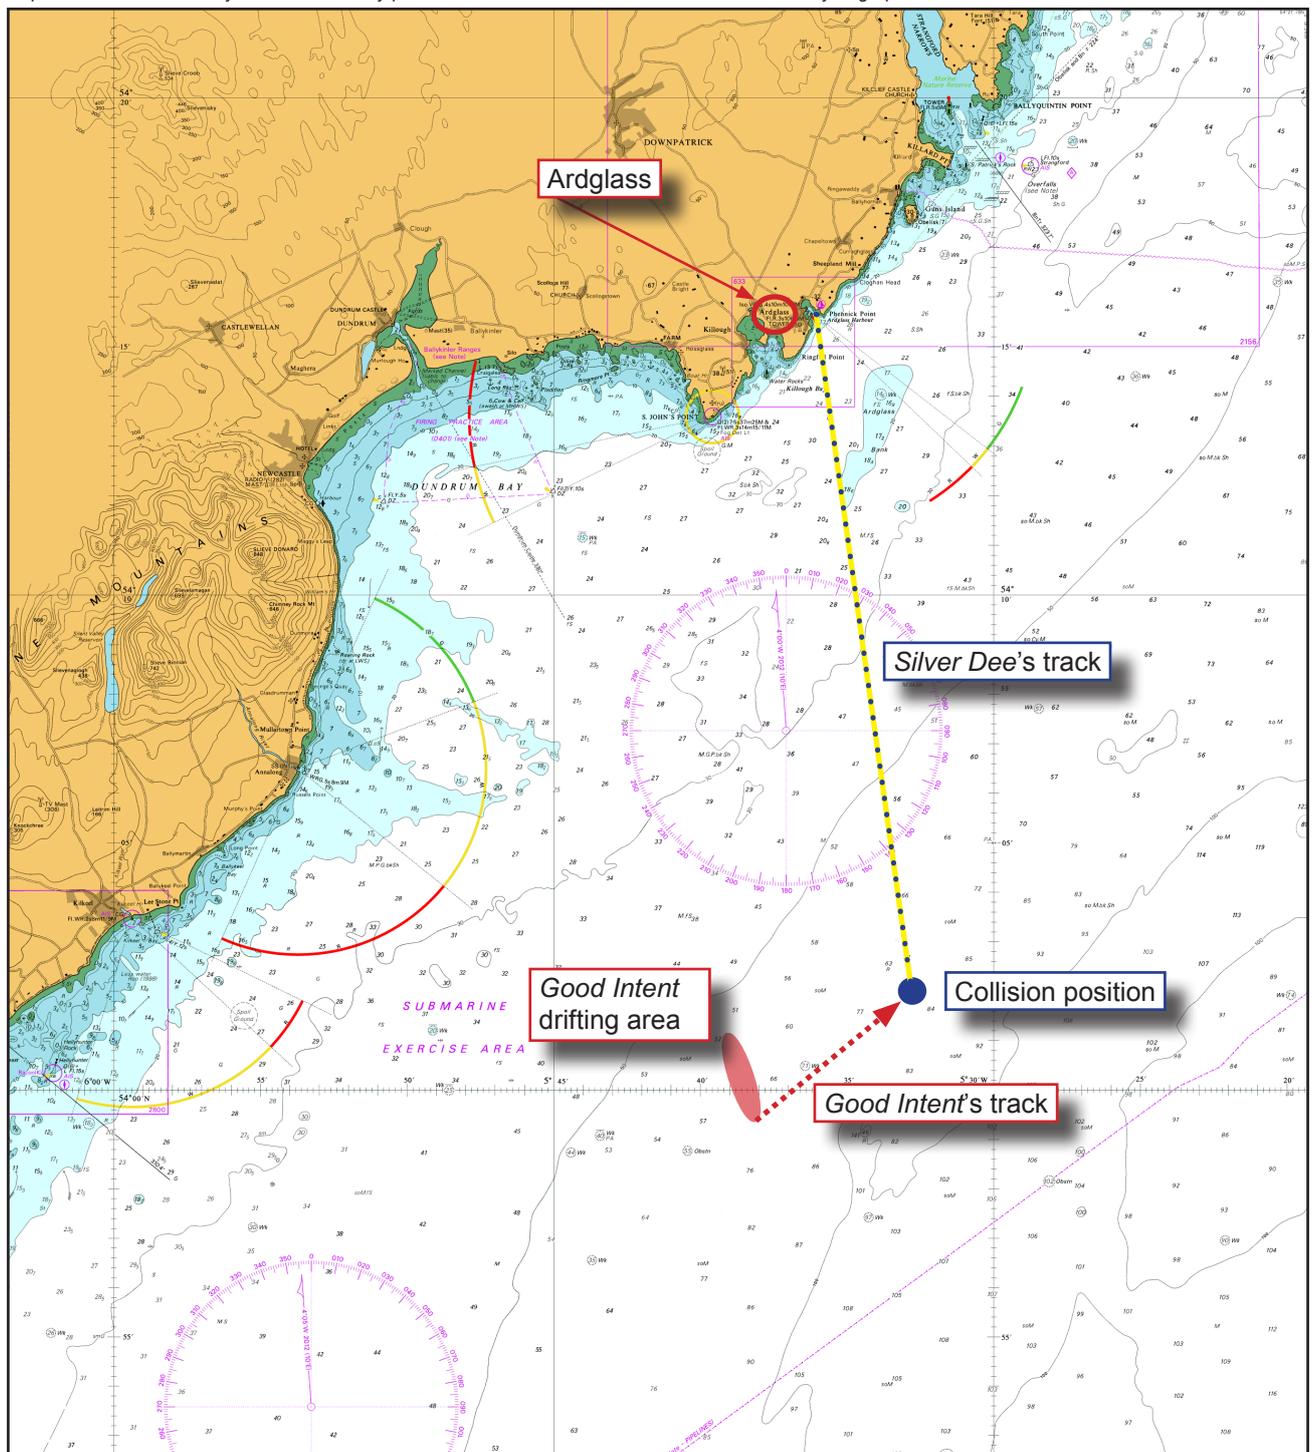
Figure 1: Extract from Chart 0044 showing tracks of *Silver Dee* and *Good Intent*

At 0430, the distance between *Silver Dee* and *Good Intent* was 9.25nm and closing (Figure 1). The visibility was good and the vessels were displaying navigation and deck lights. Therefore, by the time the vessels had closed to 3nm at about 0500, they would have been in sight of each other and showing on the radar displays. At that point, if both vessels had maintained their courses and speeds *Good Intent* would have passed between 0.6nm and 0.8nm ahead of *Silver Dee*.

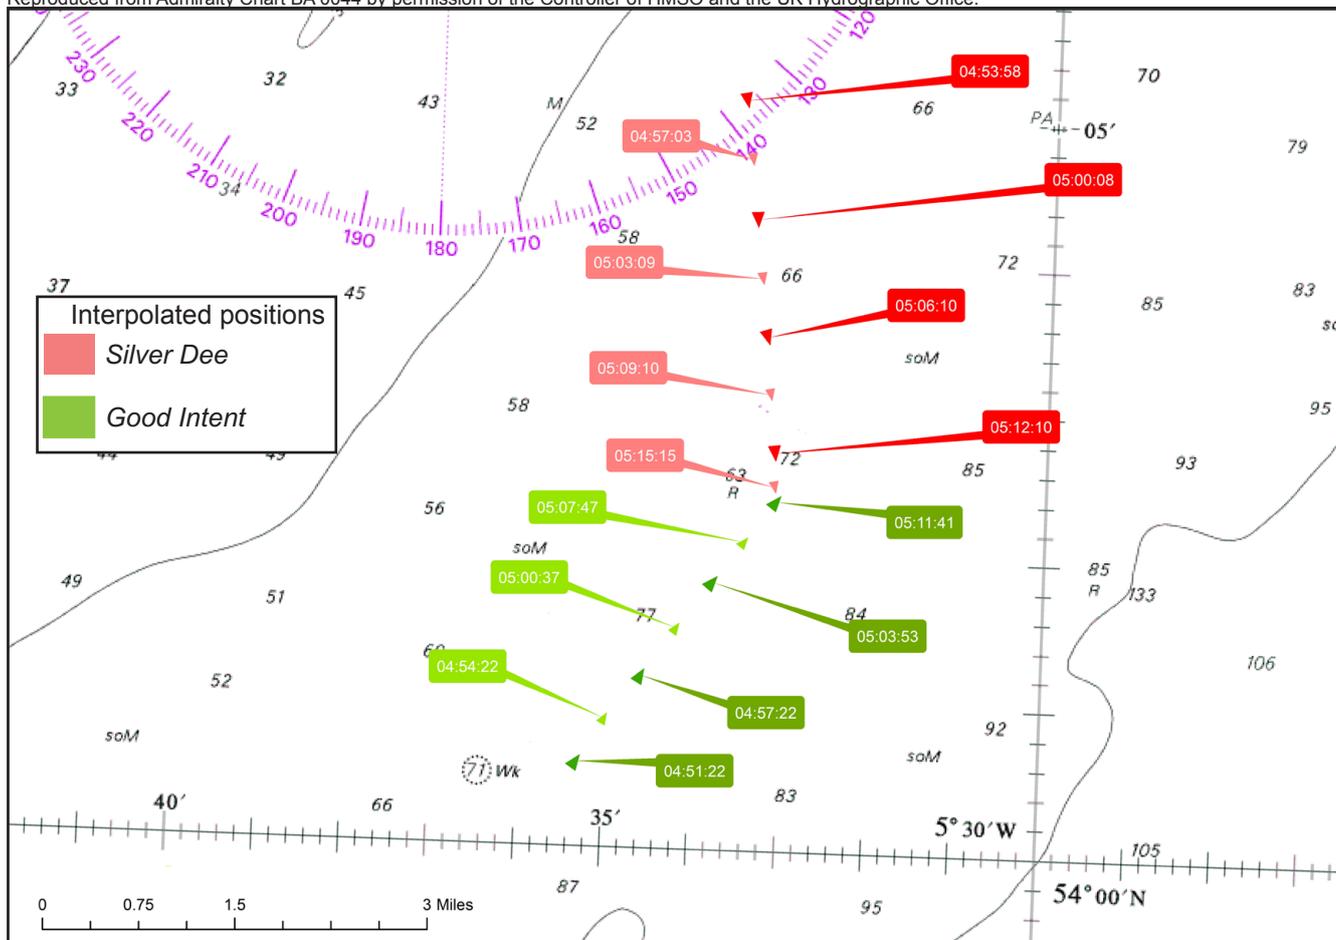
Figure 2: AIS tracks of *Silver Dee* and *Good Intent*

At 0430, *Good Intent*'s bosun went to the wheelhouse and checked visually and by radar that no other vessels were close by. He then put the engine to 'full ahead' and selected autopilot controlled steering. *Good Intent* was soon making good a course of approximately 040° at 7.3kts (**Figures 1 and 2**). The vessel was heading towards a position about 5.6nm to the north-east that was marked by a cursor on a chart plotter. The bosun had been instructed by the vessel's skipper to be in that position at 0515 to start the day's fishing. The bosun then left the wheelhouse to prepare the fishing gear. He kept a lookout from the deck but occasionally visited the wheelhouse to check the vessel's progress.

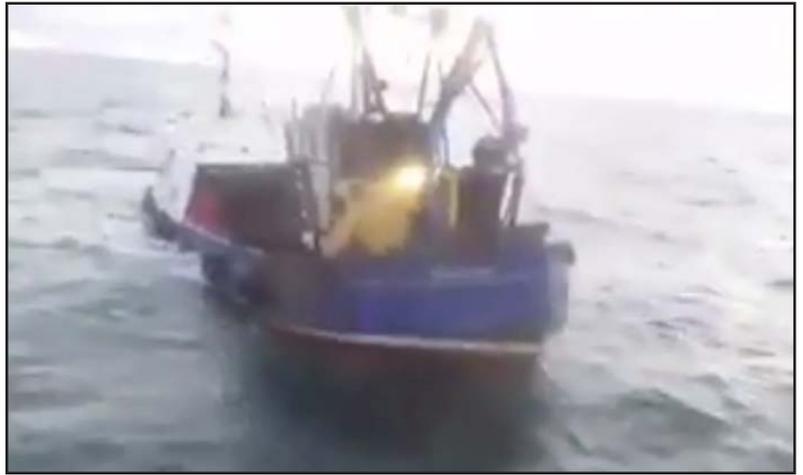
Figure 3: *Silver Dee* after abandonment

informed Belfast Coastguard on VHF radio that both vessels' crews were safe and uninjured. He also advised the coastguard that *Good Intent* did not appear to be in immediate danger. Over the next few minutes, *Silver Dee* slowly submerged (**Figure 3**) and eventually sank at about 0545 (**Figure 4**). Shortly afterwards, the vessel's Emergency Position Indicating Radio Beacon floated to the sea surface and started transmitting. Its liferaft also released and inflated.

Silver Dee's rapid flooding was due to its lack of a collision bulkhead and other watertight subdivisions. Floodwater was able to rush through the damaged planking at the stem and then spread quickly through the vessel.

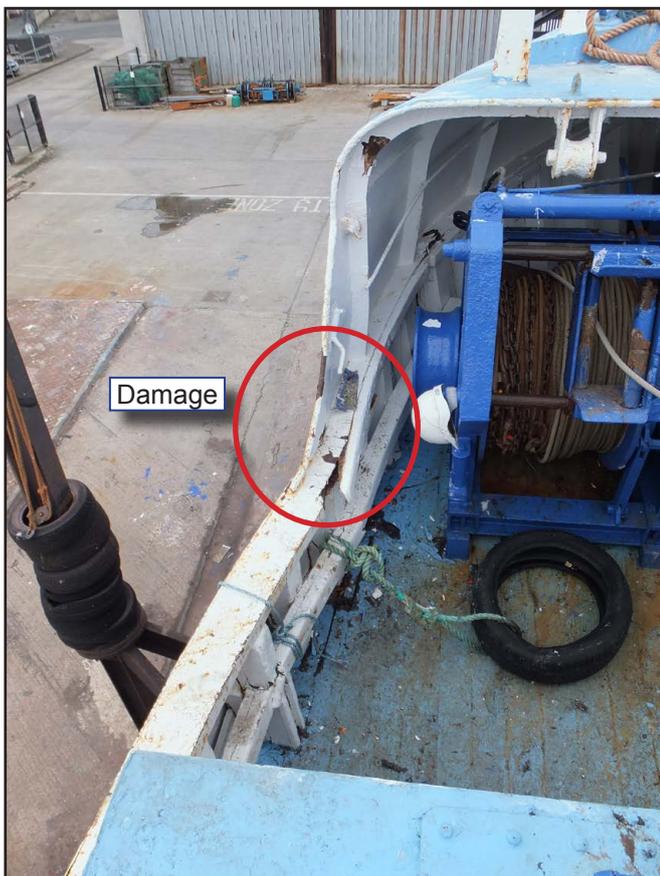
Figure 5: Damage to port shoulder of *Good Intent*

Good Intent proceeded to Ardglass where *Silver Dee*'s crew disembarked. Inspection in port established that *Good Intent* had suffered damage to steelwork and planking on its port side (**Figure 5**).

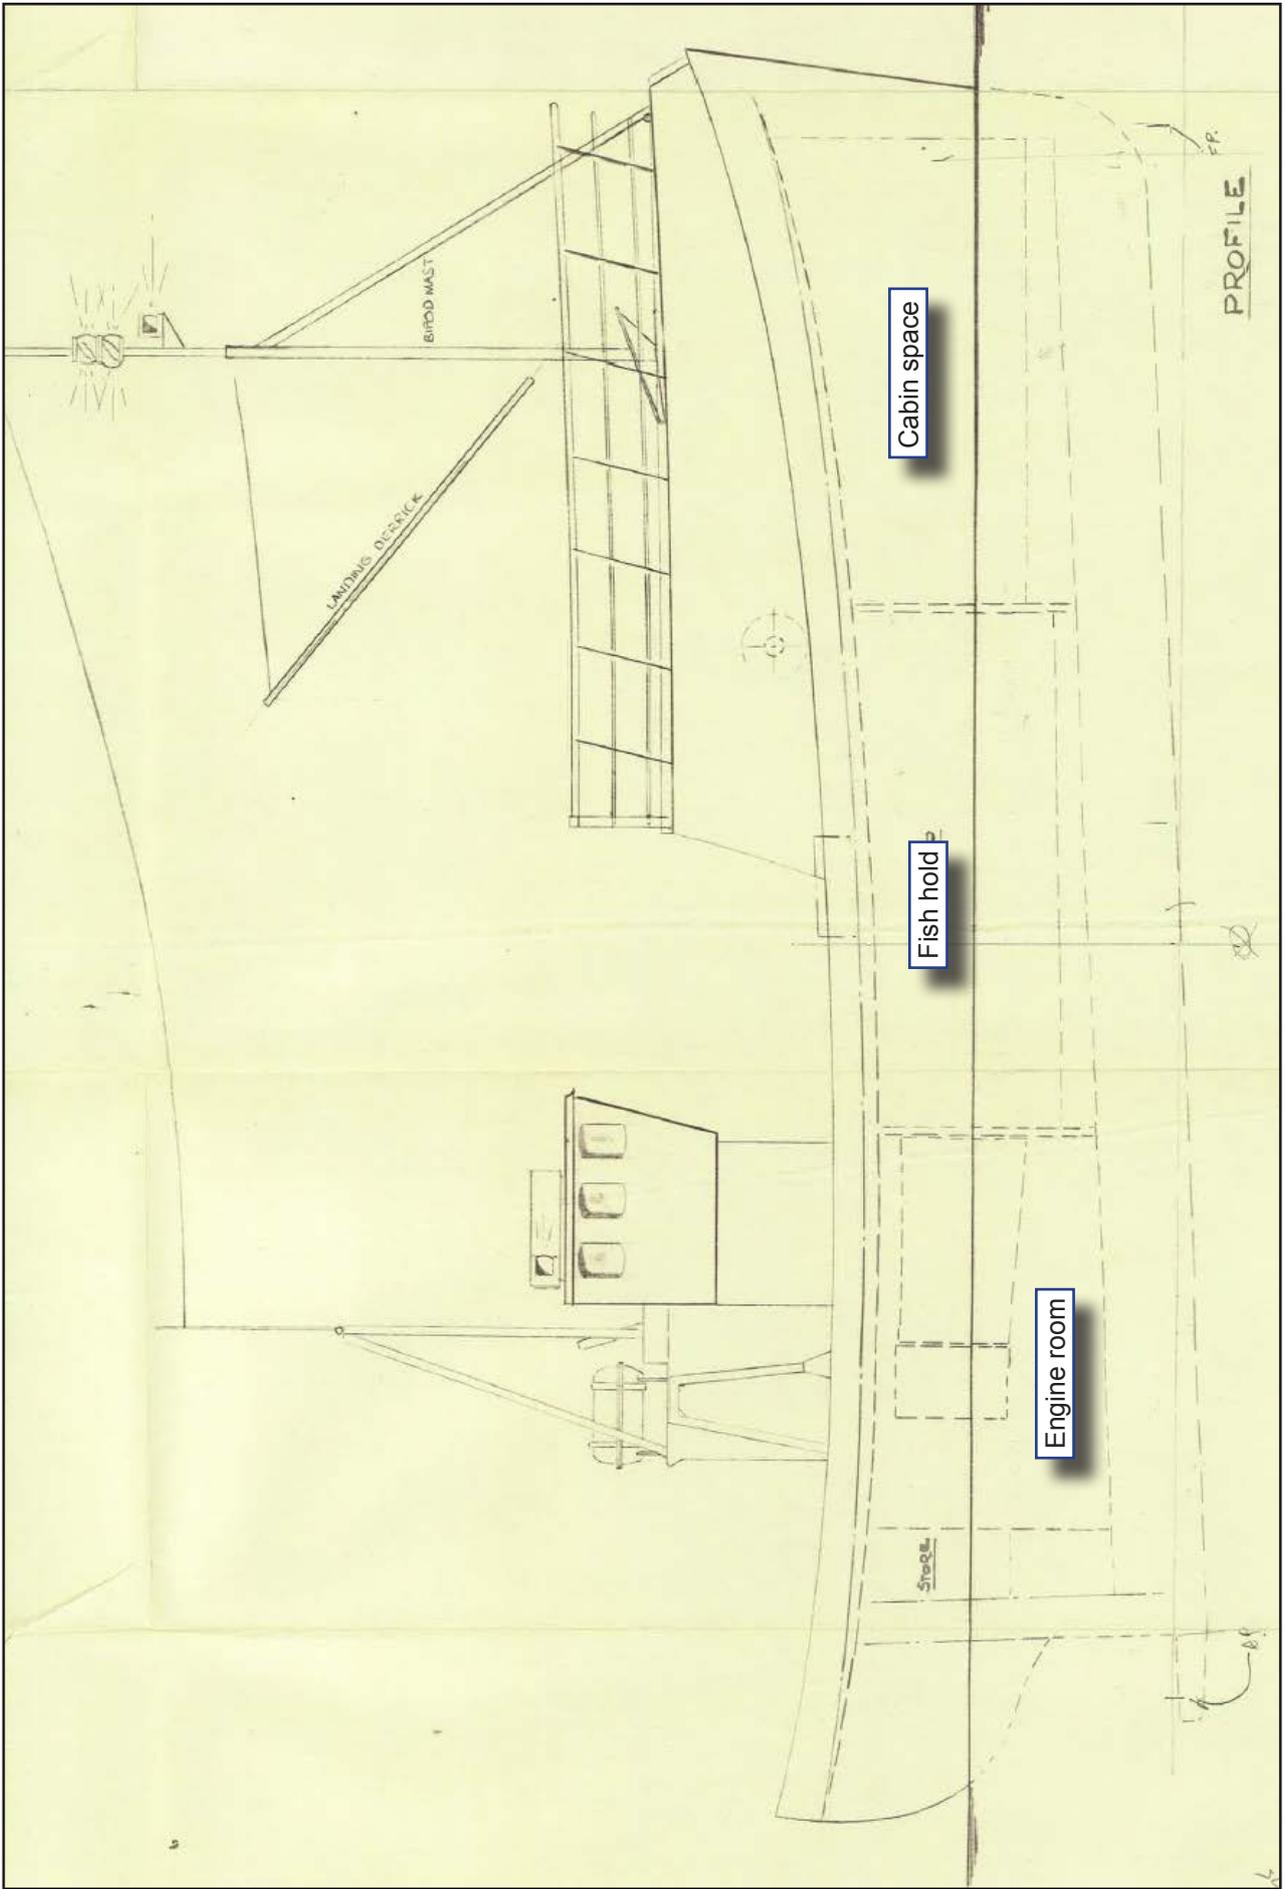
Figure 6: Silver Dee side profile

Silver Dee and *Good Intent* were wooden, twin-rigged stern trawlers. *Silver Dee* was 18.54m in length and was built in 1971. *Good Intent* was 18.21m in length and was built in 1981. Both vessels complied with the requirements of The Fishing Vessels (Safety Provisions) Rules 1975. *Silver Dee* had three main compartments below the waterline; the cabin space, the fish hold and the engine room (**Figure 6**). The vessel was not fitted with a collision bulkhead or any other watertight bulkheads.

Since the Fishing Vessels (Safety Provisions) Rules 1975 were introduced, there have been numerous changes to the construction requirements applicable to new vessels; *Silver Dee* did not have to meet these revised requirements due to "grandfather rights"⁹. Had *Silver Dee* been constructed today, it would be required to be fitted with a collision bulkhead and watertight bulkheads either side of the engine room. Specifically MSN 1770 (F)¹⁰ states:

In vessels constructed of wood, a collision bulkhead and bulkheads at the fore and aft ends of the machinery space, should be provided. The after bulkhead of the machinery space may terminate on a horizontal, flat that extends aft to the stern, above the line of shafting. The bulkheads and flat referred to in this section should be of adequate strength and gasketed and/or caulked to prevent significant leaks or flooding.

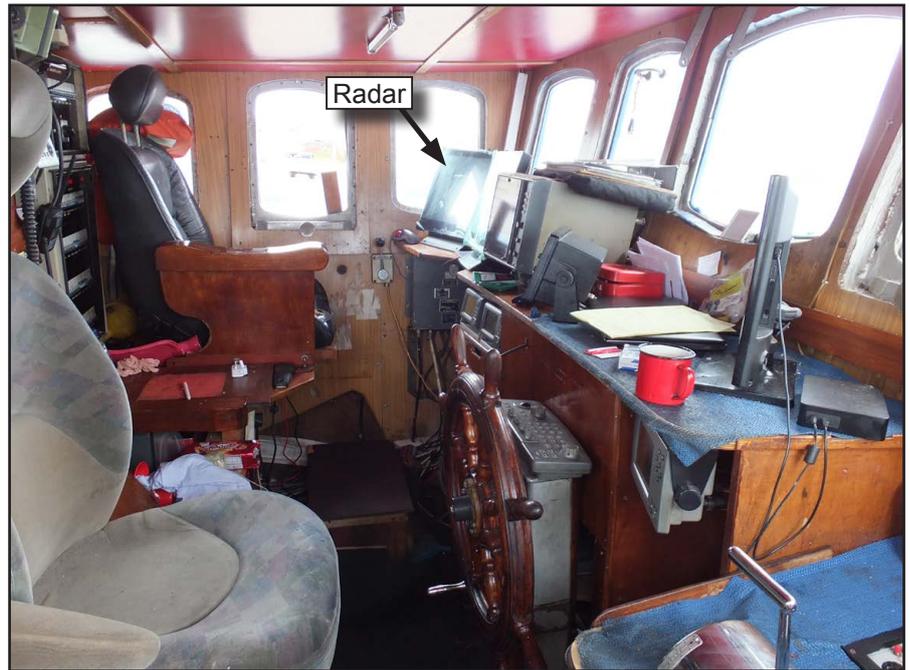
Figure 7: *Good Intent*'s wheelhouse

The wheelhouses of *Silver Dee* and *Good Intent* were similarly equipped with two plotters, a radar display, an echo sounder, two VHF radios, two GPS⁷ receivers, an AIS⁸ and an autopilot. The vessels' AISs were not integrated with the radar displays or the plotters. Before the collision, *Silver Dee*'s skipper had switched the radar display between the 3nm and 6nm range scales; *Good Intent*'s radar display was set on the 3nm range scale. No watch alarm was fitted on board either vessel. *Silver Dee*'s wheelhouse had a chair located on the centreline. Two chairs were fitted in *Good Intent*'s wheelhouse, one either side of the centreline (Figure 7).

However, it would have been almost impossible for the bosun to enter the wheelhouse, look at the plotter and adjust the engine control lever without looking out of the windows with peripheral vision. Therefore, it is likely that the bosun did not notice *Silver Dee* because the vessel was obscured from his view by either the port side wheelhouse chair, the radar display or a window frame (**Figure 7**).

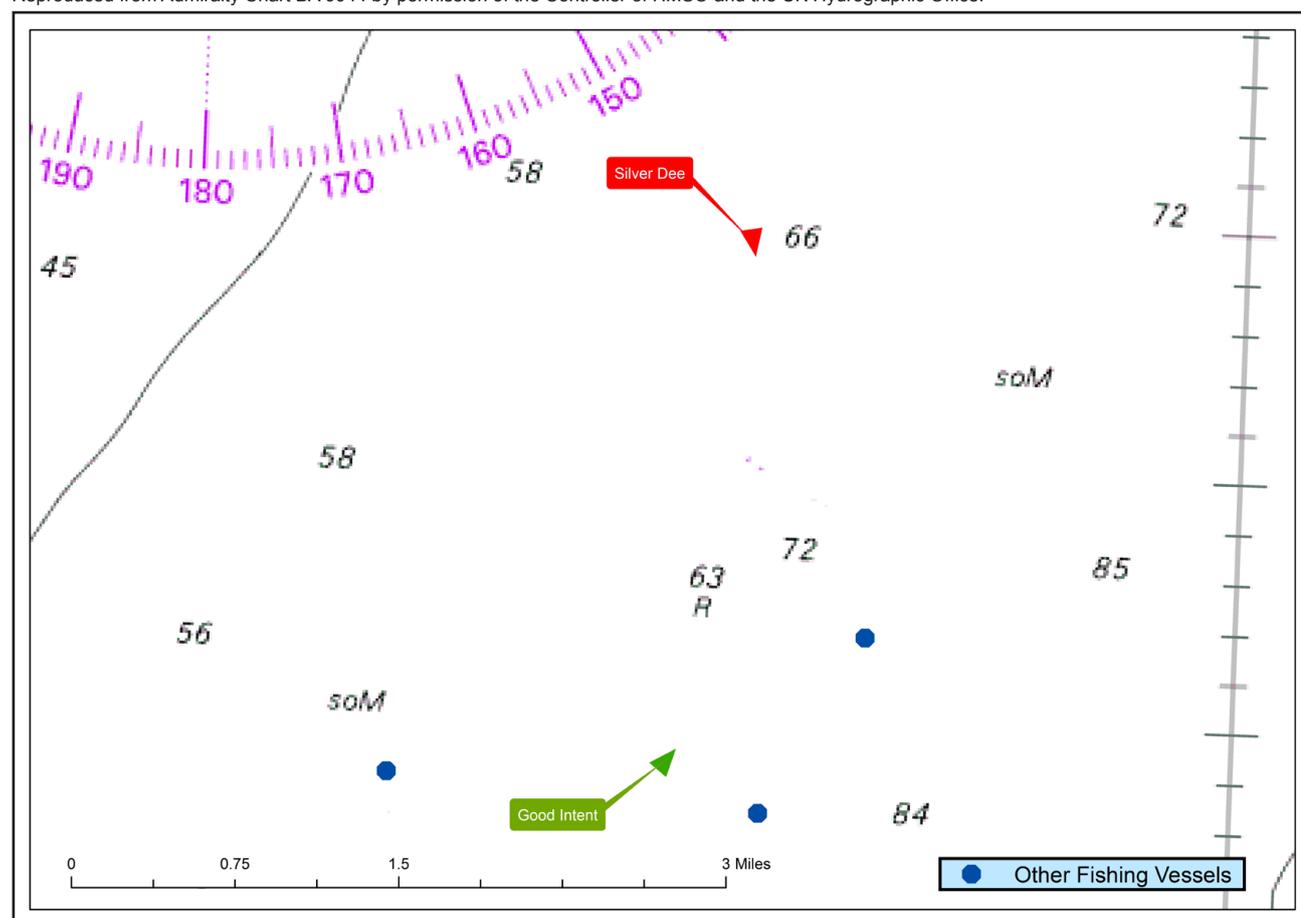
Figure 8: Disposition of vessels at 0500

Throughout the passage, the skipper was seated in the wheelhouse chair and appears to have been relatively inactive. He was 'relaxed' about other nearby fishing vessels heading in a similar direction, which was a routine occurrence, and he did not monitor their movement. At 0500, *Good Intent* was one of four fishing vessels within 3nm that were ahead of *Silver Dee* (**Figure 8**) but the skipper did not notice that *Good Intent* was moving to the north-east. Such movement would have been readily apparent by radar and by sight, as *Silver Dee*'s port navigation light would have been visible.
