ACCIDENT

Aircraft Type and Registration:	Agusta Bell 206B Jet Ranger III, G-OMDR	
No & Type of Engines:	1 Allison 250-C20B turboshaft engine	
Year of Manufacture:	1981 (Serial no: 8610)	
Date & Time (UTC):	27 June 2014 at 1553 hrs	
Location:	Near Gamston Airport, Nottinghamshire	
Type of Flight:	Private	
Persons on Board:	Crew - 1	Passengers - None
Injuries:	Crew - None	Passengers - N/A
Nature of Damage:	Damage to main rotor transmission driveshaft couplings, isolation mount, transmission stop mount, swashplate support, tachometer generator and freewheeling unit	
Commander's Licence:	Private Pilot's Licence (Helicopters)	
Commander's Age:	44 years	
Commander's Flying Experience:	850 hours (of which 500 were on type) Last 90 days - 32 hours Last 28 days - 12.5 hours	
Information Source:	AAIB Field Investigation

Synopsis

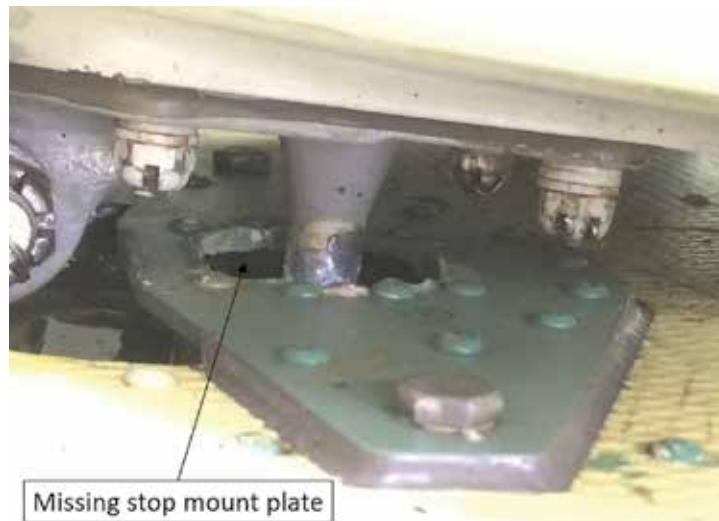
**Figure 2**

Amongst the photographs the pilot sent by email were images of the transmission drag pin and stop mount, and the main transmission driveshaft, forward coupling and isolation mount. The maintenance manager examined the photographs and, when looking at the stop mount support plate (see Figure 2), he did not see any damage or cracked paint on the domed heads of the attachment rivets. Furthermore, he did not see any disturbance of the sealant between the stop mount support and the fuselage upper deck. He observed that the drag pin attachment hardware appeared undamaged, as did the drag pin itself, apart from some loss of paint on the side of the pin. This, in his experience, was not an abnormal condition. He did not notice the absence of the stop mount plate, which had detached.

Pilot's photograph of damage to transmission drag pin and stop mount assembly

The transmission drag pin had made heavy lateral contact with the stop mount plate and the rivets attaching the stop mount plate to the support plate had failed in shear, releasing the stop mount plate which was found lying loose beneath the support plate. The drag pin's paint finish had been abraded, revealing the bare metal surface beneath.

A second opportunity to detect the damage occurred when the maintenance manager reviewed the pilot's photographs of the helicopter. These showed the missing stop mount plate and the gouge in the isolation mount. The maintenance manager stated that his decision to approve the helicopter for the return flight was influenced by the pilot's positive report of how the helicopter had performed on the sectors following the loss of control event, and also by the fact that the driveshaft couplings had not been excessively overheated. It is possible that these factors promoted confirmation bias⁵ when he reviewed the photographs of the damaged isolation mount, which was similar to, but more severe than, previous examples he had seen. He did not detect the absence of the stop mount plate that was missing in one of the pilot's photographs, as his attention was drawn to

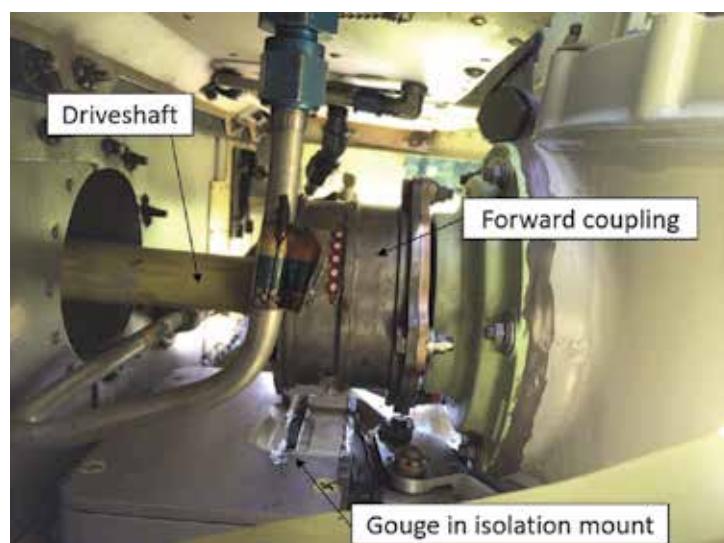
**Figure 3**

When looking at the driveshaft area (see Figure 3), the maintenance manager observed that the dots on the red temperature indicator stickers, on the forward driveshaft coupling, were white, indicating that the coupling had not been overheated excessively. He noted a gouge in the isolator mount top plate, which was similar in his experience to previous B206 heavy landing events, but he did not ask the pilot to measure the gouge depth and did not refer to the AMM for allowable damage limits. The pilot advised the maintenance manager that the mast was "free to move left and right" and photographs taken by the pilot showed no visible contact marks on the main rotor pitch links or the mast cowling. The maintenance manager verbally approved the helicopter to fly back to Biggin Hill Airport for further examination at the owner's maintenance facility, and no defects were recorded in the helicopter's technical log either before or after these flights.

Pilot's photograph of damage to isolation mount

The isolation mount top plate was gouged through its entire thickness and the internal elastomeric damper material had mostly dis-bonded due to overload, rendering the isolator incapable of providing significant vibration damping.

states that the maximum allowable depth of damage to the isolation mount top cover plate is 0.080" (2.0 mm). The top cover plate thickness is 5.2 mm.

The maintenance manual requires a pylon whirl inspection to be carried out if the isolation mount damage limits are exceeded or the pilot reports extreme cyclic inputs. Had the maintenance manual been consulted, it is improbable that the helicopter would have been approved for continued flight.

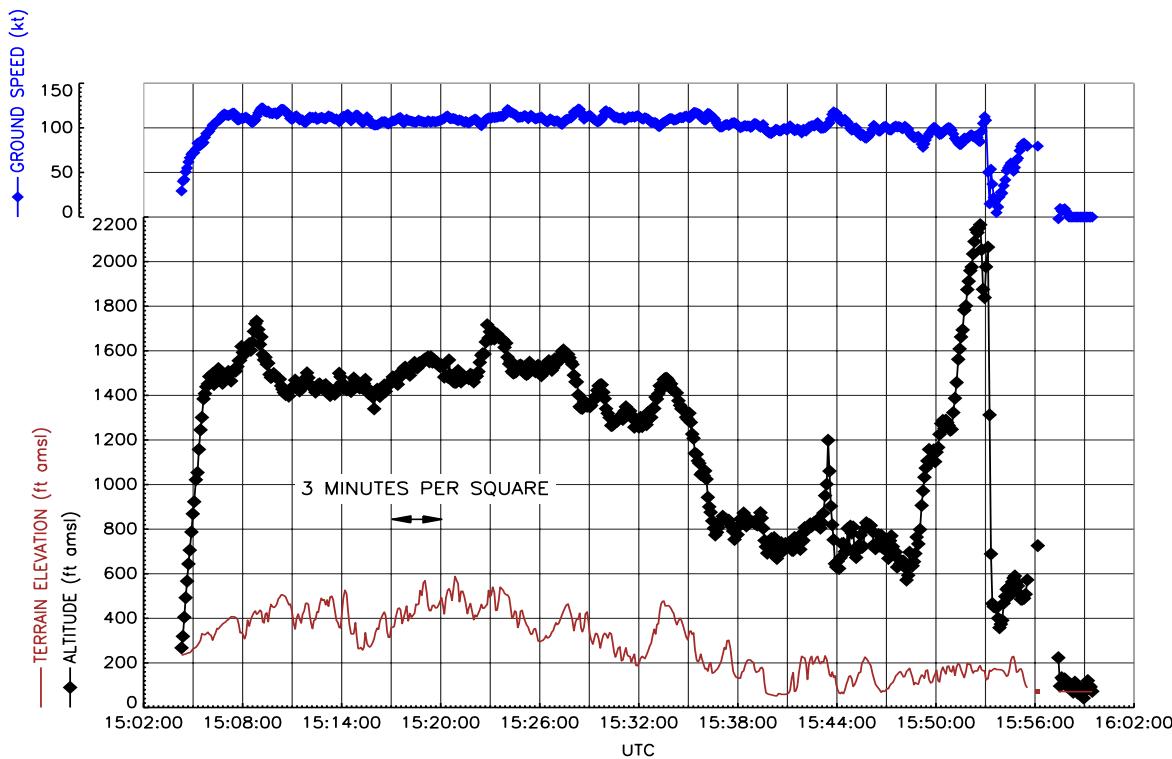
Figure 6
Flight from Bicester to Gamston

The flight from Bicester (see Figure 6) started at 1504 hrs on 27 June 2014. The helicopter initially tracked north at a height of approximately 1,000 ft agl. At 1533 hrs, it descended to approximately 600 ft agl, before descending further to approximately 400 ft agl. After this, the helicopter climbed to a height of approximately 2,000 ft agl over a four-minute period.

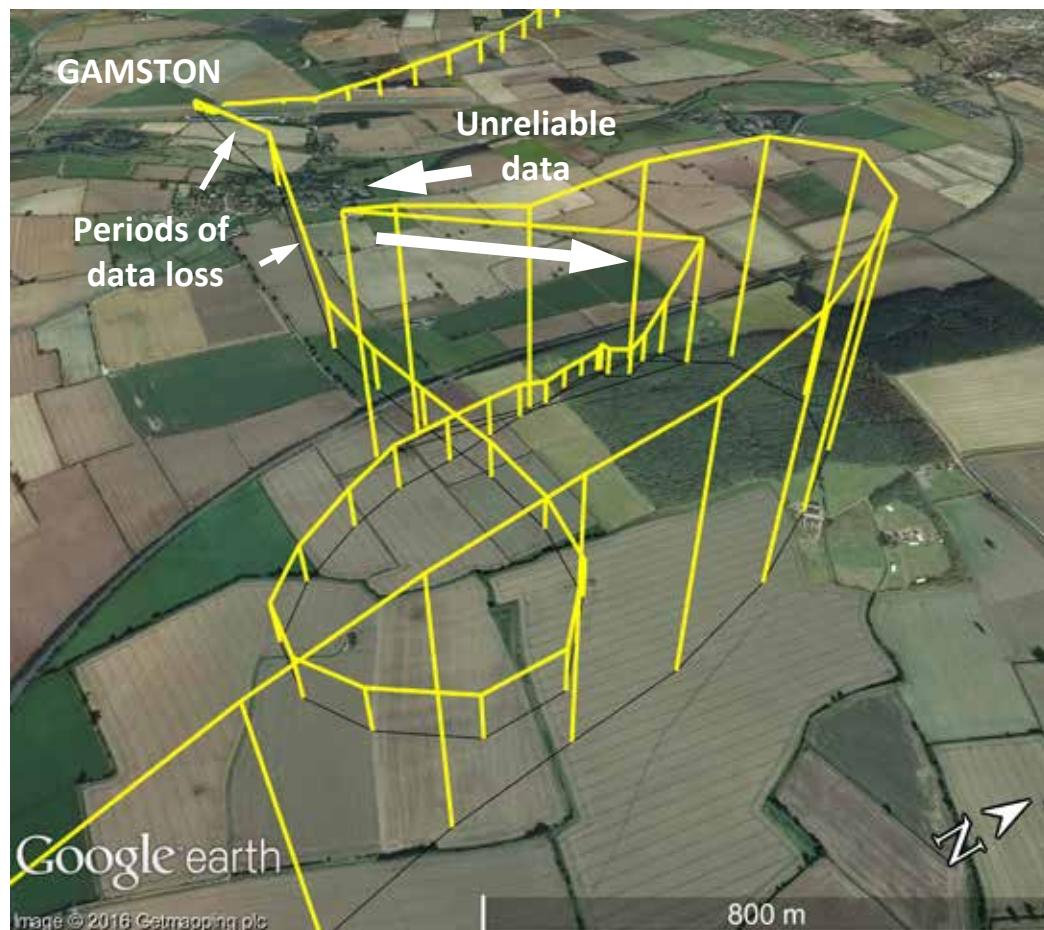
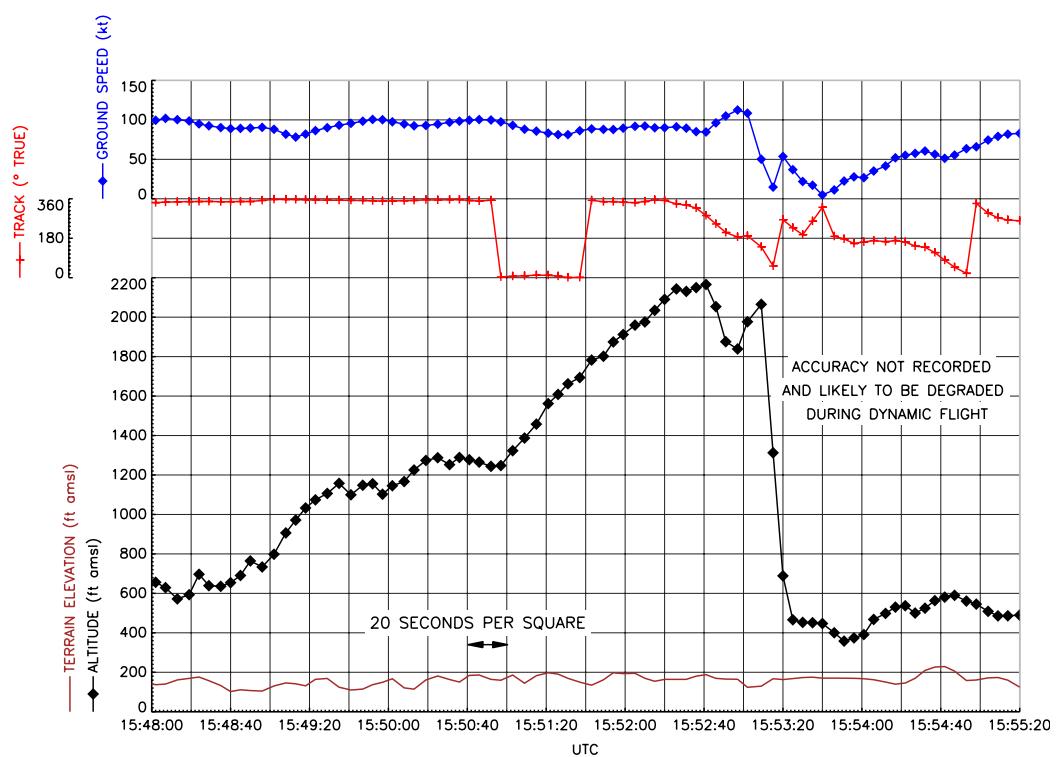
Figure 7
Loss of control

On reaching this height, the helicopter began a turn to the left, achieving a track change of 90° in approximately 20 seconds, and a descent was initiated (see Figure 7). As the data becomes less reliable under dynamic situations, it could not be used to accurately assess the dynamic manoeuvres that followed.

The highest rate of descent indicated by the data was 6,000 ft/min but this is unlikely to be accurate. The data indicated that the helicopter then flew level at a height of approximately 300 ft agl but with a reducing ground speed. The helicopter then descended further, the speed increased and the helicopter then climbed again. After control was regained, the aircraft proceeded to Gamston Airport.
