**ACCIDENT**

<b>Aircraft Type and Registration:</b>	EC135 T1, G-NWPS	
<b>No &amp; Type of Engines:</b>	2 Turbomeca Arrius 2B1A turboshaft engines	
<b>Year of Manufacture:</b>	1998 (Serial no: 63)	
<b>Date &amp; Time (UTC):</b>	25 November 2015 at 0929 hrs	
<b>Location:</b>	Bilsdale, North Yorkshire	
<b>Type of Flight:</b>	Commercial Air Transport (Passenger)	
<b>Persons on Board:</b>	Crew - 1	Passengers - 2
<b>Injuries:</b>	Crew - None	Passengers - None
<b>Nature of Damage:</b>	Damage to fenestron tail rotor; duct surface lacerated, hub cover destroyed and foreign object damage to fenestron blades	
<b>Commander's Licence:</b>	Commercial Pilot's Licence	
<b>Commander's Age:</b>	44 years	
<b>Commander's Flying Experience:</b>	3,482 hours (of which 133 were on type) Last 90 days - 54 hours Last 28 days - 6 hours	
<b>Information Source:</b>	Aircraft Accident Report Form submitted by the pilot

**Synopsis**

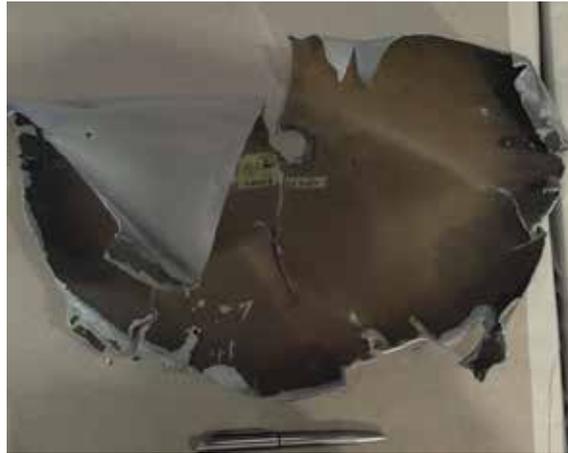
**Figure 1**

It was discovered that the fenestron unit on the tail of the helicopter had been significantly damaged. The hub cover had detached and was found distorted and lacerated (Figure 1). Also, a damaged piece of metal, measuring approximately 20 cm square, was found nearby. The pilot concluded that this had been sucked into the fenestron duct, hitting the hub cover. The hub then detached and one, or both, of these metal objects appeared to have been ingested by the fenestron fan. The duct surface was deeply cut, the paintwork was badly scraped and the fan blades bore signs of foreign object damage (Figure 2).

Remains of fenestron hub cover

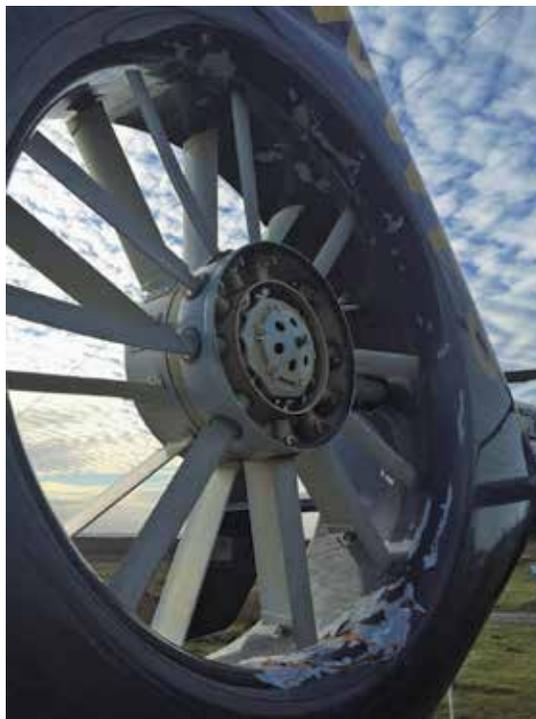
**Figure 2**

Damaged fenestron duct with hub cover missing

The incident was recorded by a CCTV system. A single piece of debris was shown entering the fenestron duct, causing an apparent puff of smoke, before the tail yawed slightly to the left. It was not possible to identify the origin of the metal debris but it was painted yellow and black on one side and looked like a piece of signage.

In future, the helicopter operator will ensure, where possible, that sites are checked for loose debris before use.
