## ACCIDENT

<b>Aircraft Type and Registration:</b>	Ikarus C42 FB80, G-CEDR	
<b>No &amp; Type of Engines:</b>	1 Rotax 912-UL piston engine	
<b>Year of Manufacture:</b>	2006 (Serial no: 0606-6833)	
<b>Date &amp; Time (UTC):</b>	7 April 2015 at 1020 hrs	
<b>Location:</b>	Newtownards Airport, Northern Ireland	
<b>Type of Flight:</b>	Private	
<b>Persons on Board:</b>	Crew - 1	Passengers - None
<b>Injuries:</b>	Crew - 1 (Fatal)	Passengers - N/A
<b>Nature of Damage:</b>	Aircraft destroyed	
<b>Commander's Licence:</b>	National Private Pilot's Licence	
<b>Commander's Age:</b>	55 years	
<b>Commander's Flying Experience:</b>	89 hours (of which 23 were on type) Last 90 days - 4 hours Last 28 days - 1 hour	
<b>Information Source:</b>	AAIB Field Investigation

## Synopsis

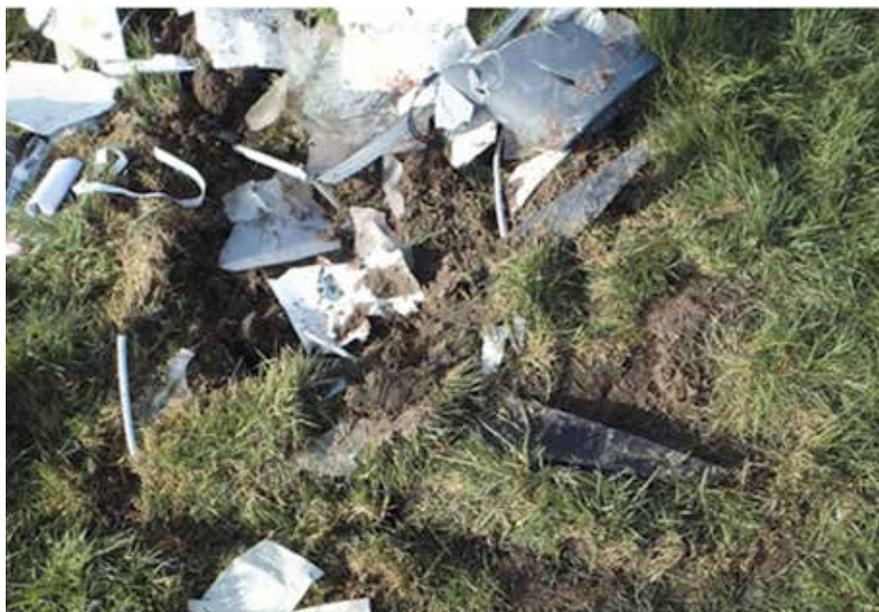
**Figure 1**

Two of the propeller blades had dug into the ground during the impact sequence and failed close to the propeller hub (see Figure 1). The third blade remained attached to the hub but had split along the leading edge. The forward face of this blade had broken into two sections and had separated from the rest of the blade. These sections were located approximately 10 m to the right of the wreckage.

Propeller blades embedded in the ground

Detailed examination of the remains of the propeller confirmed that the two propeller blades which had broken close to the propeller hub had been the first two blades to strike the ground during the impact sequence and had failed in overload. The forward face of the third blade, which had split along its leading edge during the impact, had failed due to bending and torsional overload. No pre-existing structural abnormalities were found within the blades and no evidence was found that the blades had struck the runway surface prior to the accident.

throughout the aircraft's fuel system. Although an estimation of the engine's power at impact could not be made, the damage to the propeller and the ground marks it produced were consistent with the engine operating at relatively high power as it struck the ground.
