INCIDENT

Aircraft Type and Registration:	British Aerospace 146-200, D-AMGL	
No & Type of Engines:	4 Avco Lycoming ALF502R-5 turbofan engines	
Year of Manufacture:	1986 (Serial no: 2055)	
Date & Time (UTC):	16 August 2015 at 1736 hrs	
Location:	London City Airport	
Type of Flight:	Passenger Transport	
Persons on Board:	Crew - 4	Passengers - 77
Injuries:	Crew - None	Passengers - None
Nature of Damage:	Damage to right main gear shock-absorber and hole in right main gear door	
Commander's Licence:	Airline Transport Pilot's Licence	
Commander's Age:	N/A	
Commander's Flying Experience:	4,900 hours (of which 4,500 were on type)	
Information Source:	AAIB Field Investigation

Synopsis

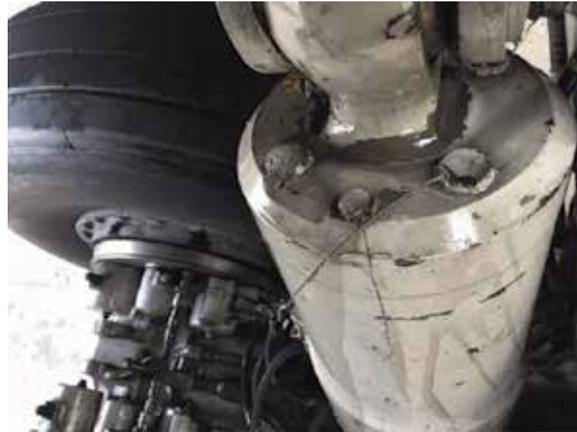
Figure 1

The images in Figures 1 and 2 were taken by the commander shortly after the aircraft had taxied to the stand and the passengers had disembarked. An oil stain was readily visible on the ground around the right main gear leg and there was a piece of broken locking wire (Figure 1) attached to the top of the shock-absorber. Bubbles of oil were coming from a hole where a bolt head was missing and oil was seeping from the base of the bubbles. Over the next 24 hours the rate of bubbles originating from the hole slowed significantly. The shock-absorber was removed and taken to the manufacturer for examination.

Image taken just after landing - shock-absorber on the right main gear leg

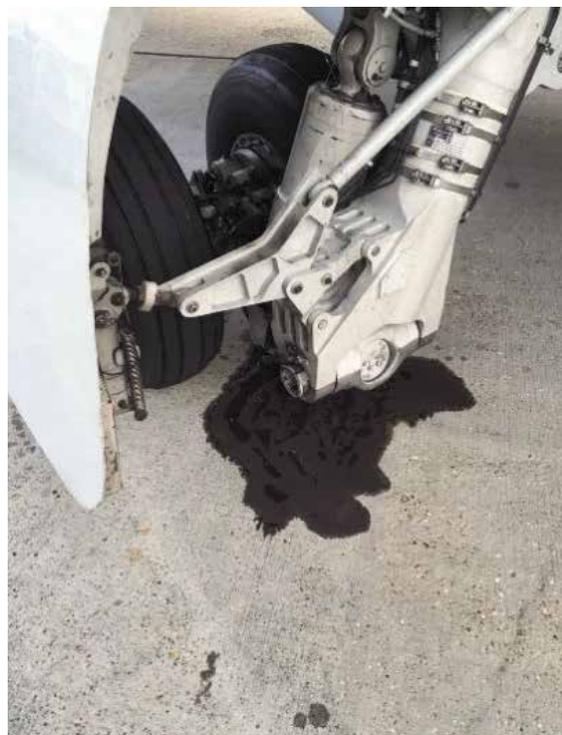
Figure 2

Image taken just after landing - right main gear

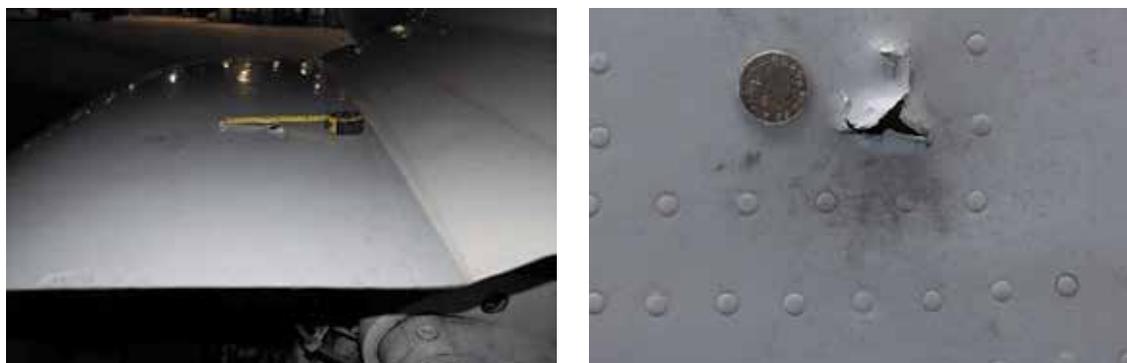
Figures 3 and 4

The landing gear door had been punctured from the inside – see Figures 3 and 4. The location and the size of the hole was consistent with the missing bolt head being forced against the inside of the door without the bolt head passing through the door structure.

Images of the hole in the right main landing gear door.
Note: the coin and bolt head have approximately the same diameter

A subjective comparison of the rate of oil loss between that observed at London City Airport and that measured during the investigation of the shock-absorber suggested that the bolt became detached within a few hours of landing at London City. The location and dimensions of the hole in the landing gear door were consistent with the bolt becoming detached and then being pressed against the inside of the landing gear door on retraction. It is therefore probable that the bolt became detached either during, or shortly before, the takeoff from Frankfurt.

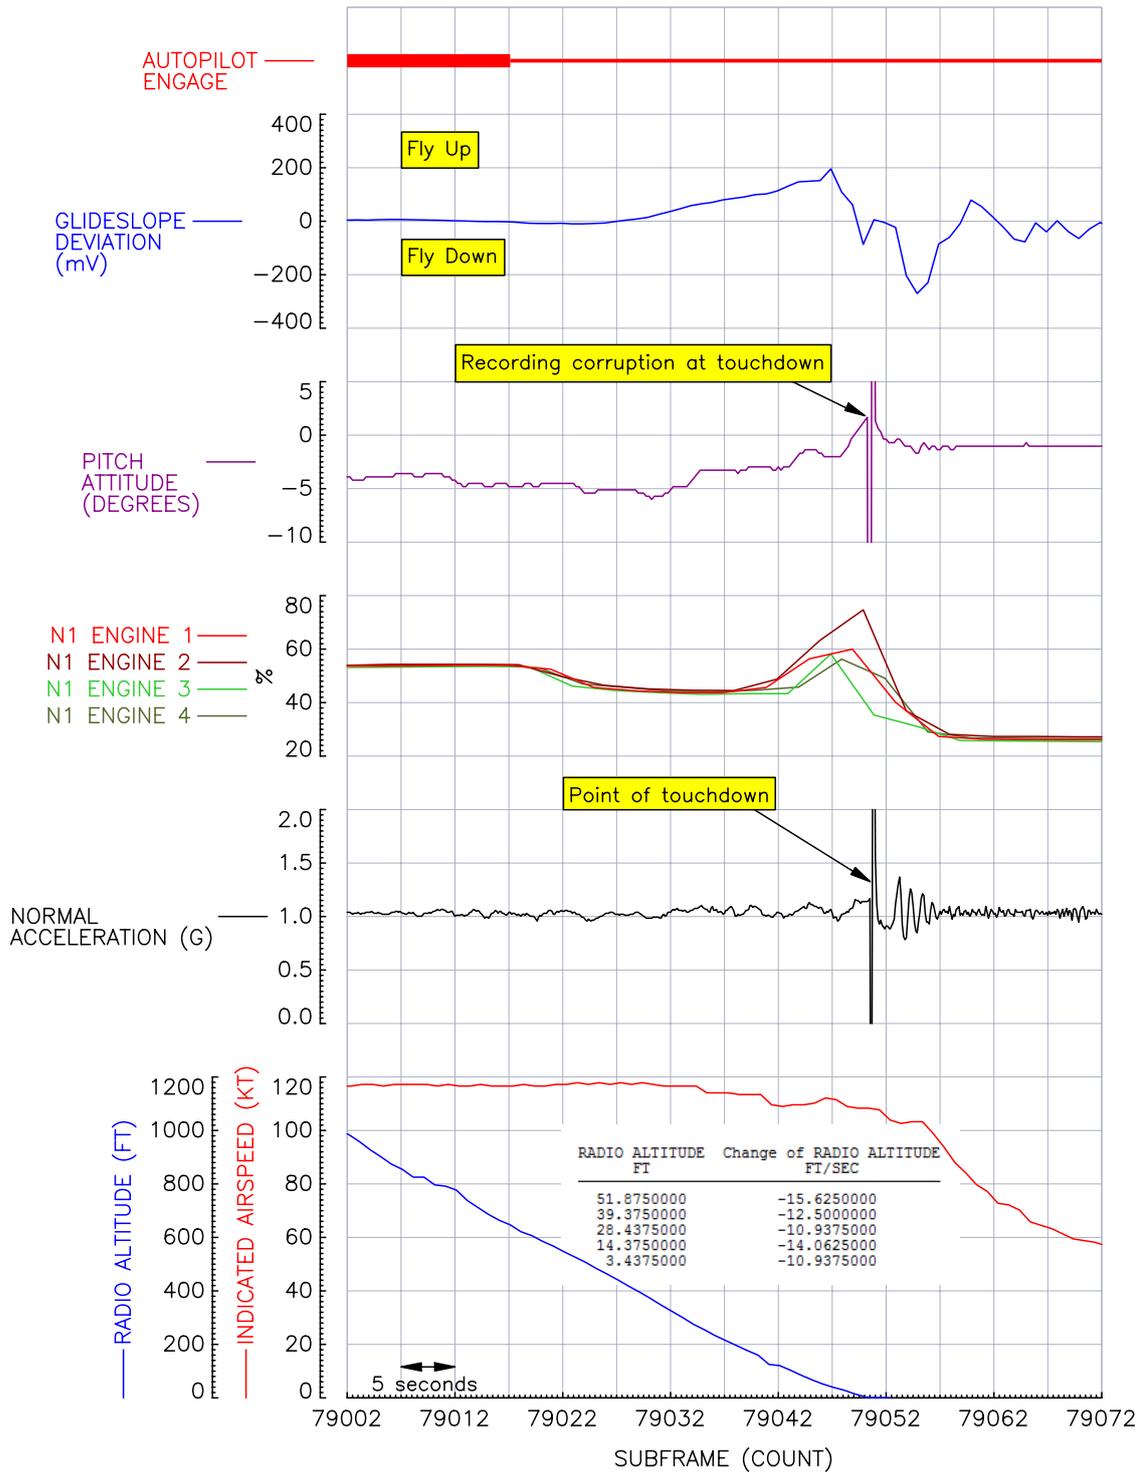
Figure 5

The FDR was used to plot the key parameters that were available for the landing and these are shown in Figure 5. However, it should be noted that around the point of touchdown the recording was corrupt for a number of parameters. Tape-based recorders are more sensitive to impact shock and such corruption does not affect solid-state devices.

It was not possible to make a precise assessment of the descent rate at touchdown; however, over the preceding few seconds of data, descent rates of around 10 ft/sec were recorded. The applicable Aircraft Maintenance Manual quotes, in the section related to '*Inspection after overweight, hard or high drag/side load landing*':

Flight Data Recorder parameters for the landing sequence including tabular information on the change of Radio Altitude over the last 5 seconds of flight

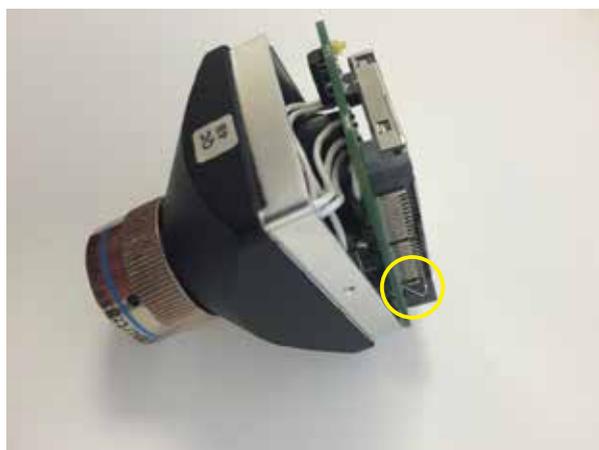
In addition to the FDR and CVR, the aircraft was also fitted with a Quick Access Recorder (QAR) which in this case was designed to record to a removable solid state CompactFlash (CF) card. The card was downloaded but found to be blank. On further investigation, the QAR was found to have damage to two pins that are part of the electrical interface from the unit to the CF card. Figure 6 shows the visible damage to one of these pins, highlighted in yellow.

Damage to one of the pins forming the QAR unit's CF card electrical interface

The manufacturer of the QAR confirmed that the affected pins were the electrical ground signals for the CF card. The risk of potential damage to the QAR unit, by incorrect insertion of a CF card, had been highlighted by the manufacturer in a Service Information Letter, QAR001, dated 1 July 2005.

After the aircraft operator was informed of the damage to the QAR unit, a check of other units in their fleet highlighted two examples where damage had occurred. The operator subsequently published its own internal bulletin advising of the issue and has placed decals on the QAR units, showing the correct CF card orientation.

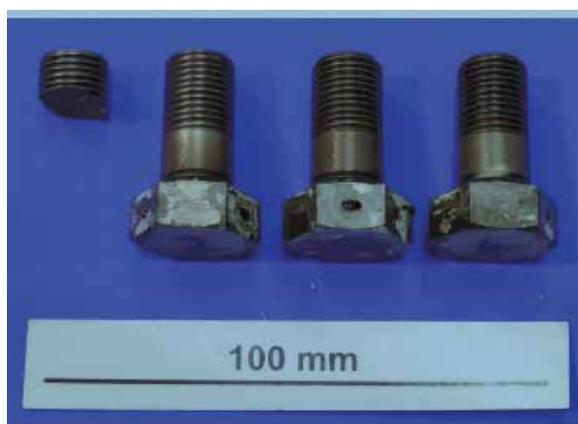
Figure 8a

The half of the fractured attachment bolt that had remained in the shock-absorber was removed and subjected to a metallurgical examination (Figure 8a). Three crescent-shaped fatigue cracks were observed on the outer edge of the fracture surface (Figure 8b). The conclusion of the metallurgical examination was that the bolt had fractured due to the initiation of multiple fatigue cracks from a number of locations. These locations were where the bolt interfaced with the outer cylinder, and no defects were observed at these initiation sites. No evidence of cracking was found in the other three bolts.

Image of fractured bolt compared with the three remaining complete bolts

The serial number on the heads of the three remaining bolts confirmed that these three bolts were fitted during the overhaul in 1998. In April 2015 the shock-absorber had completed over 23,100 landings. Given that the bolts were replaced in 1998 after 2,013 landings, then at the time of the incident the bolts had completed at least 21,000 landings, which exceeds their 18,100 landing fatigue-life limit.

limit, and hence the bolt that fractured had also probably exceeded this limit. There was some evidence that the three remaining bolts were slightly over-torqued, which might have contributed to the bolt fracturing.

As a result of this occurrence the operator has put in place a system to record the landings for the bolts on the shock-absorbers.

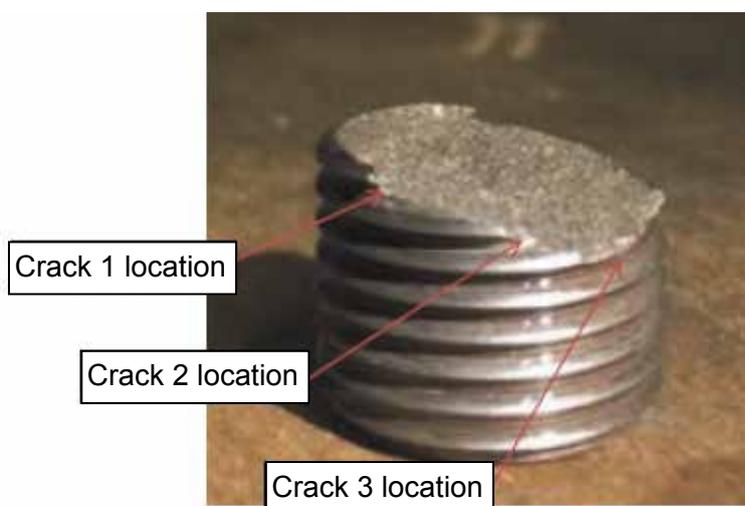
Figure 8b

Image of fractured bolt showing fatigue crack locations
