ACCIDENT

Aircraft Type and Registration:	Folland Gnat T Mk 1, G-TIMM	
No & Type of Engines:	1 Rolls-Royce Orpheus 101 turbojet engine	
Year of Manufacture:	1962 (Serial no: FL519)	
Date & Time (UTC):	1 August 2015 at 1302 hrs	
Location:	Approx 1 mile north of Oulton Park, Cheshire	
Type of Flight:	Aerial Work	
Persons on Board:	Crew - 1	Passengers - None
Injuries:	Crew - 1 (Fatal)	Passengers - N/A
Nature of Damage:	Aircraft destroyed	
Commander's Licence:	Private Pilot's Licence	
Commander's Age:	39 years	
Commander's Flying Experience:	706 hours (of which 218 hours were on type) Last 90 days - 6 hours Last 28 days - 2 hours	
Information Source:	AAIB Field Investigation

Synopsis

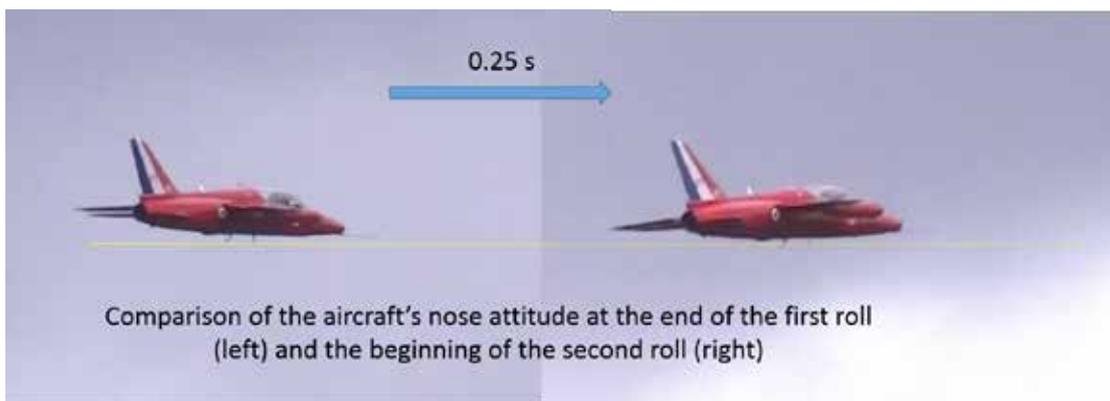
G-TIMM approached the display line from 'crowd left' and commenced a roll about its longitudinal axis, and the left image in Figure 9 shows the aircraft attitude at the end of that manoeuvre relative to the horizontal yellow line. The pilot then appeared to increase the attitude of the aircraft prior to commencing the second roll, as shown in the right image in the Figure, although the increase appeared slight on the video.

Aircraft attitude before the second rolling manoeuvre

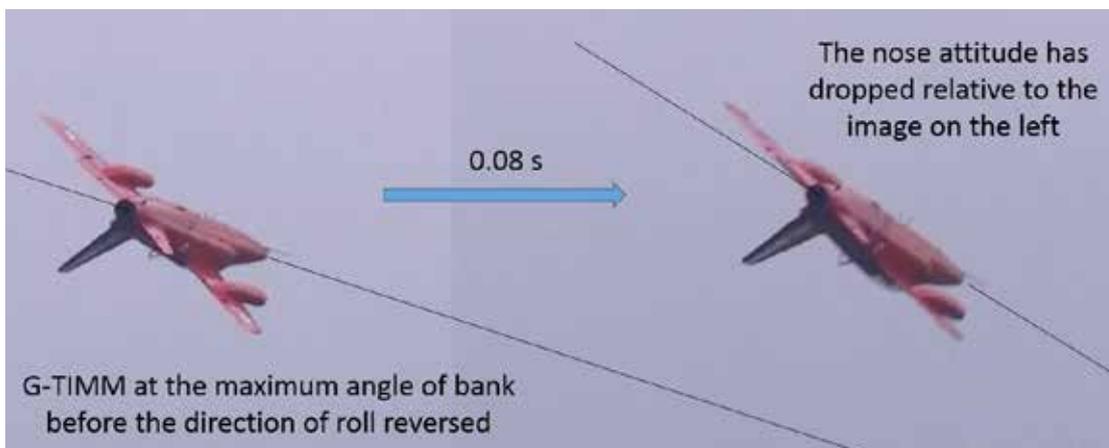
Figure 10

When G-TIMM reached the attitude shown in the left image within Figure 10, the nose attitude dropped relative to the horizon, a drop which was marked on the video. The black lines on the Figure are drawn along a line from the nose of the aircraft through the centre of the jet pipe at its rear to illustrate the drop in nose attitude (shown by the fact that the lines are not parallel).

Comparison of the aircraft attitude during the rolling manoeuvre

The images in Figures 9 to 14 and the information in Table 2 show that the accident sequence began when, with the aircraft at 107° angle of bank to the left, the nose attitude dropped relative to the horizon (Figure 10). The cause of this change in aircraft attitude was not determined.

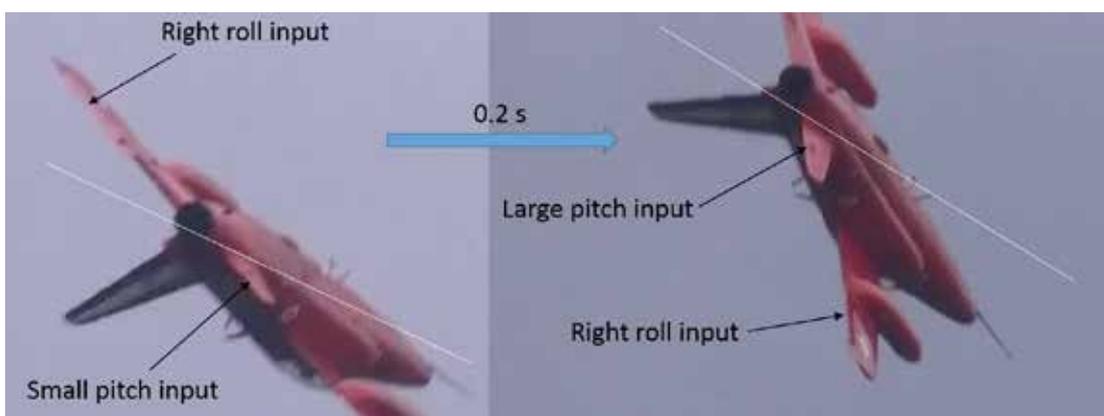
Immediately after the nose dropped, the direction of roll reversed to the right. Control inputs consistent with this are shown in the left image of Figure 11 by the 'upward' deflection of the right aileron (upward relative to aircraft axes) and, in the right image, by the 'downward' deflection of the left aileron (downward relative to aircraft axes). Approximately 0.2 seconds after the direction of roll reversed, a control input was made to the tailplane whereby its trailing edge moved upwards considerably (upwards relative to aircraft axes). The white lines in Figure 11 are drawn through the leading and trailing edges of the tailplane to illustrate its movement (shown by the fact that the white line in the first image crosses the underside of the aircraft forward of the two aerials whereas, in the second, it passes aft of the two aerials).

Reversal of roll direction and increase in pitch input

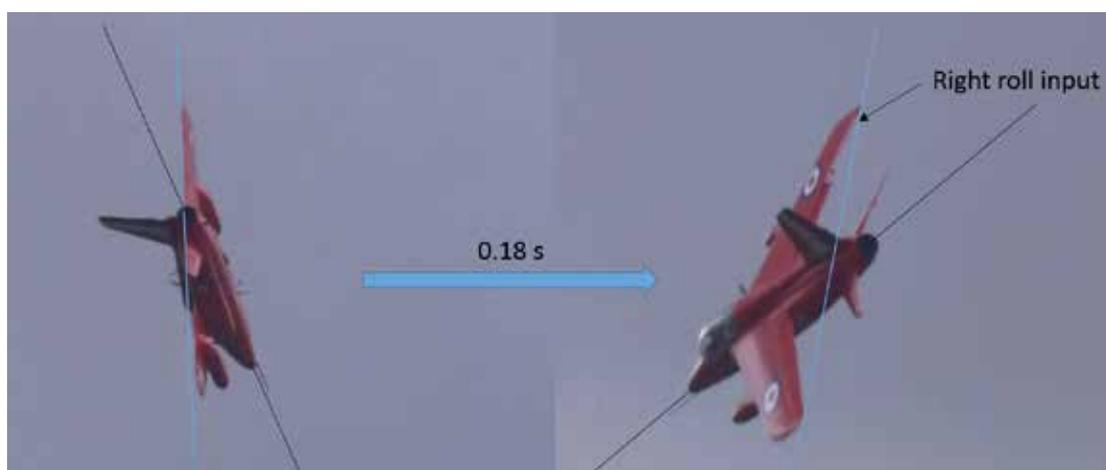
The movement of the tailplane caused the aircraft to pitch (rotate) markedly about its lateral axis. This is shown in Figure 12 by the fact that the first image shows the underside of the aircraft while the second shows its top surfaces. The black lines, once again drawn through the nose and jet pipe, also show the marked change in aircraft pitch attitude.

Increase in pitch attitude and reduction in bank angle

The right aileron in the second image is deflected upward indicating that there is a right roll control input. Reference to the blue lines, drawn through the trailing edges of each wingtip, shows that the angle of bank was reducing in response to this input ie the aircraft was rolling right towards a more upright attitude.

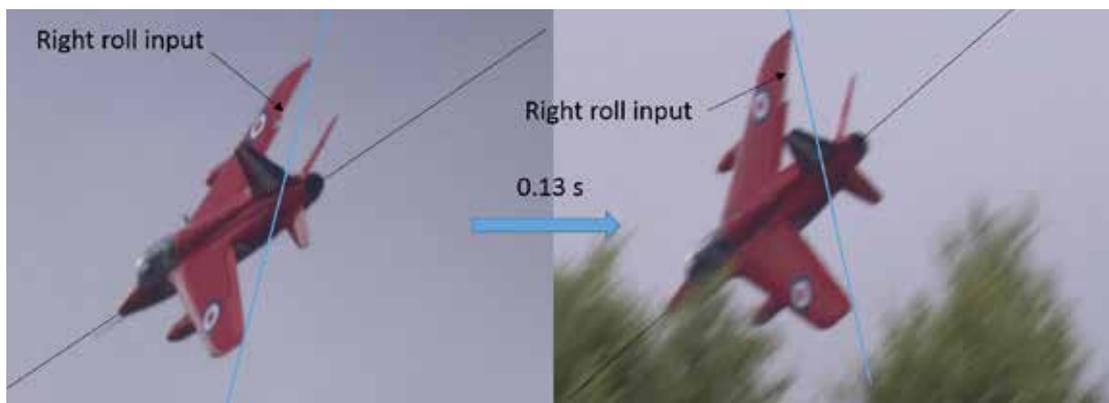
Following the marked change in pitch attitude shown in Figure 12, the nose attitude of the aircraft dropped further, illustrated by the fact that the black lines in Figure 13 are not parallel. The right aileron is still deflected upwards, indicating a control input for right roll. However, a comparison of the two blue lines shows that the aircraft was rolling left as it descended towards tree-top height.

Left roll with right roll control input

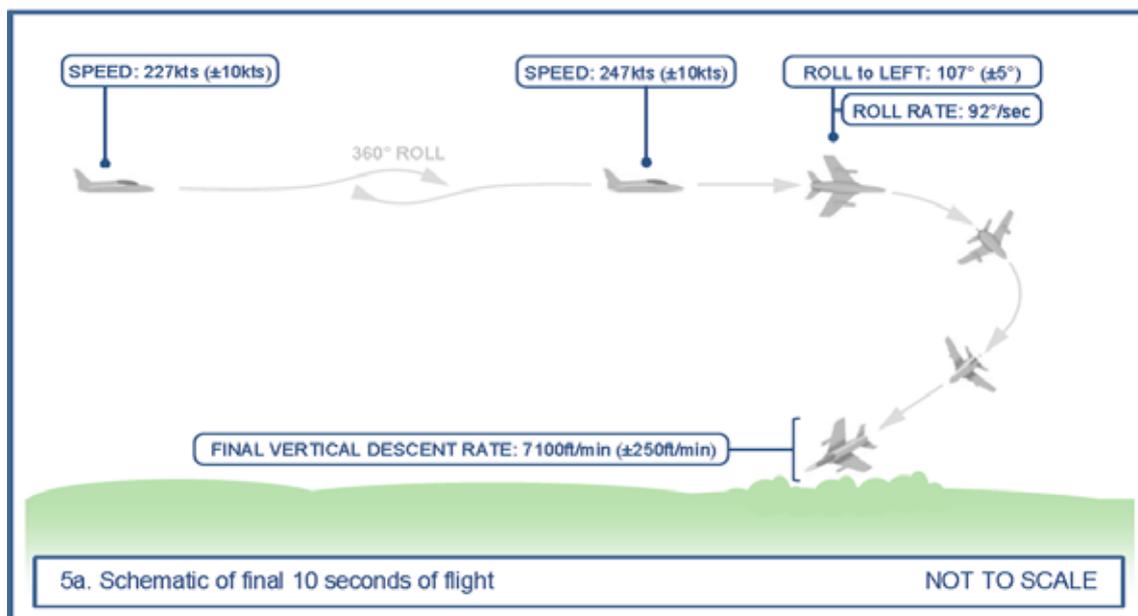
Schematic representation of the final 10 seconds of flight

Figure 14 shows that the first rolling manoeuvre was flown at 227 kt ± 10 kt, approximately 73 kt below the usual entry speed of 300 kt, and the second rolling manoeuvre at 247 kt ± 10 kt, approximately 53 kt slower than the usual entry speed. These speeds were below the recommended minimum speed of 280 kt (although the Pilot's Notes suggested that pilots with experience could fly aileron rolls at unspecified slower speeds). Aircraft rolling at lower speeds have an increased tendency for the nose attitude to drop during the manoeuvre and, if this is not anticipated, it can lead to a lower-than-normal nose attitude at the end of the roll. This can influence the following manoeuvre especially if, as video evidence suggested in this case, the nose attitude was raised only slightly ahead of the second roll. A lower-than-normal nose attitude at the beginning of the second roll, combined with a speed still below the recommended minimum, might account for the drop in nose attitude during the manoeuvre. However, other possibilities for the drop in nose attitude could not be discounted, such as disorientation, visual illusion or distraction.
