ACCIDENT

Aircraft Type and Registration:	Piper PA-E23-250 Aztec, G-LIZZ	
No & Type of Engines:	2 Lycoming IO-540-C4B5 piston engines	
Year of Manufacture:	1973 (Serial no: 27-7405268)	
Date & Time (UTC):	20 August 2015 at 1631 hrs	
Location:	St Mary's Airport, Isles of Scilly	
Type of Flight:	Private	
Persons on Board:	Crew - 1	Passengers - 2
Injuries:	Crew - None	Passengers - None
Nature of Damage:	Damaged beyond economic repair	
Commander's Licence:	Airline Transport Pilot's Licence	
Commander's Age:	58 years	
Commander's Flying Experience:	4,300 hours (of which 2,000 were on type) Last 90 days - 110 hours Last 28 days - 57 hours	
Information Source:	Aircraft Accident Report Form submitted by the pilot and further enquiries by the AAIB

Synopsis

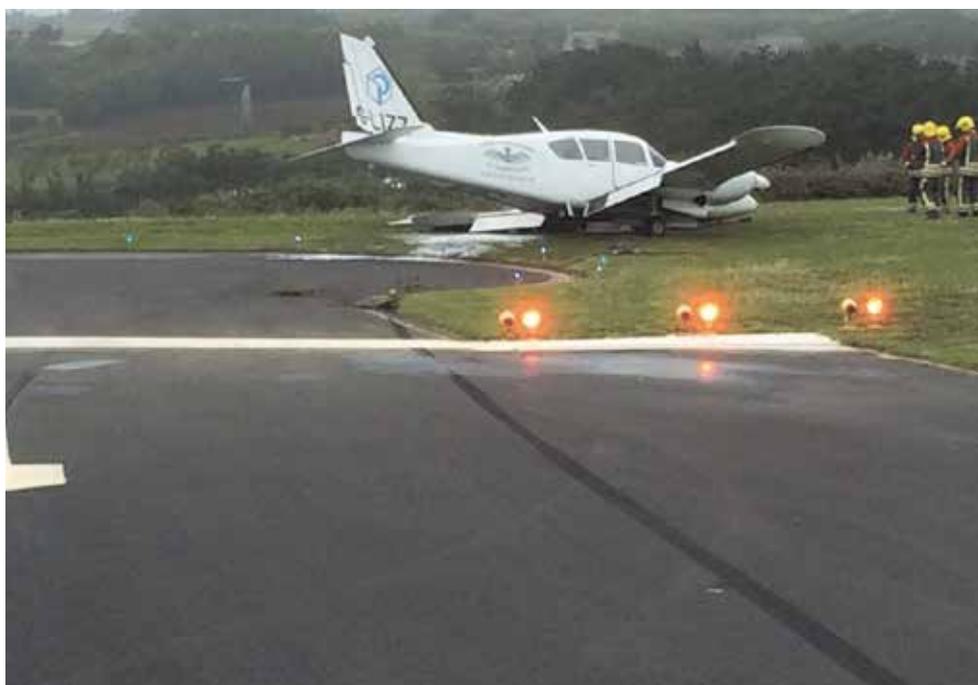
The aircraft landed approximately 200 m from the threshold, close to the top of the slope. As the aircraft reached the top, the pilot considered it was too fast to stop before the end of the runway. Aware of a precipice in the overshoot he steered the aircraft to the right. The aircraft departed the paved surface at the end of the runway and onto grass at its edge. As it did so, the nose and left main landing gear collapsed and the aircraft came to a halt. See Figure 1. The pilot secured the aircraft’s systems and the occupants vacated the aircraft uninjured. The RFFS were quickly in attendance.

Figure 1
G-LIZZ after the accident
