INCIDENT

Aircraft Type and Registration:	Sikorsky S-92A, G-VINL	
No & Type of Engines:	2 General Electric Co CT7-8A turboshaft engines	
Year of Manufacture:	2014 (Serial no: 920226)	
Date & Time (UTC):	22 August 2014 at 1805 hrs	
Location:	Golden Eagle complex, North Sea	
Type of Flight:	Commercial Air Transport (Passenger)	
Persons on Board:	Crew - 2	Passengers - 1
Injuries:	Crew - None	Passengers - None
Nature of Damage:	None	
Commander's Licence:	Airline Transport Pilot's Licence	
Commander's Age:	49 years	
Commander's Flying Experience:	5,700 hours (of which 401 were on type) Last 90 days - 70 hours Last 28 days - 18 hours	
Information Source:	Aircraft Accident Report Form submitted by the pilot

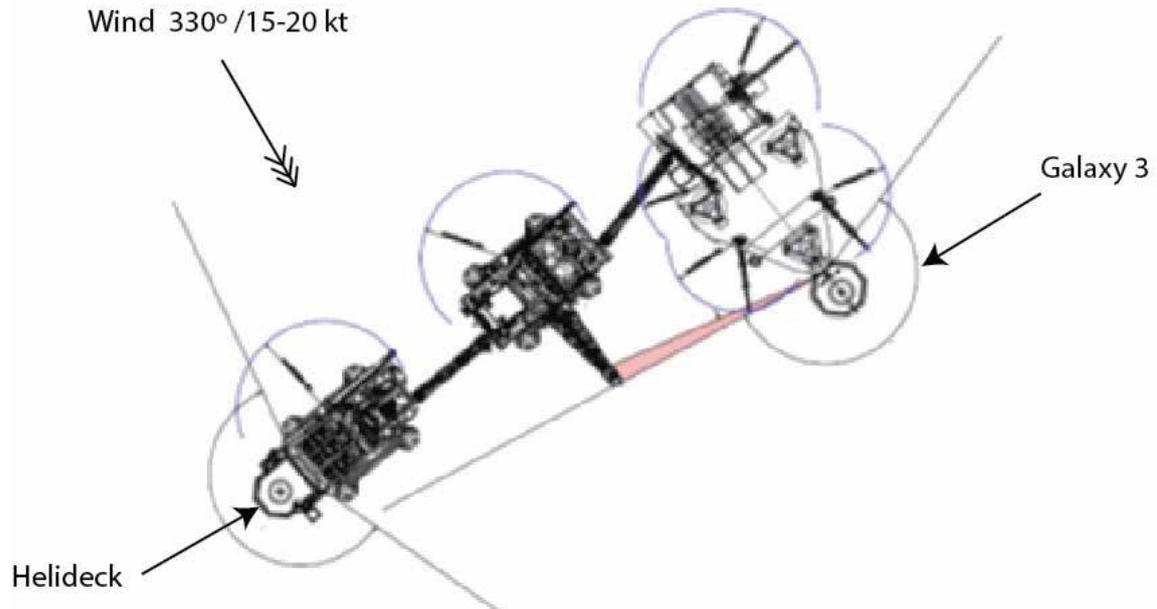
Figure 2
The Buzzard complex

Three separate, fixed platforms make up the Buzzard complex (Figure 2), with the helideck on the south-western end of the complex. The average orientation of the complex is 050°/230°M. The Galaxy 3 jackup rig is attached to the south-easterly side of the most eastern platform. The Buzzard complex lies on a bearing of 205°M from the Paragon MSS1, at a range of 7 nm. When arriving from the Paragon MSS1, the commander expected the line of platforms to pass down his right side, before turning to the right to land into wind (330°-340°M at 15-20 kt).

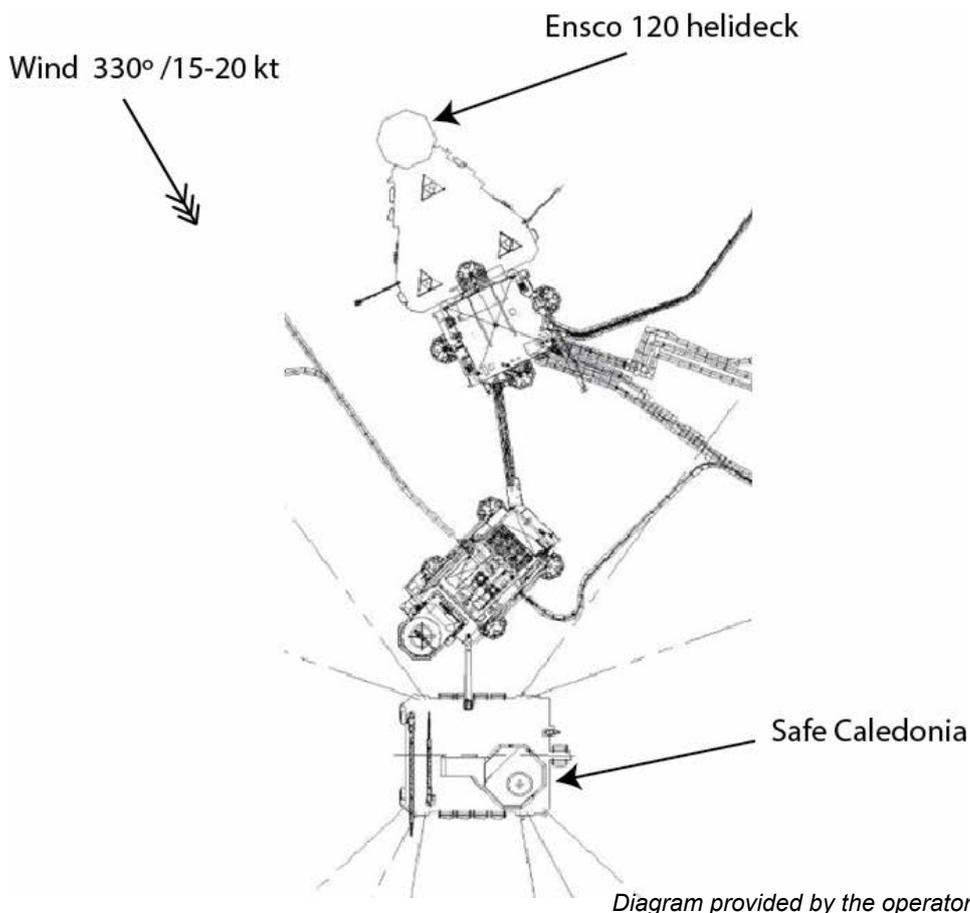
Figure 3

Two separate, fixed platforms make up the Golden Eagle complex (Figure 3). The helideck is on the Ensco 120 jackup rig, which is attached to the northern side of the northern platform. The Safe Caledonia semi-submersible is attached to the southern side of the southern platform. The average orientation of the complex is approximately 170°/350°M. It lies on a bearing of 354°M from the Paragon MSS1, at a range of 3 nm. From the Paragon MSS1, it would appear as a large mass of structures, with indistinguishable individual installations.

Golden Eagle Rig complex
