**ACCIDENT**

<b>Aircraft Type and Registration:</b>	Bell 206B Jet Ranger II, G-RAMY	
<b>No &amp; Type of Engines:</b>	1 Allison 250-C20 turboshaft engine	
<b>Year of Manufacture:</b>	1974 (Serial no: 1401)	
<b>Date &amp; Time (UTC):</b>	6 June 2015 at 0805 hrs	
<b>Location:</b>	Near Creg-ny-Baa, Isle of Man	
<b>Type of Flight:</b>	Private	
<b>Persons on Board:</b>	Crew - 1	Passengers - None
<b>Injuries:</b>	Crew - 1 (Fatal)	Passengers - N/A
<b>Nature of Damage:</b>	Aircraft destroyed	
<b>Commander's Licence:</b>	Private Pilot's Licence (Helicopter)	
<b>Commander's Age:</b>	48 years	
<b>Commander's Flying Experience:</b>	786 hours (of which 71 hours were on type) Last 90 days - approximately 6 hours Last 28 days - approximately 6 hours	
<b>Information Source:</b>	AAIB Field Investigation

**Summary**

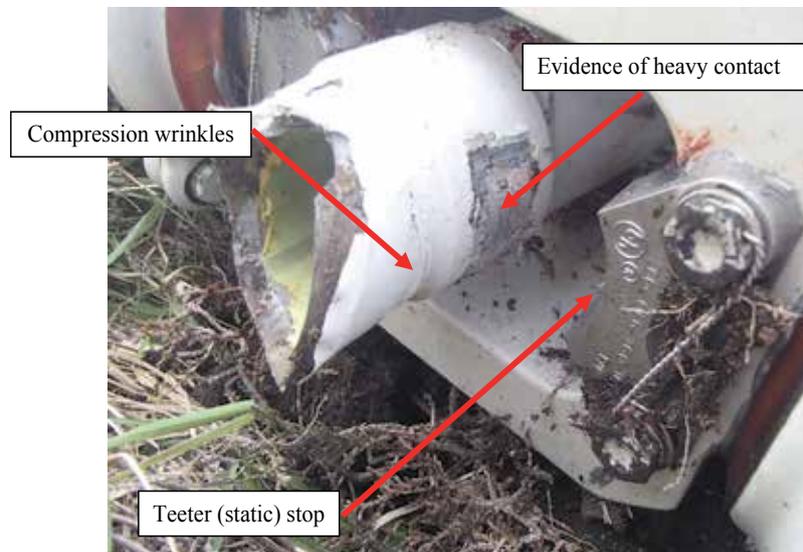
**Figure 3**

Examination of the main rotors and rotor head revealed that the rotor mast had failed approximately 3 inches below the rotor head lower surface. It was evident that the mast had failed as a result of bending overload after coming into violent contact with one of the teeter, or static stops; see Figure 3. A deep cut in the ground close to where the rotors

were found indicated that the rotor disc had struck the earth in a near-vertical attitude and one blade had broken under the sudden bending and compressive load. Both blades had been extensively scuffed over an area around their mid-span points, with the most severe damage being on the leading edges and undersides.

View of fractured mast, showing evidence of contact between mast and teeter ('static') stop

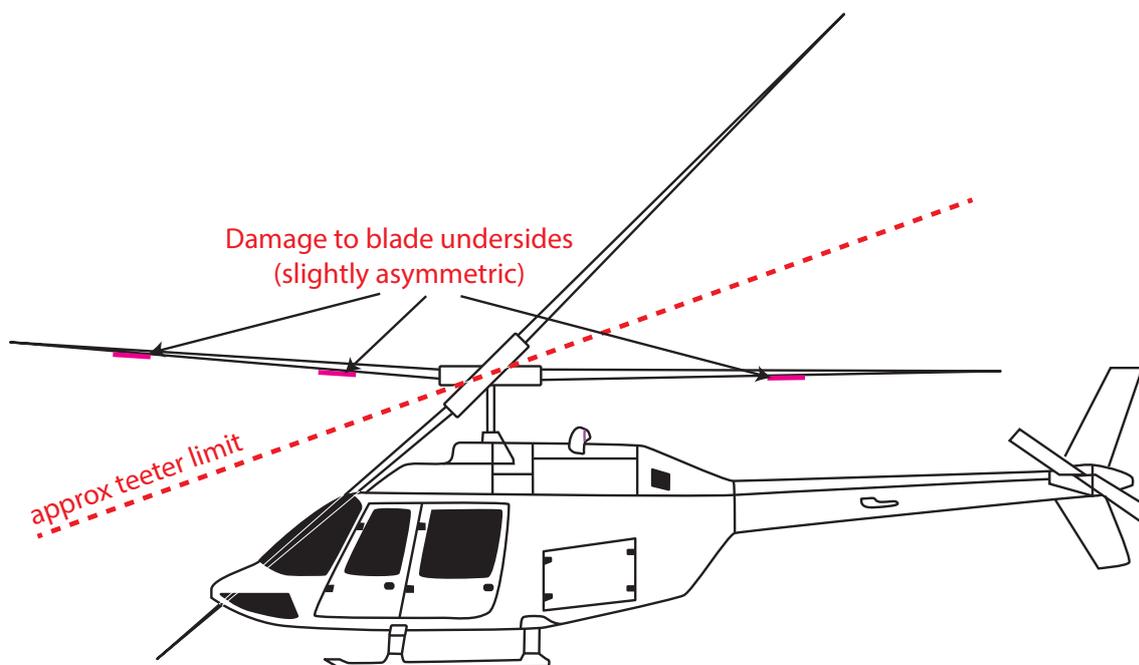
**Figure 4**

As already noted, there were areas of scuffing and paint transfer on the underside of both blades. These areas started approximately 90 and 104 inches from the centre of the hub and were not symmetrical. The paint marks were consistent with the blades having struck the right side of the nose of the helicopter, this conclusion being supported by the observed damage to the structure and that fragments from the nose were recovered from the furthest downwind part of the debris trail. Additional confirmation was provided by the VOR instrument, which had been located in the upper right area of the instrument binnacle but was found some distance from the main wreckage as a result of being struck by a blade, leaving a characteristic indentation in the casing. One blade exhibited a scuffed region that began a relatively short distance, 42 inches, from the hub centre, the result of the blade underside coming into contact with the front of the glassfibre fairing on the cabin roof. The combined information enabled a precise assessment of where the rotor blades had struck the airframe, illustrated in Figure 4.

Showing blade strike location on fuselage

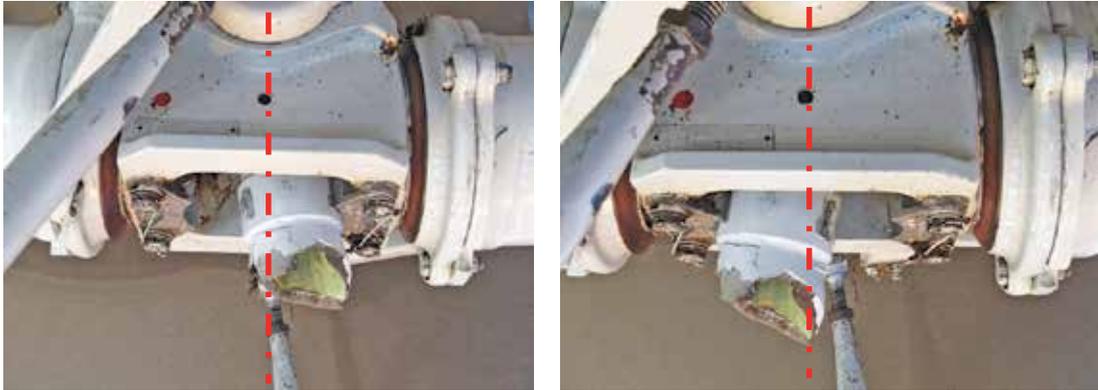
**Figure 5**

The hub assembly had remained intact although it was clear that the static (teeter) stops had come into heavy contact with the mast, such that they applied severe, reverse bending loads in the spanwise plane of the blades. Figure 5 shows the relative angular motion that occurred between the mast and hub.

View of hub showing angular movement between hub and mast, resulting in heavy mast contact with teeter stops

The bending loads had been higher in one direction, as can be seen in Figure 5, where the surface of the mast adjacent to the static stop contact displayed compression wrinkles. The mast had become permanently bent in that direction, although the final failure was probably closer to the opposite direction, as evidenced by a shear lip, also visible in Figure 5. This feature, together with the permanent deformation of the mast and the 45° shear plane of most of the fracture face, indicated that the mast failure was the result of bending overload, which, in itself, was characteristic of 'mast bumping'. Such events can involve a large number of bending reversals within a short time. However, in this case, the relatively clean nature of the fracture face, in conjunction with the rotor blades being intact when they separated from the airframe, suggested that the bending failure occurred within one or two revolutions.
