ACCIDENT

Aircraft Type and Registration:	Reims Cessna F152, G-BFEK	
No & Type of Engines:	1 Lycoming O-235-L2C piston engine	
Year of Manufacture:	1977 (Serial no: 1442)	
Date & Time (UTC):	2 February 2016 at 1320 hrs	
Location:	Gloucestershire Airport	
Type of Flight:	Training	
Persons on Board:	Crew - 1	Passengers - None
Injuries:	Crew - None	Passengers - N/A
Nature of Damage:	Right wing tip, propeller and engine	
Commander's Licence:	Student pilot	
Commander's Age:	53 years	
Commander's Flying Experience:	27 hours (of which 26 were on type) Last 90 days - 14 hours Last 28 days - 5 hours	
Information Source:	Aircraft Accident Report Form submitted by the pilot

Synopsis

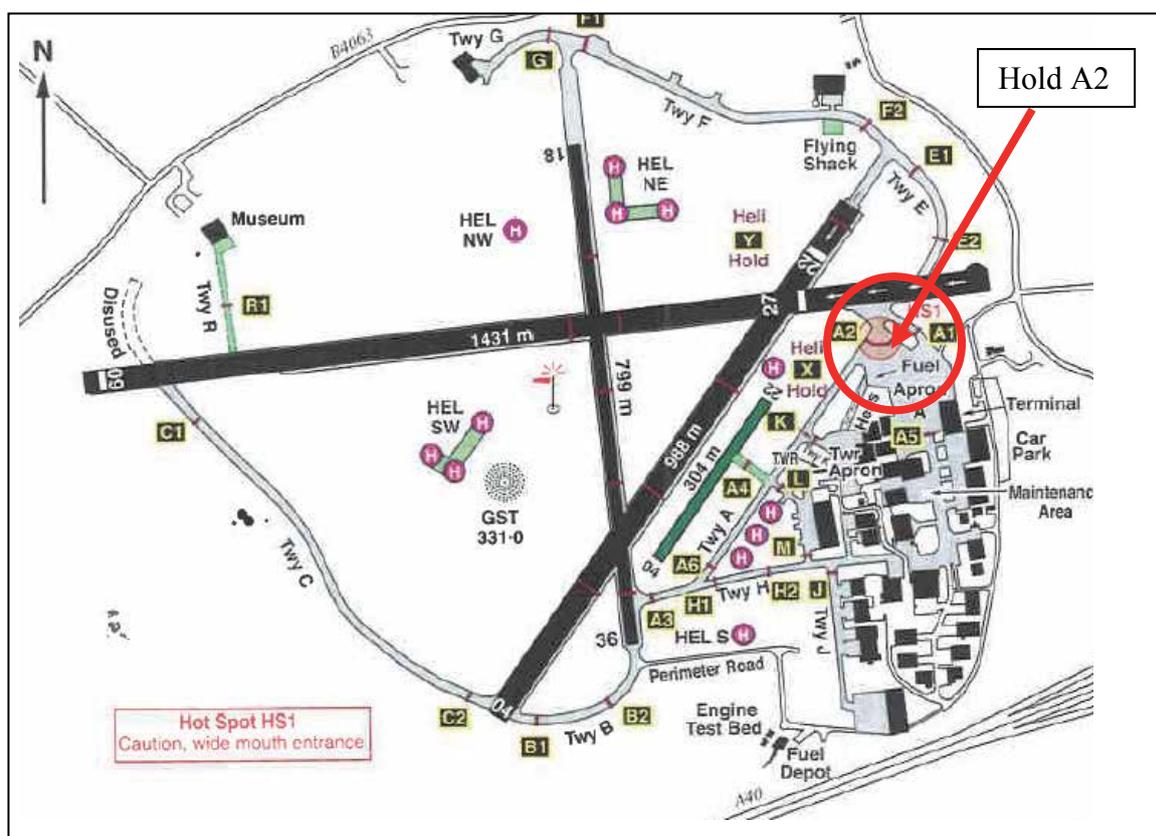
Figure 1

Airfield layout, showing location of incident

The incident occurred in a congested part of the airfield that had already been identified as a 'Hot Spot', and is marked as such in Figure 1. The apron and taxiways are used by rotary and fixed wing traffic and, in addition to the two helicopter refuelling points that featured in this event, there are other frequently used helicopter landing sites nearby, including 'Spot 2', shown in Figure 3, and 'Spot 5', which is located just off to the right edge of the image in Figure 3, approximately 55 m from G-BFEK's holding point.

The airfield operator has implemented a number of changes, including not conducting rotors-running refuelling operations on the large 'H'. Restrictions on the use of Spots 2 and 5 include the stipulation that Spot 5 can only be utilised if there are no fixed wing aircraft holding at A2. There is likely to be a reduction in rotors-running refuelling operations as a result of these measures. Finally, fixed-wing operators will be encouraged to 'move up' at holding points in order to generate increased separation from nearby rotary traffic.

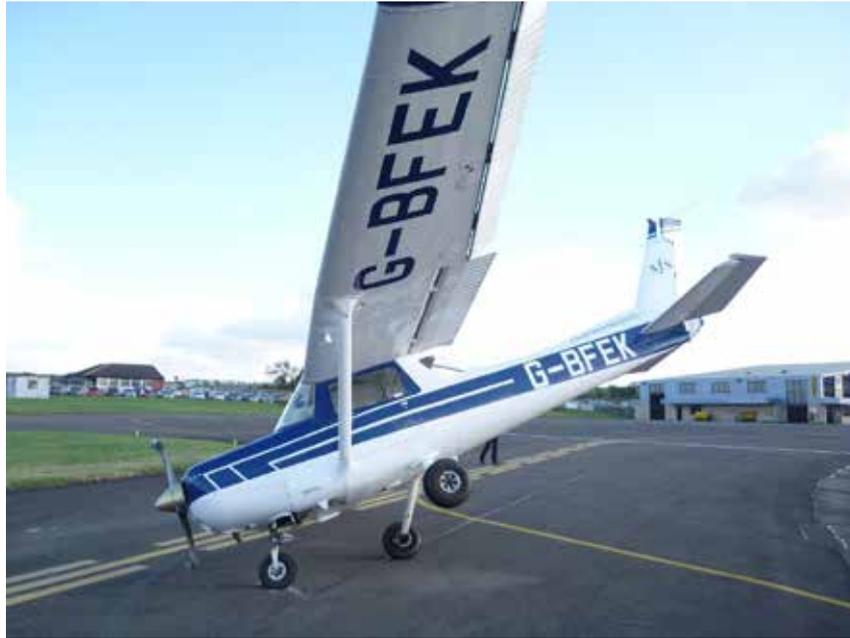
G-BFEK came to rest on the right wheel, wingtip and propeller spinner, following which the pilot transmitted a PAN call informing the tower of his situation. He then shut down the fuel and electrics and, because of the attitude of the aircraft, vacated via the passenger door. Figure 2 shows the aircraft after it had come to rest.

View of aircraft after the incident

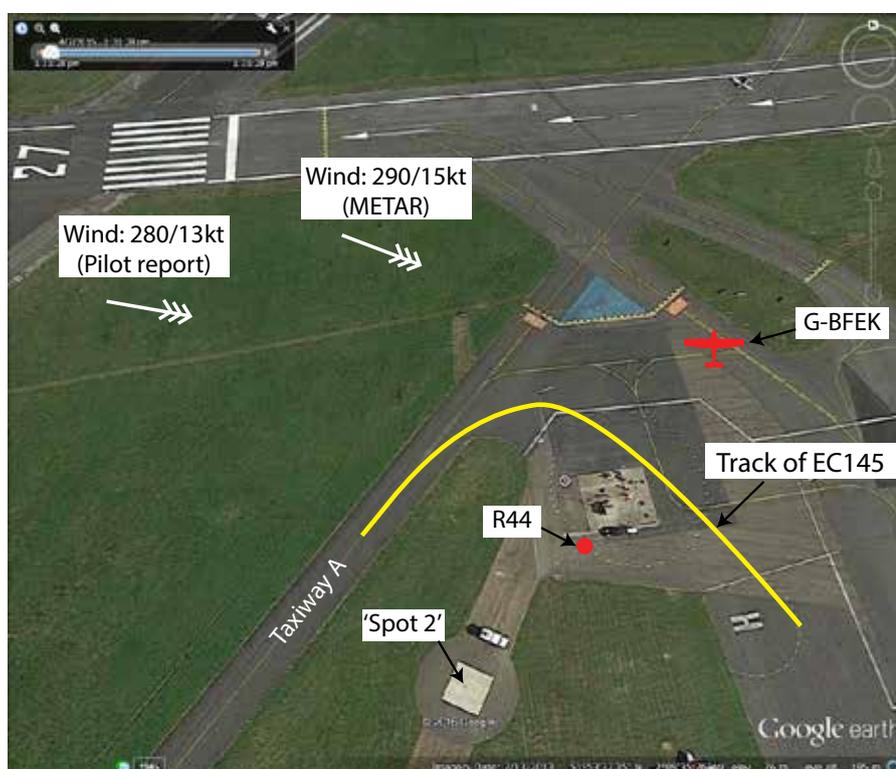
Figure 3

The approximate track of the EC145 is shown in Figure 3; this was based on an Internet-based Flight Tracking application. Whilst the accuracy cannot be guaranteed it accorded with the reports from all three pilots involved. From this it was concluded that the EC145 had, whilst hover taxiing, passed between two and three rotor diameters from G-BFEK. The Civil Aviation Authority (CAA) Safety Sense Leaflet 15, version C, notes that:

Satellite image showing approximate track of EC145 and positions of Cessna 152, G-BFEK, and the Robinson R44

The pilot of G-BFEK stated that the wind was 280°/13 kt at the time he reported ready for takeoff, and this is shown in Figure 3. However the METAR for the airfield at 1320 (the time of the accident) gave the wind as 290° at 15 kt (also shown in Figure 3), gusting 25 kt, with a strong wind warning in force. The METARS additionally showed that during the period 1020 to 1420 the wind veered from 240 to 300°.
