Report on the investigation of the heavy weather
damage to the passenger cruise ship

Pacific Star

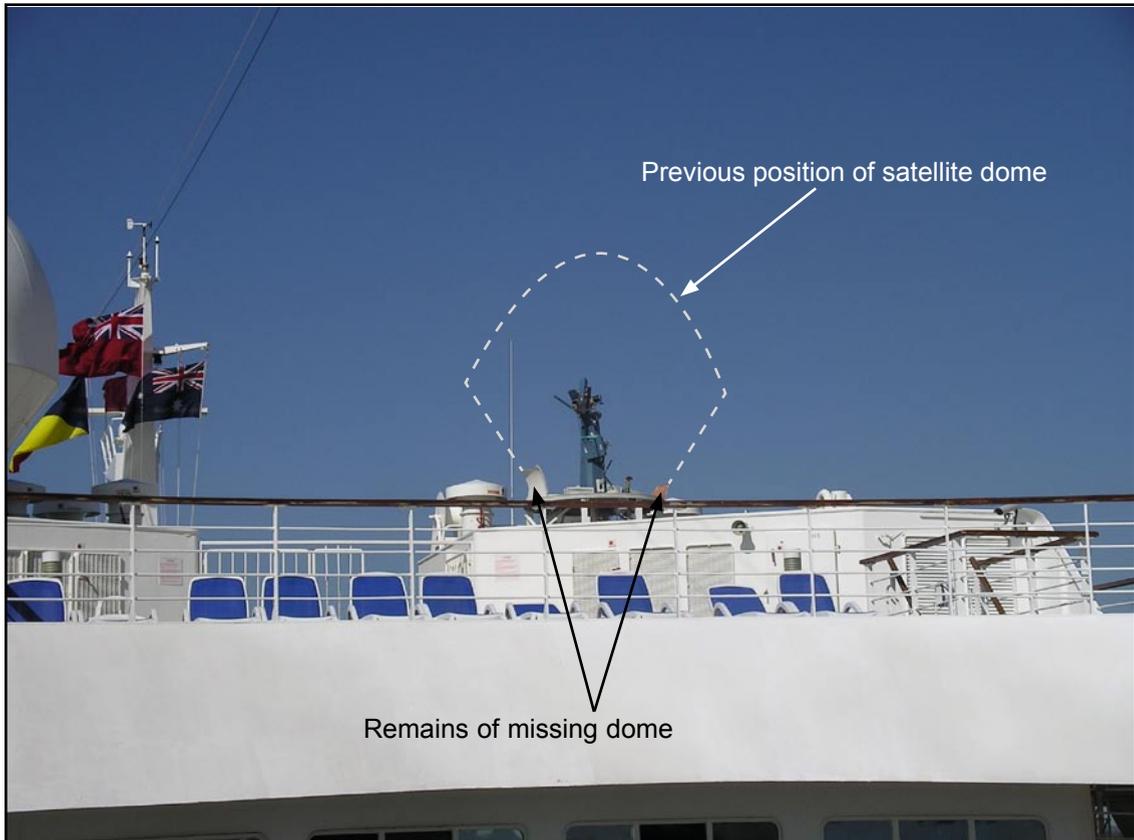
Satellite dome position

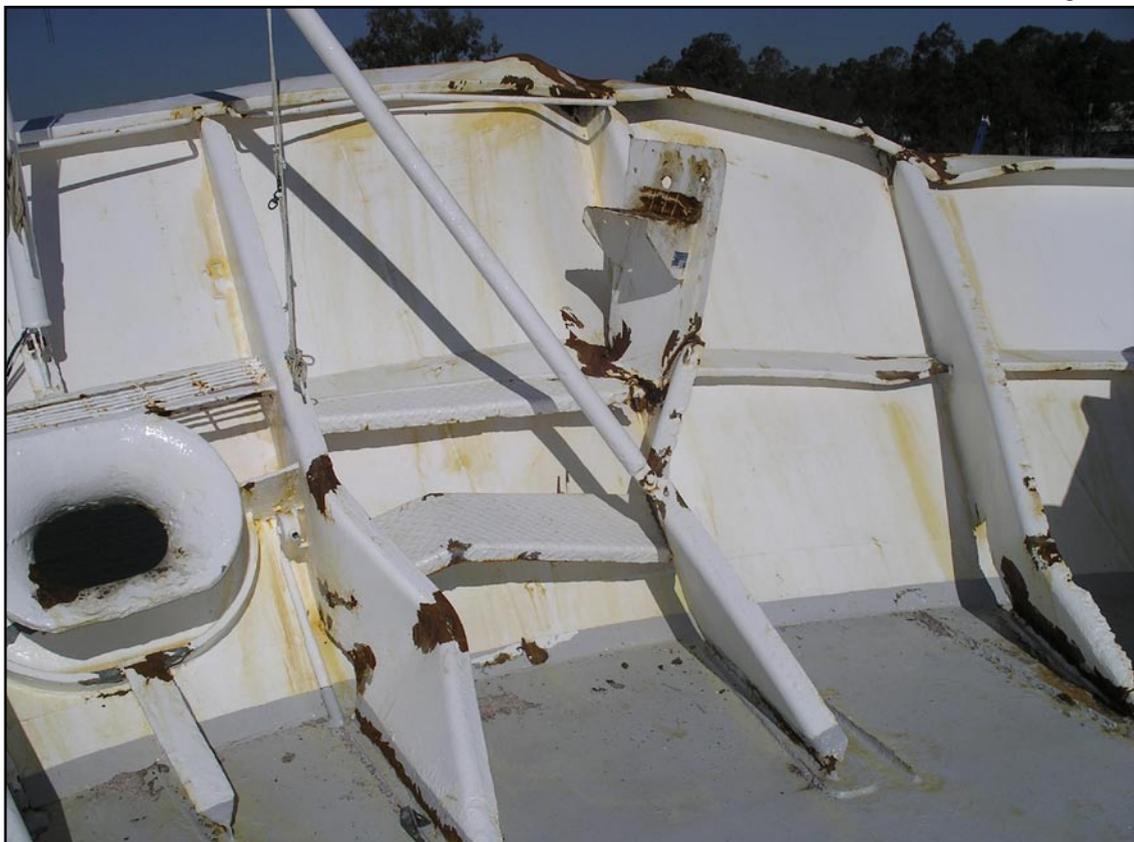
Damage to forecabin bulwark

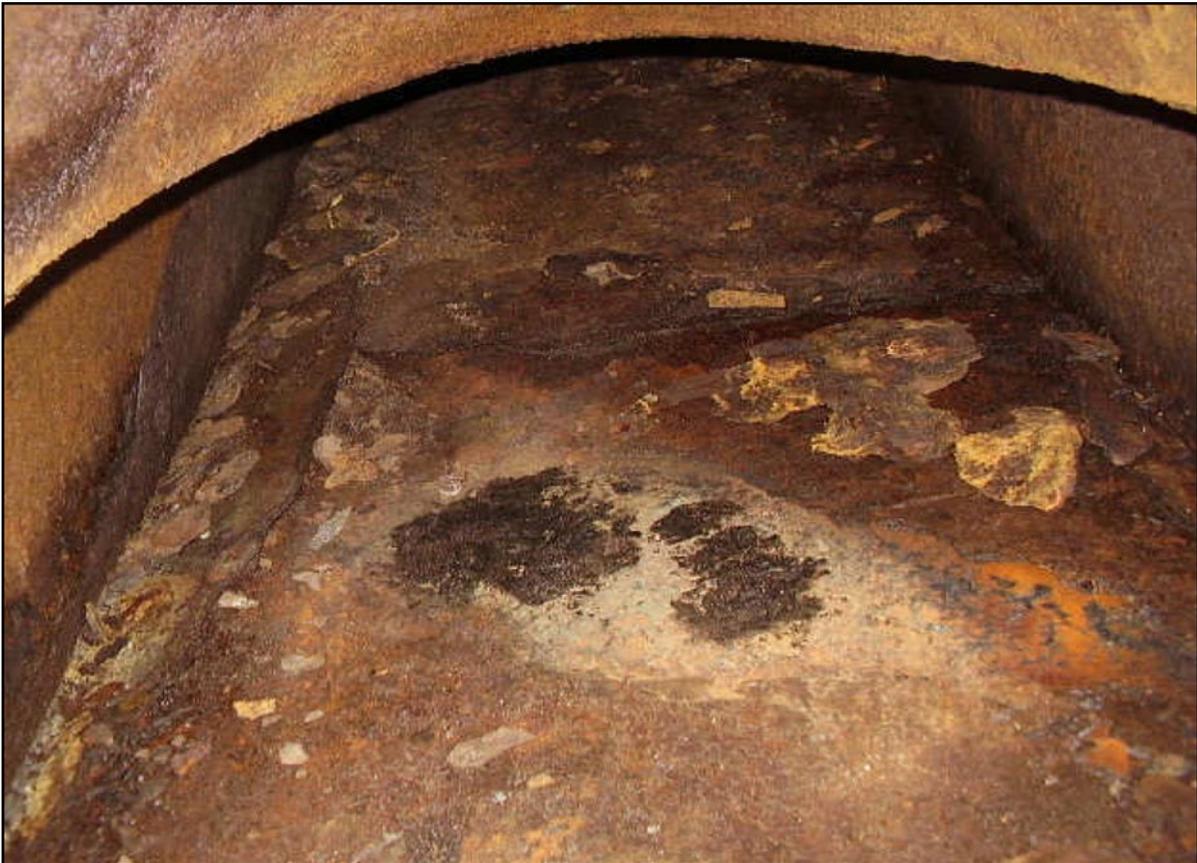
Damage to ventilation duct

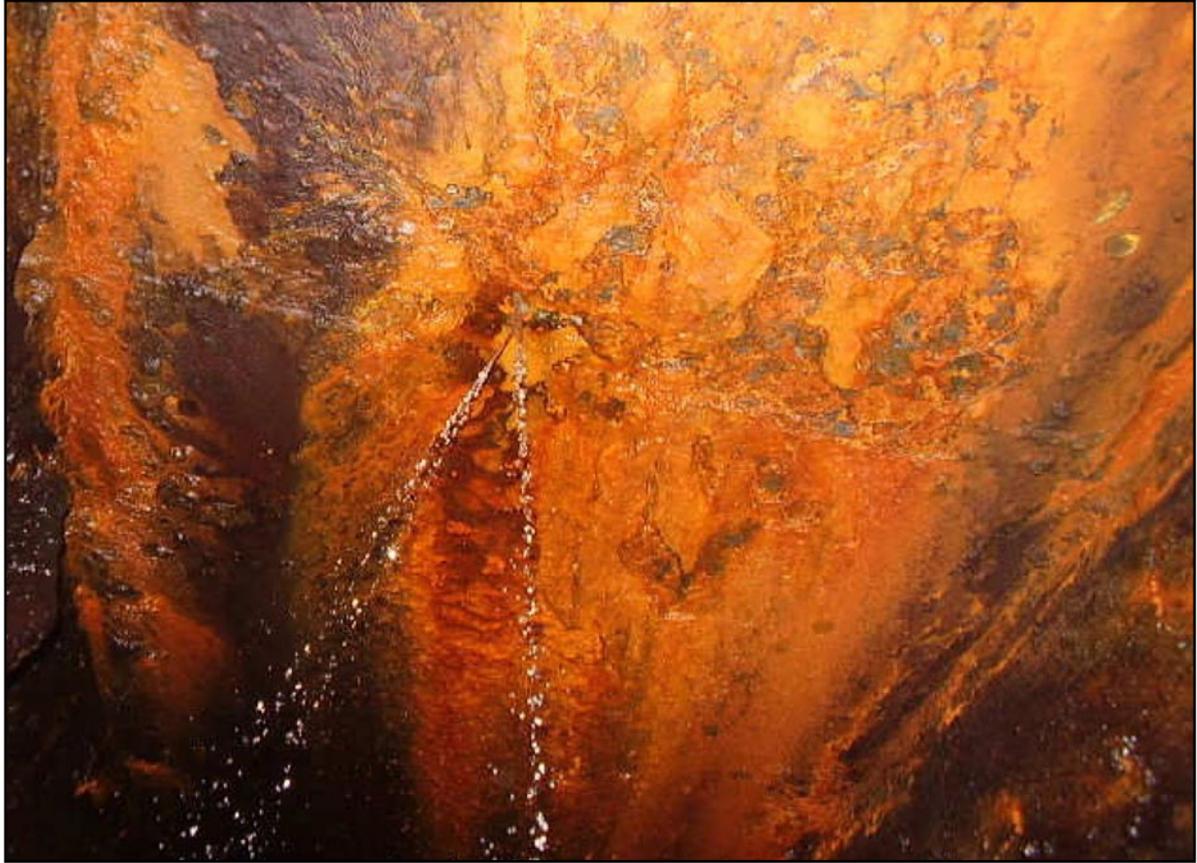
Damage to the forepeak tank

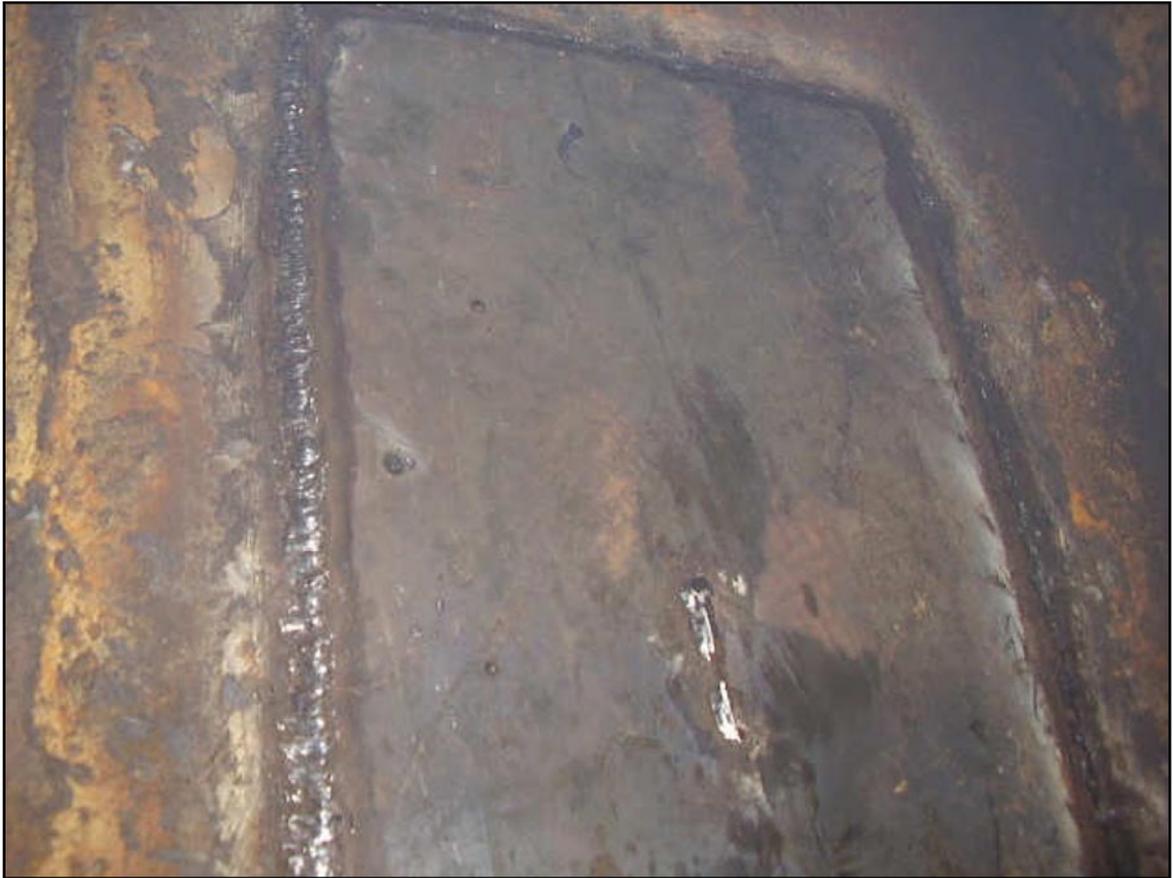
Temporary repair to the forepeak

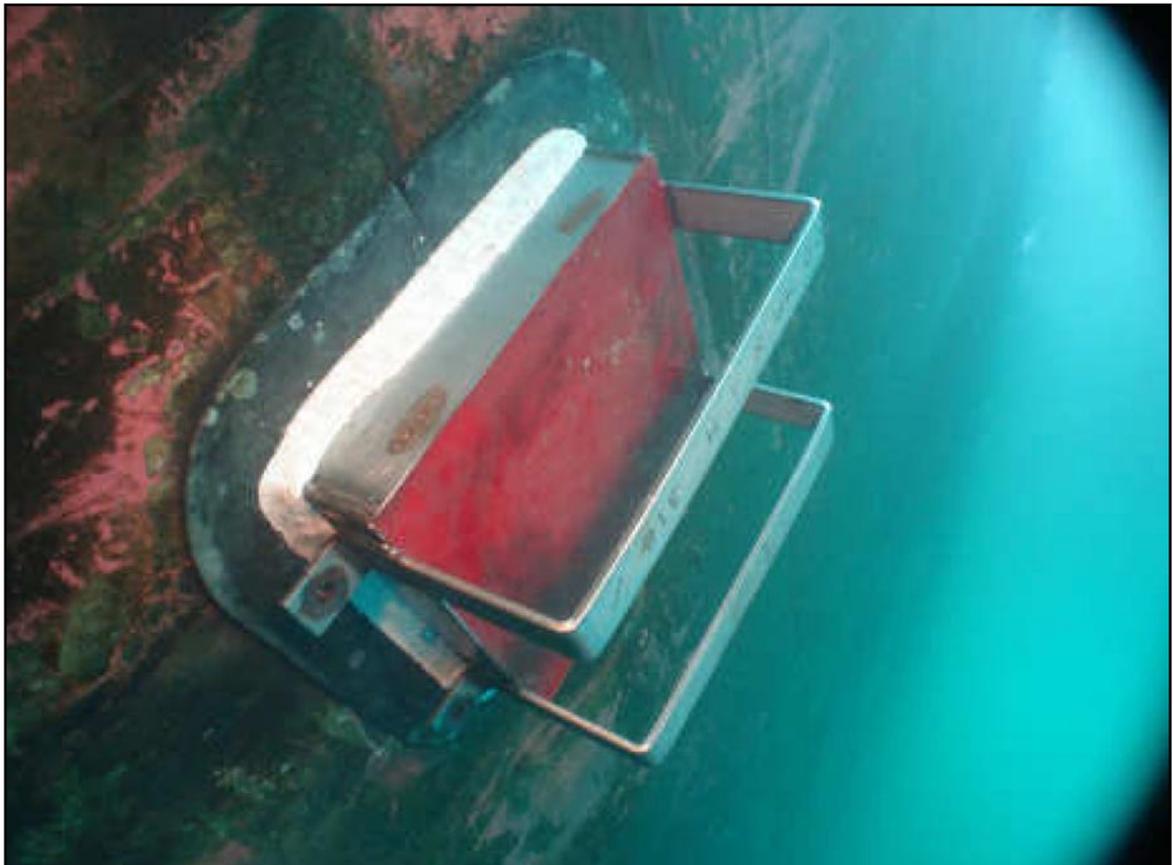
Temporary repair to No.2 deep ballast tank

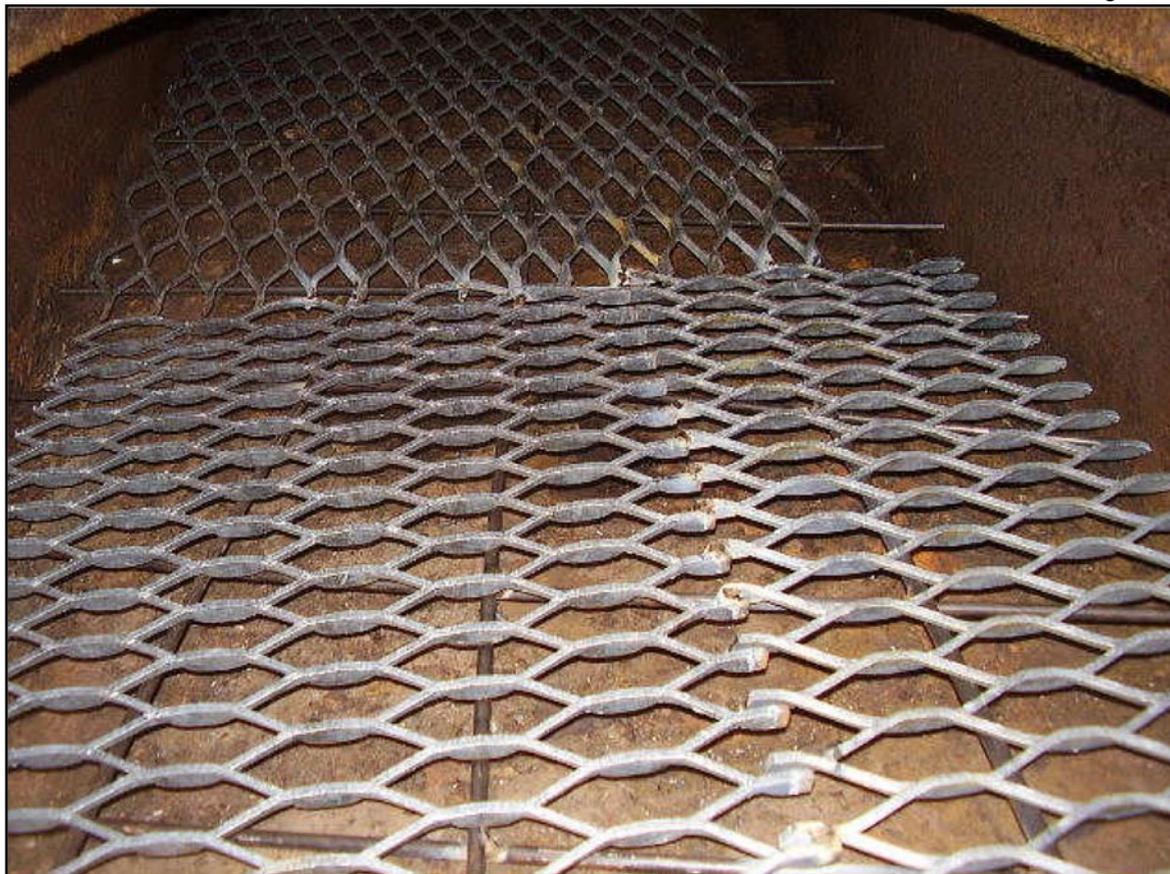
Reinforcement to cement box in ventilation duct

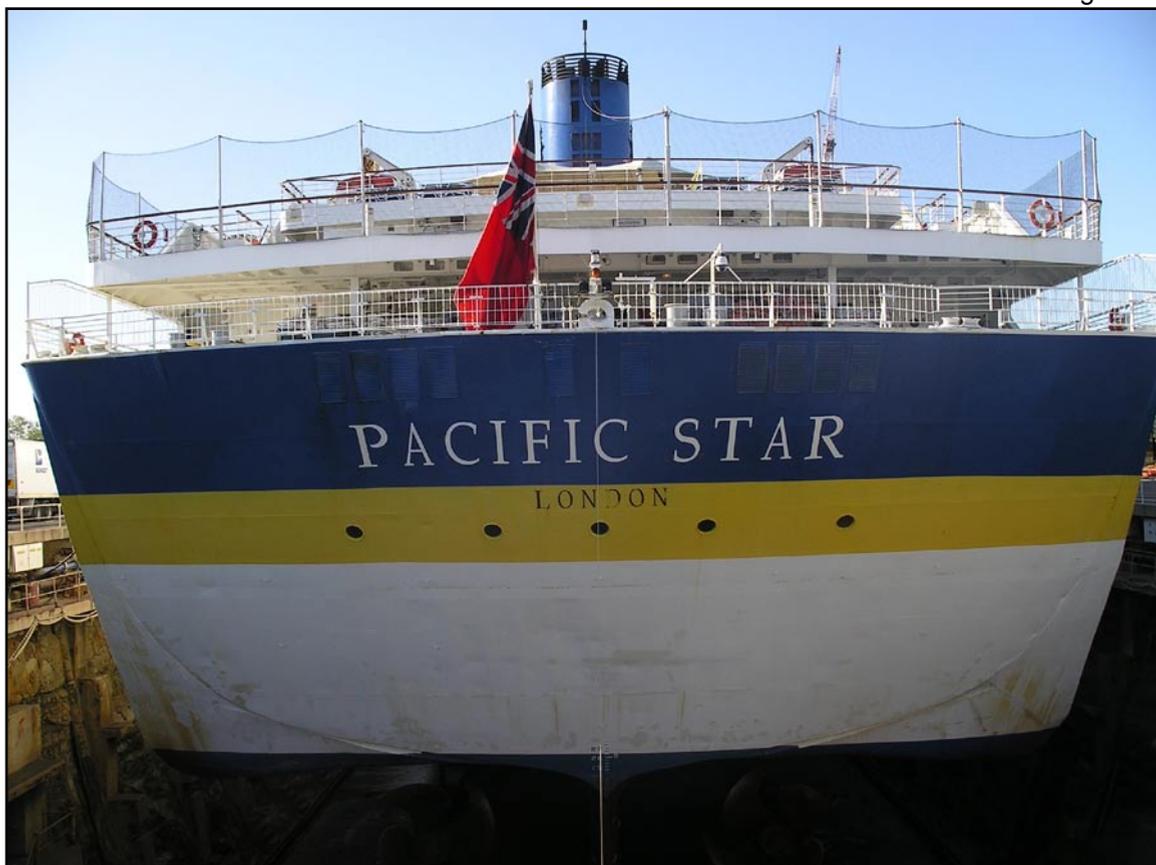
Pacific Star in dry dock in Brisbane

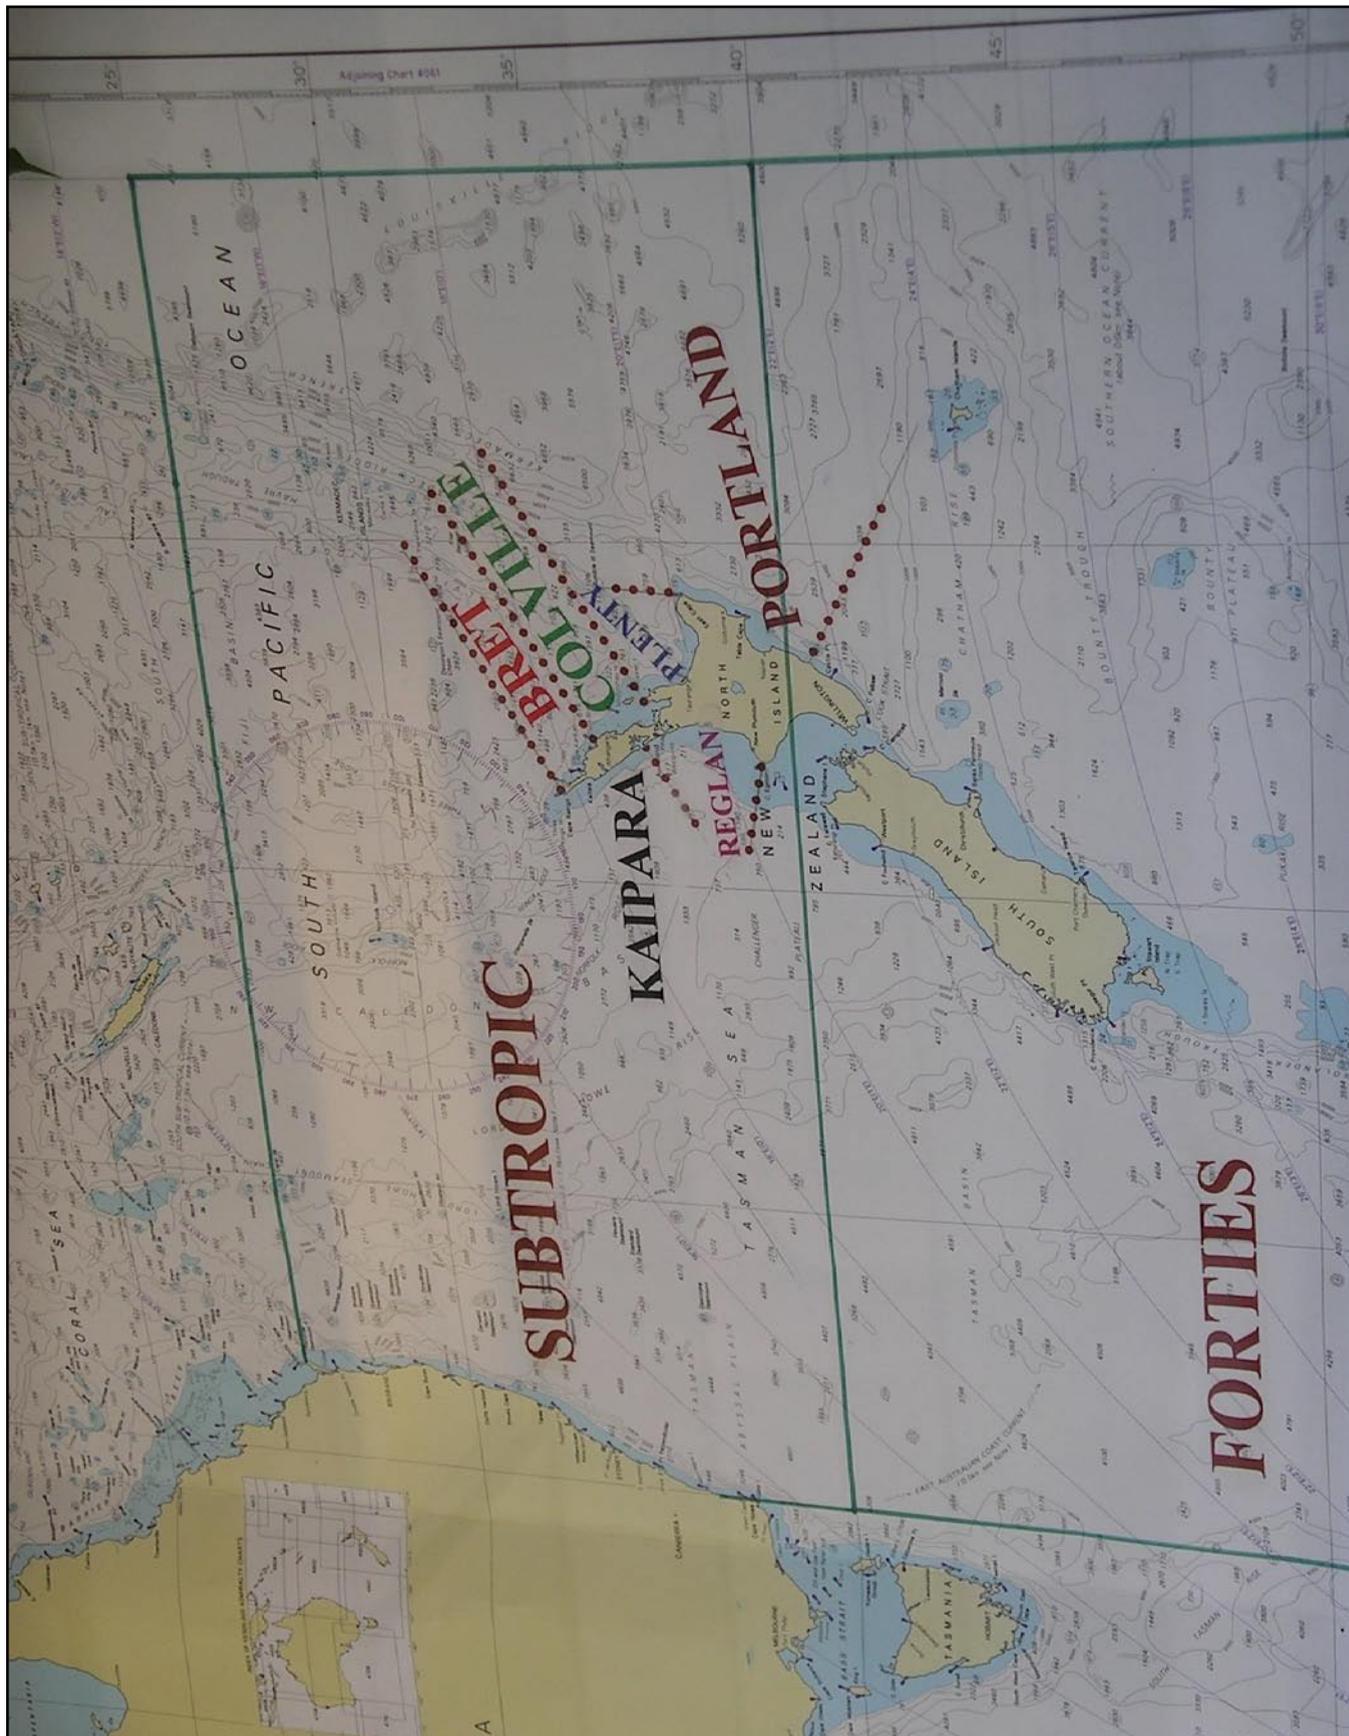
Photograph of chart on the bridge showing sea forecast areas

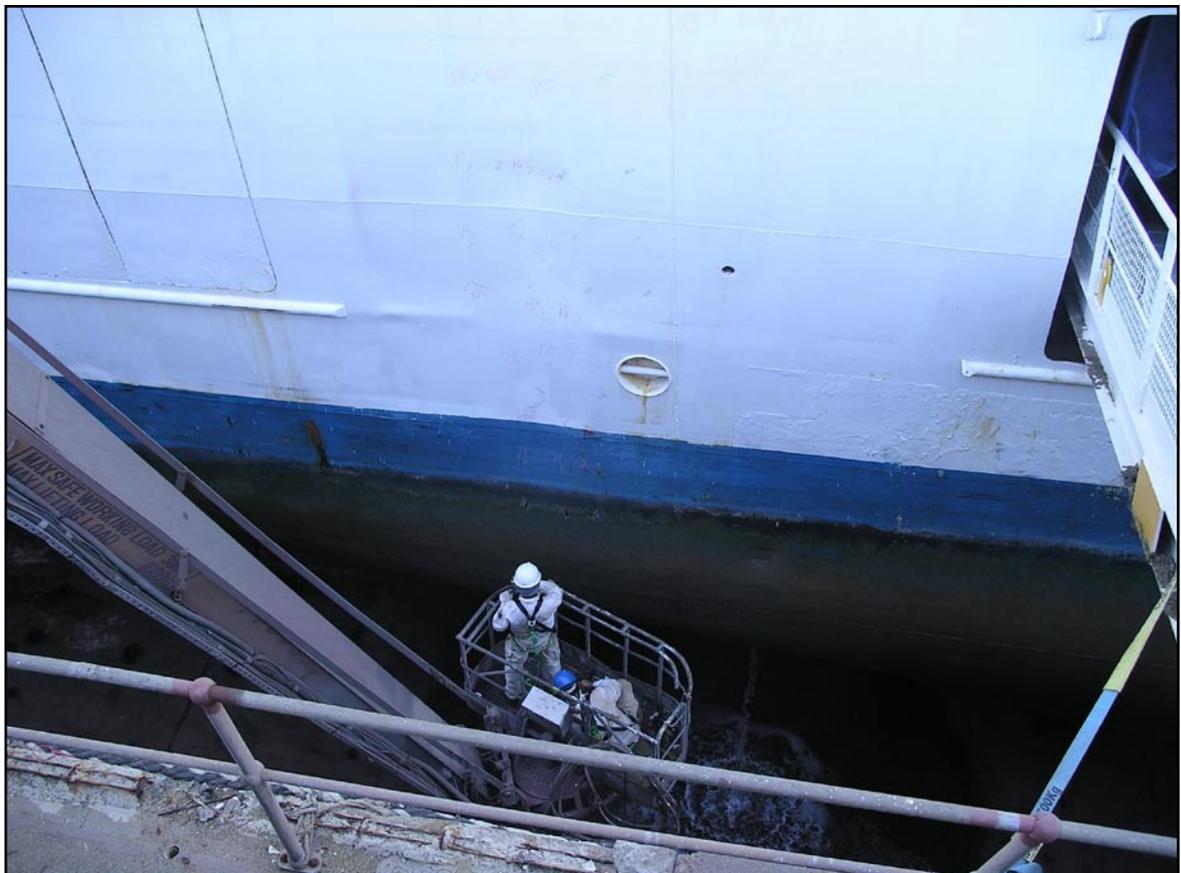
Non-destructive testing in dry dock, Brisbane

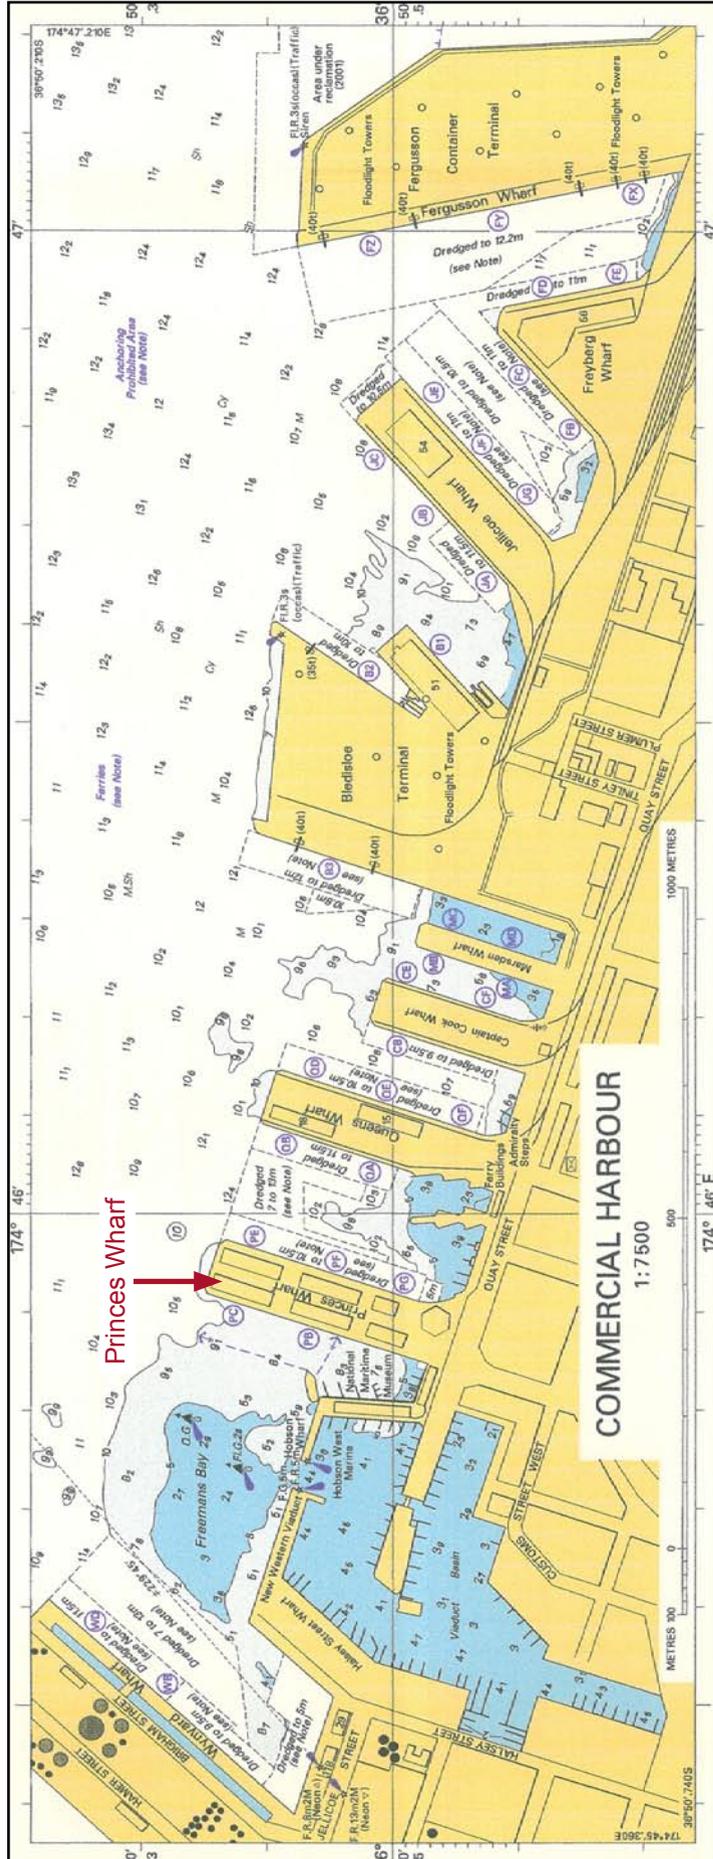
Reproduced from Admiralty Chart NZ 5322 by permission of the Controller of HMSO and the UK Hydrographic Office

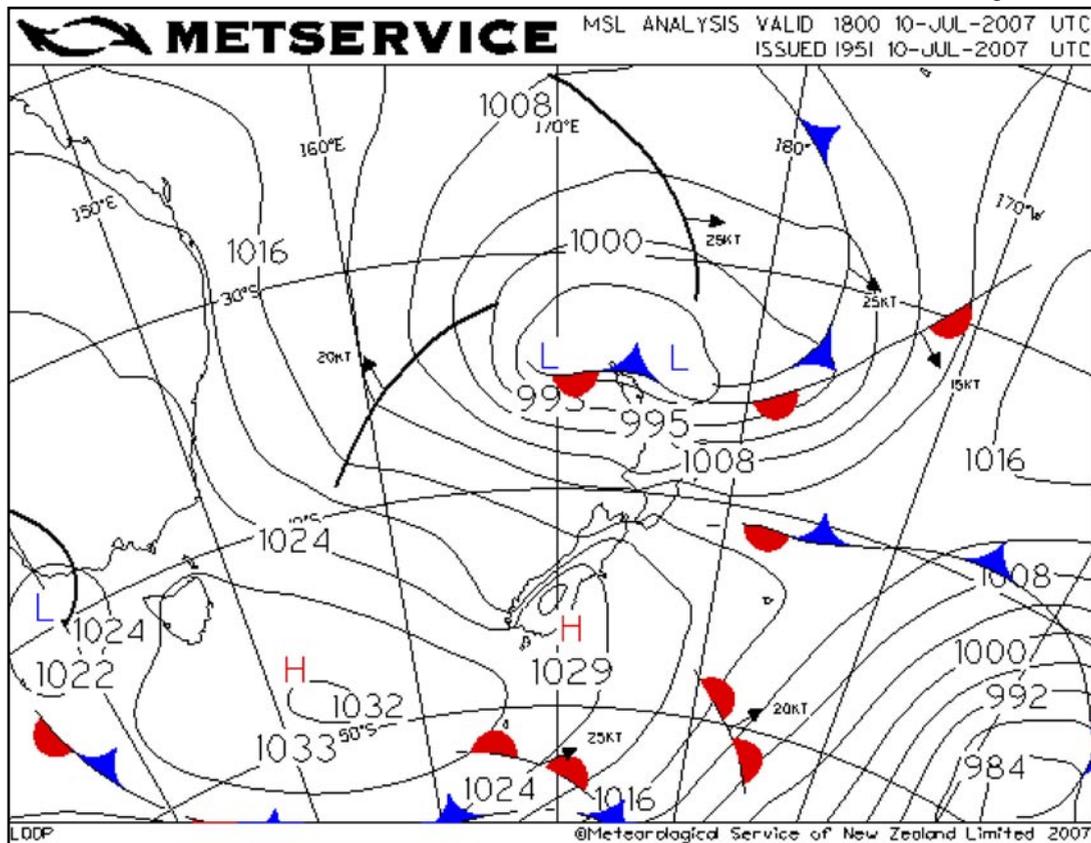
MSL analysis, valid 1800 10 July 2007
