Rail Accident Investigation Branch

# Rail Accident Report

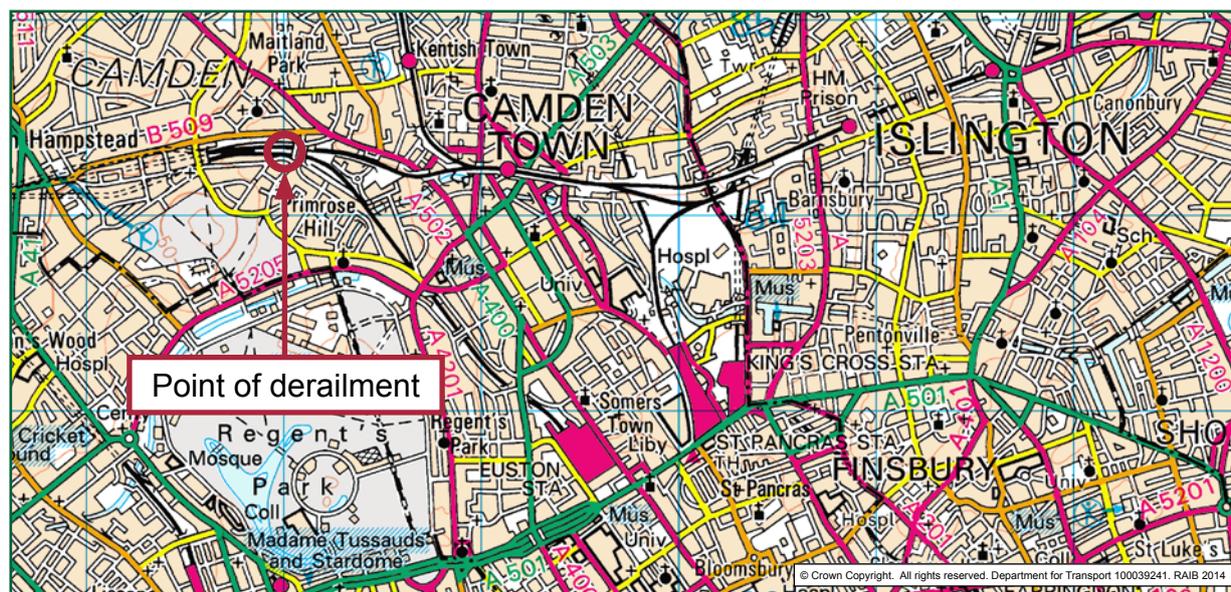
Figure 1: Extract from Ordnance Survey map showing location of derailment

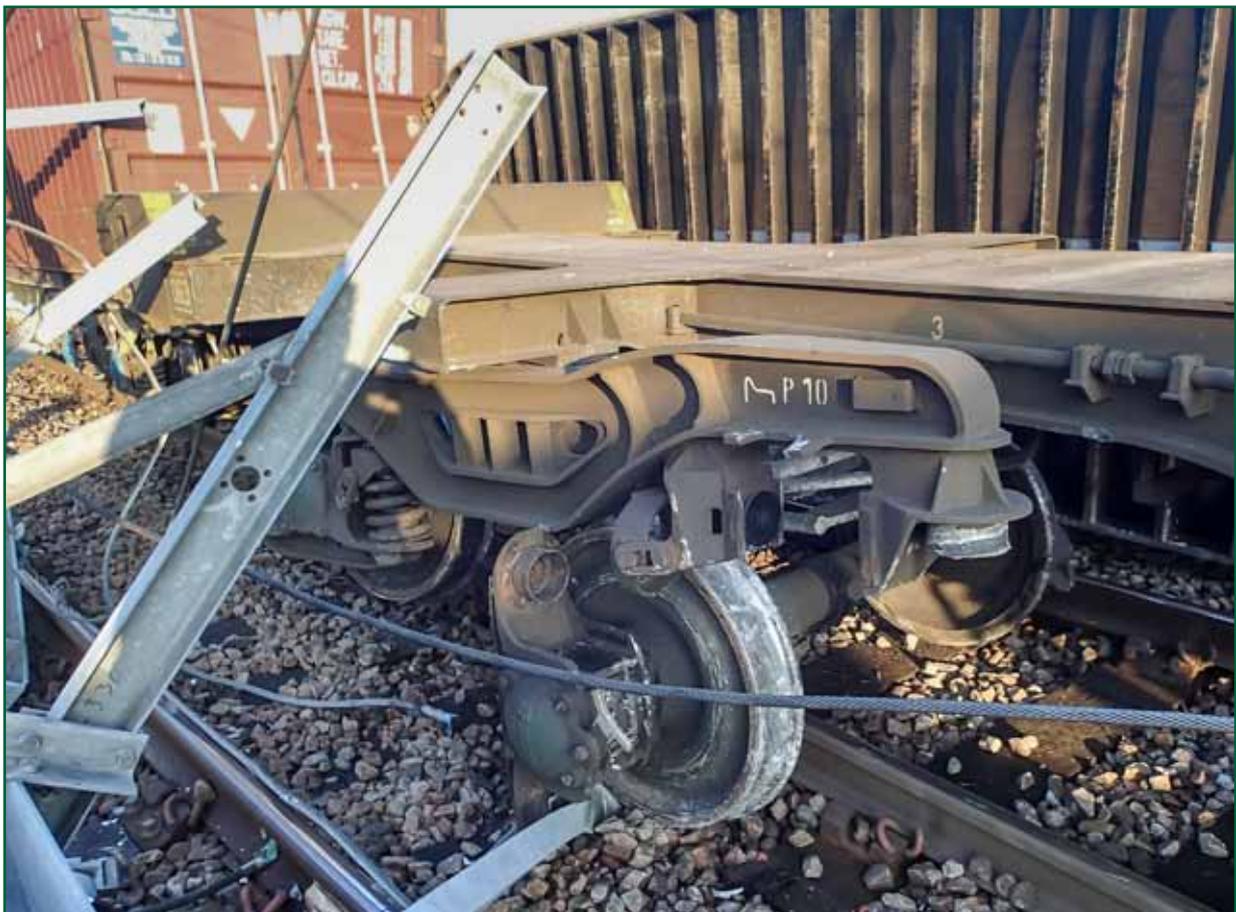
Figure 5: Trailing bogie from wagon No. 641063 following the derailment

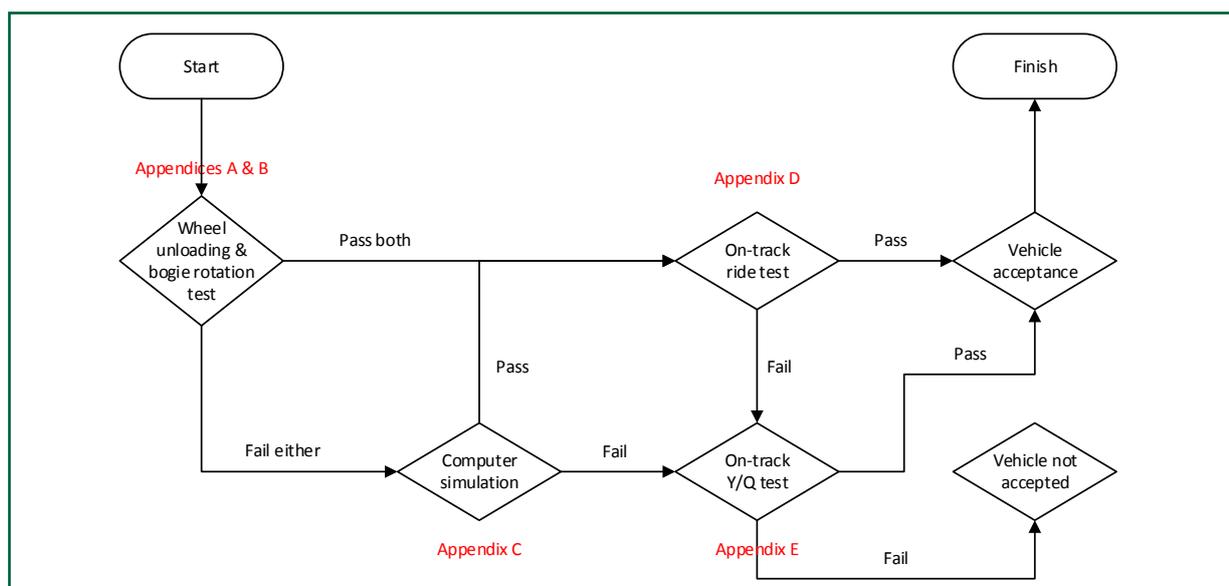
Figure 7: Flowchart showing alternative routes to acceptance contained within GM/RT2141 (also showing appendices of the standard where processes are defined)

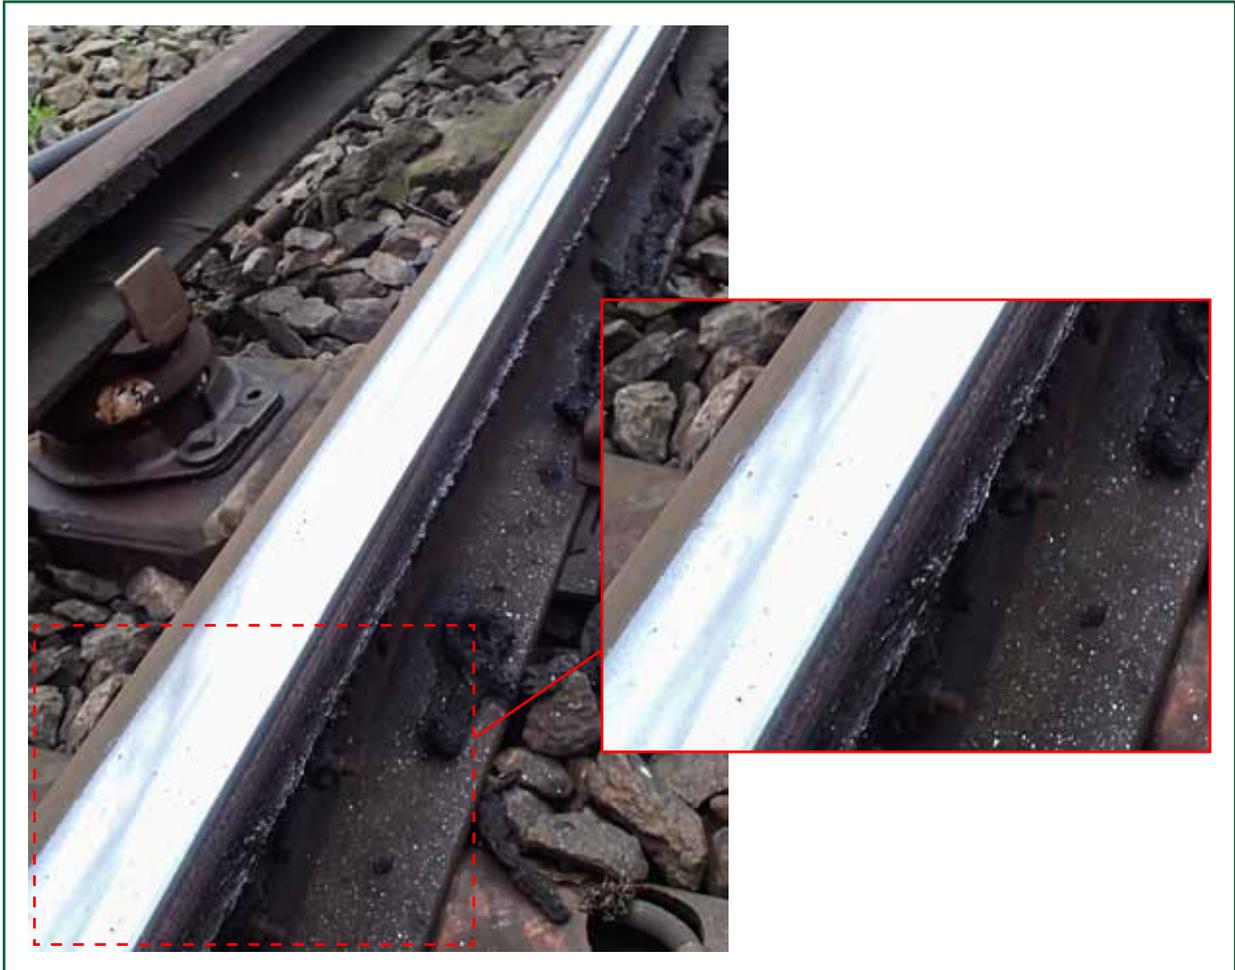
Figure 10: Rail head close to the point of derailment

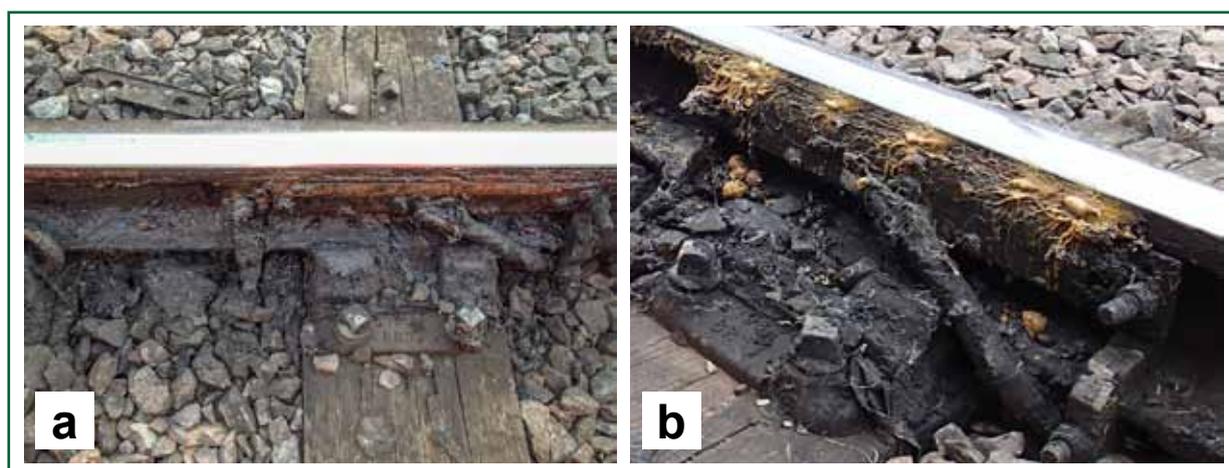
Figure 11: The grease distribution unit at the lubricator  
(a) following the derailment on 15 October 2013 and (b) showing fresh grease on 20 May 2014

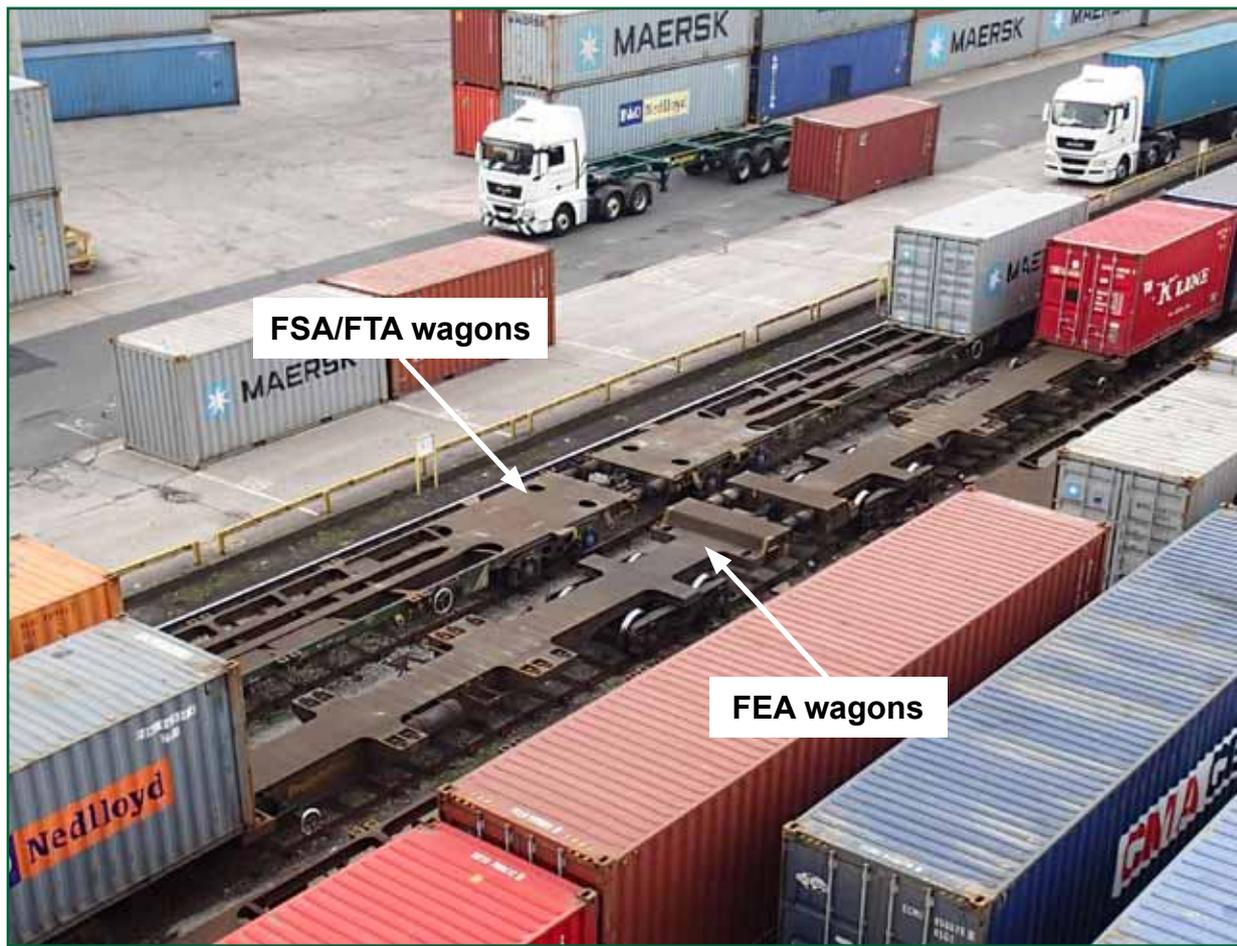
Figure 16: Different structural design of flatbed wagons
