### **GUERNSEY AIRPORT**

# Wind speed and direction recording for Guernsey Airport on 7 December 1997

### Runway Friction Trials Guernsey Airport Runway 09/27 following the accident to Fokker F27 G-BNCY

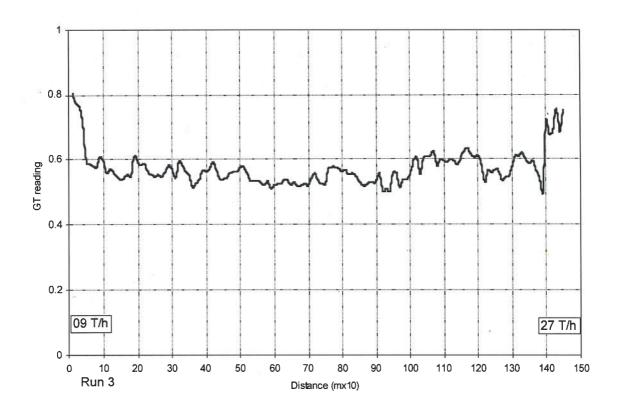
Figure 1 Run 3, 09 direction, 1.5m right of centreline

Table 3 shows the results obtained on runway 09/27. The average self-wetting GT reading for the full length of the runway is 0.62. This value is just above the maintenance planning level (see Table 1). Inspection of sample traces (Figure 1, Run 3, 09 direction, 1.5m right of centreline and Figure 2, Run 4, 27 direction, 1.5m right of centreline) shows that the surface has fairly even friction properties, with the trace varying only slightly about the mean value. This is typical for all the runs made on the surface, excepting runs 9 and 12 which passed through the painted touchdown markings. Figure 3 (Run 9, 09 direction, 10.5m left of centreline) shows the effect of these markings on the friction readings, with excursions up to approximately 0.9 GT reading in two places. This is a rather unusual situation, as painted markings normally cause the friction values to decrease. The markings on this runway are in need of renewal, however. It is likely that the paint remaining has weathered to a rough texture, causing a local increase in friction. Readings in Table 4 show the average for the centre strip of the runway, (up to 7.5m each side of the centreline), and the outer strips (from 10.5m to 19.5m from the centreline). Rubber deposits were subjectively assessed as light at both thresholds.

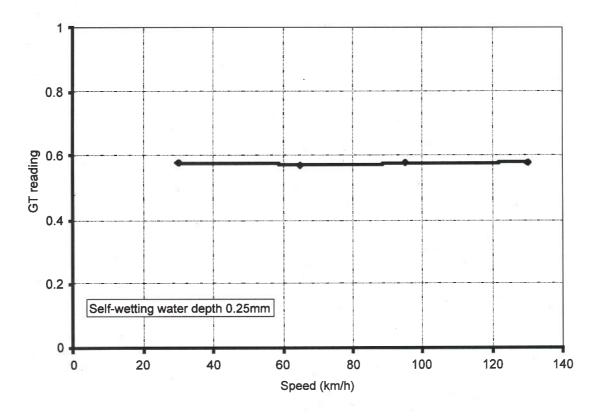
Figure 4 Speed/friction curve runway 09/27

The speed friction/curve for runway 09/27 is presented in Figure 4. A single 500m run 6m from the centreline was made at each of the speeds 30, 65, 95, and 130km/h. The curve remains essentially flat, but at a fairly low level. This indicates that the surface is providing good water clearance beneath the GT measuring tyre, but that the aggregate is polished and has a low microtexture.

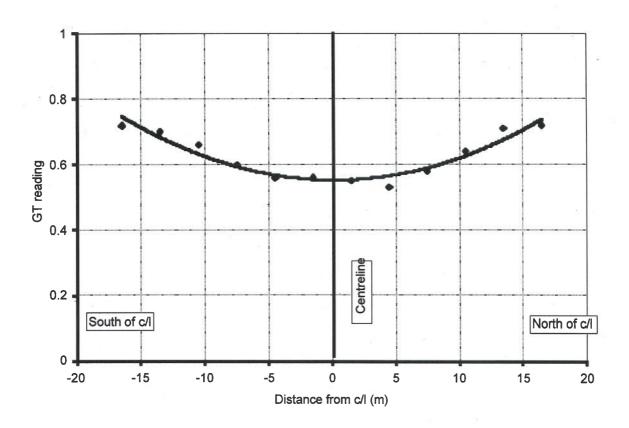
Figure 5 GT reading v Distance from centreline runway 09/27

Figure 5 is a graph showing the variation in average 65km/h full-length self-wetting GT reading with distance from the runway centreline. It can be seen that the readings show a marked variation across the width of the runway, with a rise at the untrafficked edges of the runway, where the aggregate is less polished.

Table 5 shows the average readings on the runway during rainfall. Typical traces of the runs performed in rainfall are shown at Figure 6 to Figure 8. The same general variability about the mean found in the classification trial is evident in these traces. There are no rapid reductions in friction of the type which would be caused by areas of standing water, except for a very short duration excursion at the 09 threshold in run 8 (Figure 8) approximately 1.5m from the edge of the runway and thus not in a trafficked area. The shape of the graph of friction reading against distance from the centreline, Figure 9, mirrors that obtained during the classification trial, Figure 5. The increase in friction toward the runway edges is more marked.

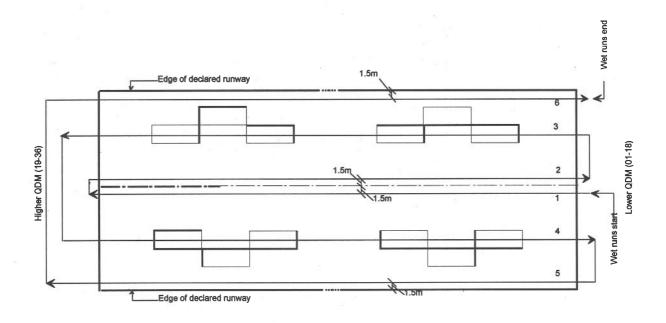
- 2. The Runway Friction Monitoring Survey test should follow a standard format as shown in the attached diagram so that each series of tests can be correlated and areas of reduced friction more readily monitored. Tests should be made using either a Mu-Meter or GripTester towed at 40mph (See Note 1). Friction values below the Maintenance Planning Level on stretches of runway in excess of 100 metres in length will be a cause for concern and the reason for such areas of reduced friction should be investigated.

Natural Rain Tracks 1 to 6 Dry Tracks 1 & 2
