PITCH CONTROL SYSTEM

ELEVATOR SERVO CONTROL SYSTEM LAYOUT

DHC-7 ELEVATOR AUTOPILOT SYSTEM

DTR 7/590

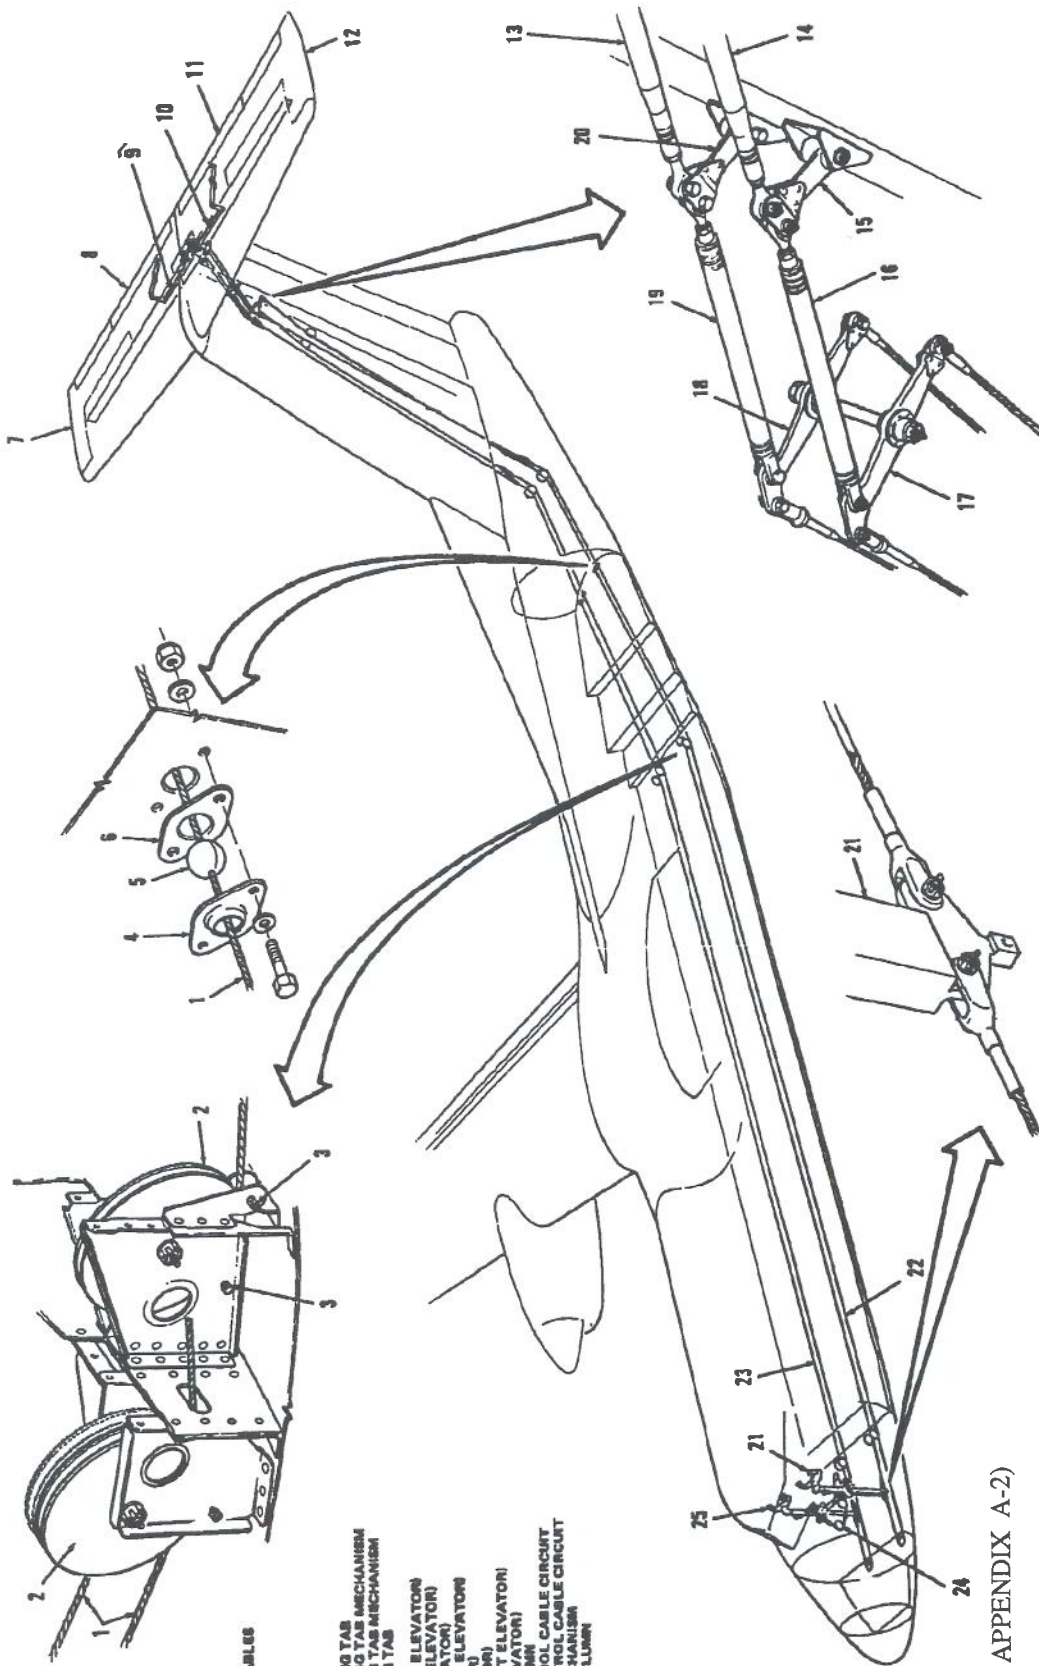
- 1. ELEVATOR CONTROL CABLES
- 2. PULLEY GUARD PIN
- 3. SEAL COVER
- 4. SEAL BALL
- 5. SEAL BASE
- 6. RIGHT ELEVATOR SPRING TAB MECHANISM
- 7. RIGHT ELEVATOR SPRING TAB MECHANISM
- 8. LEFT ELEVATOR SPRING TAB MECHANISM
- 9. LEFT ELEVATOR SPRING TAB
- 10. REAR PUSH ROD (RIGHT ELEVATOR)
- 11. REAR PUSH ROD (LEFT ELEVATOR)
- 12. IDLER ARM (LEFT ELEVATOR)
- 13. FRONT PUSH ROD (LEFT ELEVATOR)
- 14. LEVER (RIGHT ELEVATOR)
- 15. FRONT PUSH ROD (RIGHT ELEVATOR)
- 16. IDLER ARM (RIGHT ELEVATOR)
- 17. LEFT ELEVATOR CONTROL CABLE CIRCUIT
- 18. LEFT ELEVATOR CONTROL CABLE CIRCUIT
- 19. PITCH DISCONNECT MECHANISM
- 20. COPILLOT'S CONTROL COLUMN

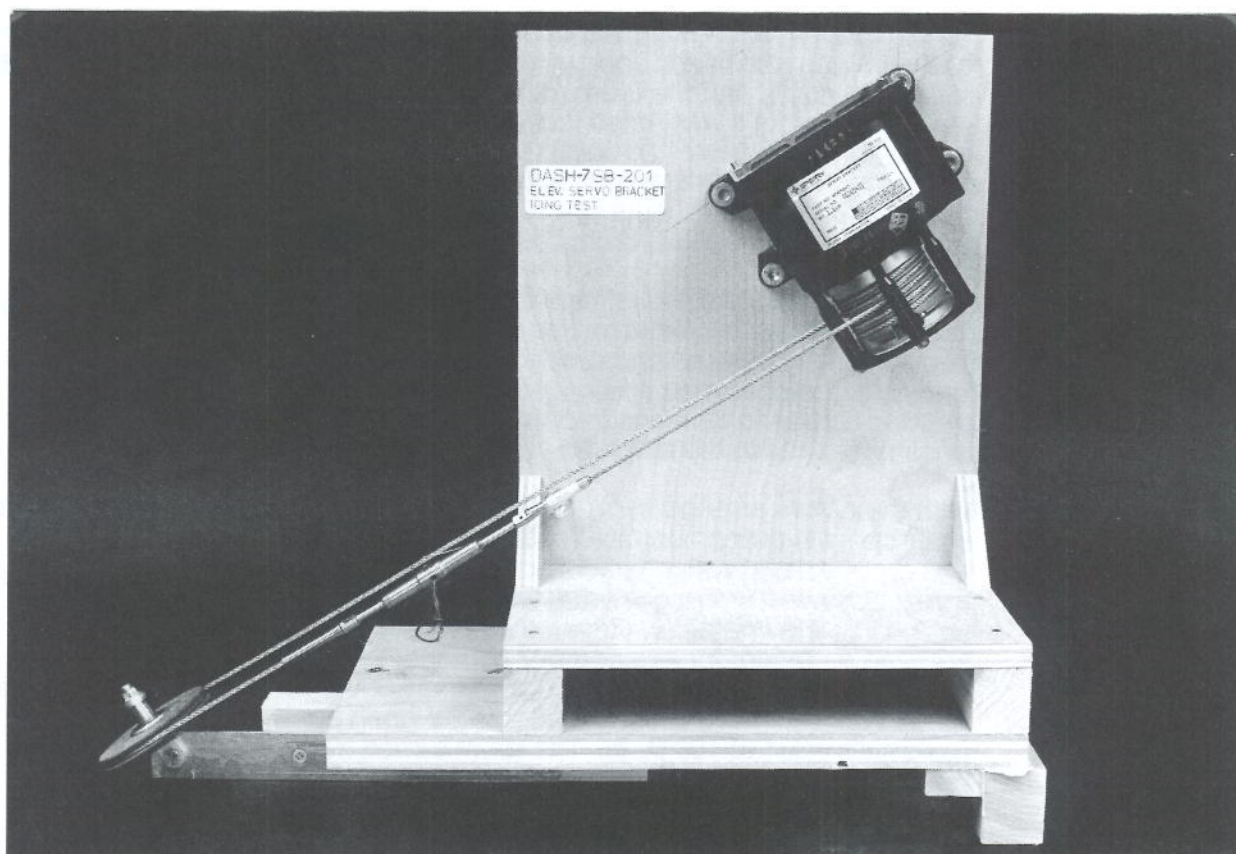
FIGURE 1.

- 2.1 A servo drum assembly Sperry P/N 400584 S/N 80105477 was mounted at a representative angle on a support stand as seen in Figure 1. The cable circuit shown was installed to apply a representative side load to the drum and to investigate the effect of ice formation on the cable itself.

- 4.3 Before commencing Test No. 3 cables were attached to the drum and, unlike the later arrangement shown in Figure 1, the cable ends were attached to the test frame. Cable tension was adjusted to 25 lb. The drum was sprayed with water for 2 minutes as per Test No. 1, Para 4.1. After 1 hour, 20 minutes cold soak at - 11 ° C, the unit was removed from the chamber. After releasing the cables, a drum breakout torque of 10 in. lb was measured.

- 4.5 It was suspected that the release of the cable tension in Tests 3 and 4 may have affected the breakout torque values by applying load to the ice, and this was in any case an unrepresentative procedure. Before the next test, therefore, the specimen was rigged with a pulley as shown in Figure 1, allowing torque to be measured with cable tension maintained. Cable tension was within the range 20 - 25 lb.
