Report on the investigation of
a close-quarter situation between

Costa Atlantica

Grand Neptune

in the Dover Strait on 15 May 2008

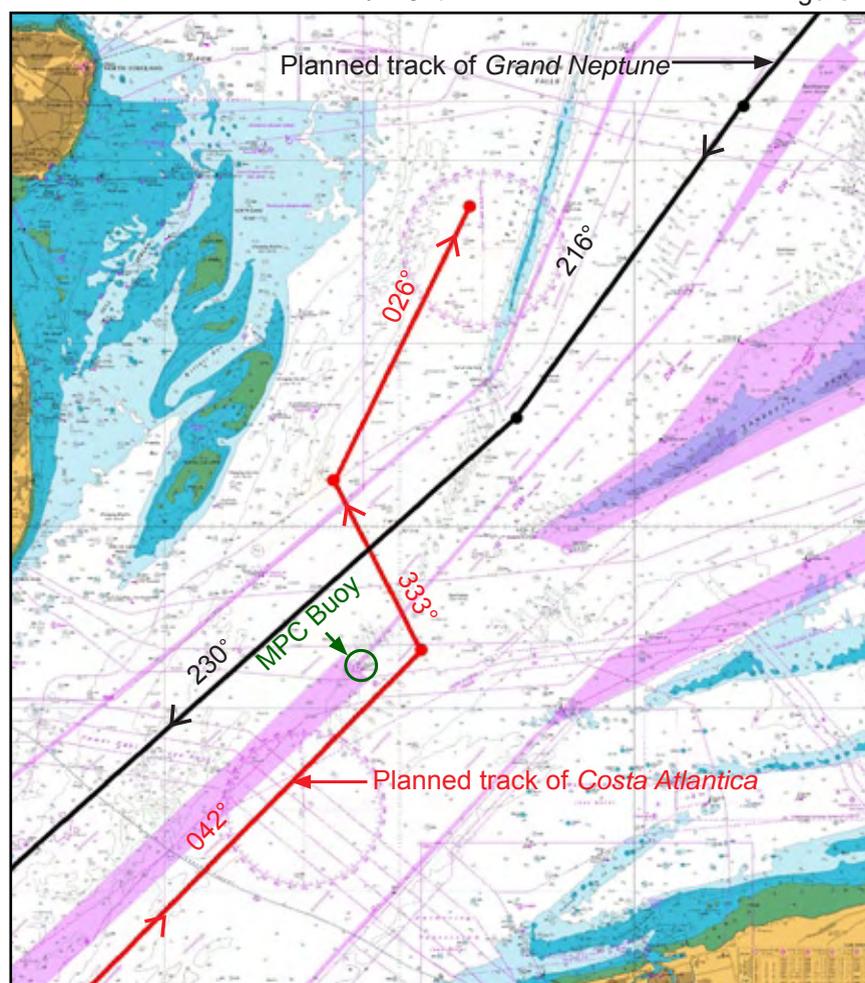
Figure 1

At 0211, *Grand Neptune* altered course to 216° and at 0245 to 230° in accordance with her passage plan (**Figure 1**). At 0249 the target of *Costa Atlantica* was acquired by radar when at a range of 5nm (**Table 1**). At 0253, the ARPA alarm sounded warning the bridge team of a dangerous target; *Costa Atlantica* was now 2.89nm away, with a CPA of 0.21nm in 5.12 minutes (**Figure 2**).

Extract of chart BA 323 - Dover Strait

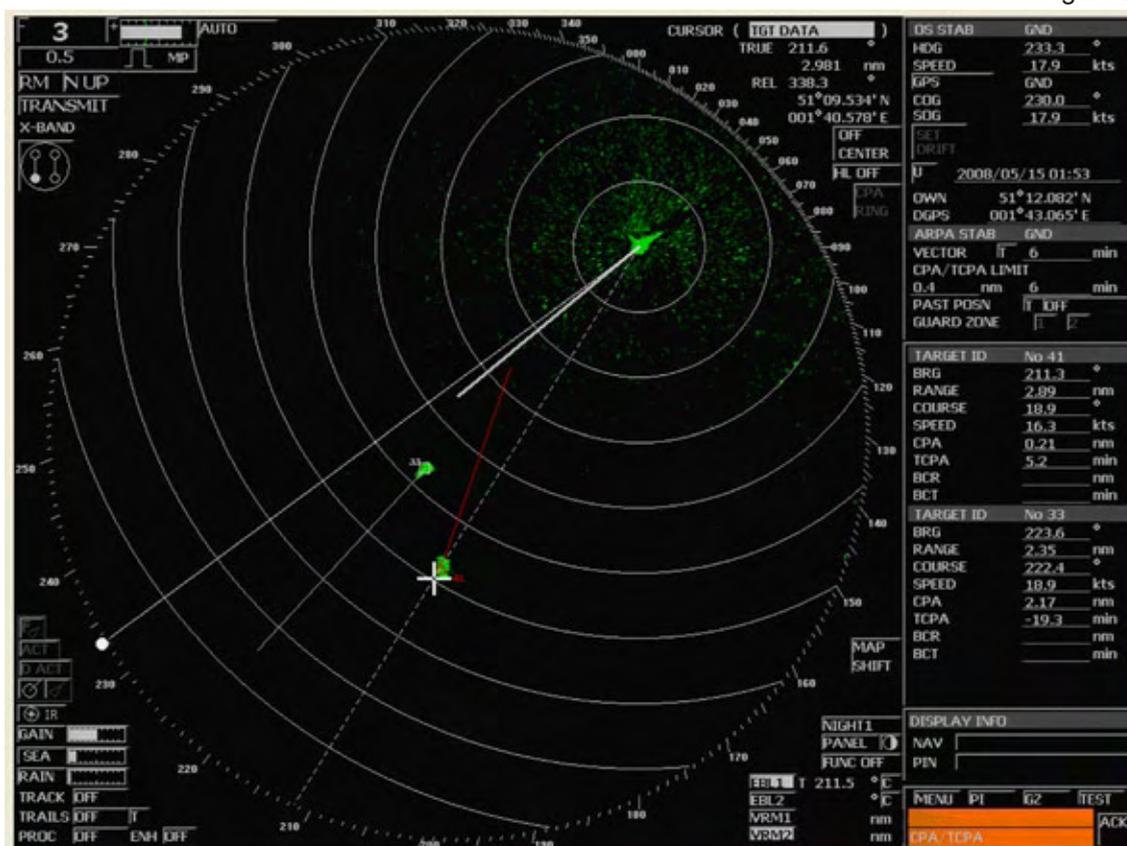
Figure 2

Grand Neptune - screen shot of radar at 0253

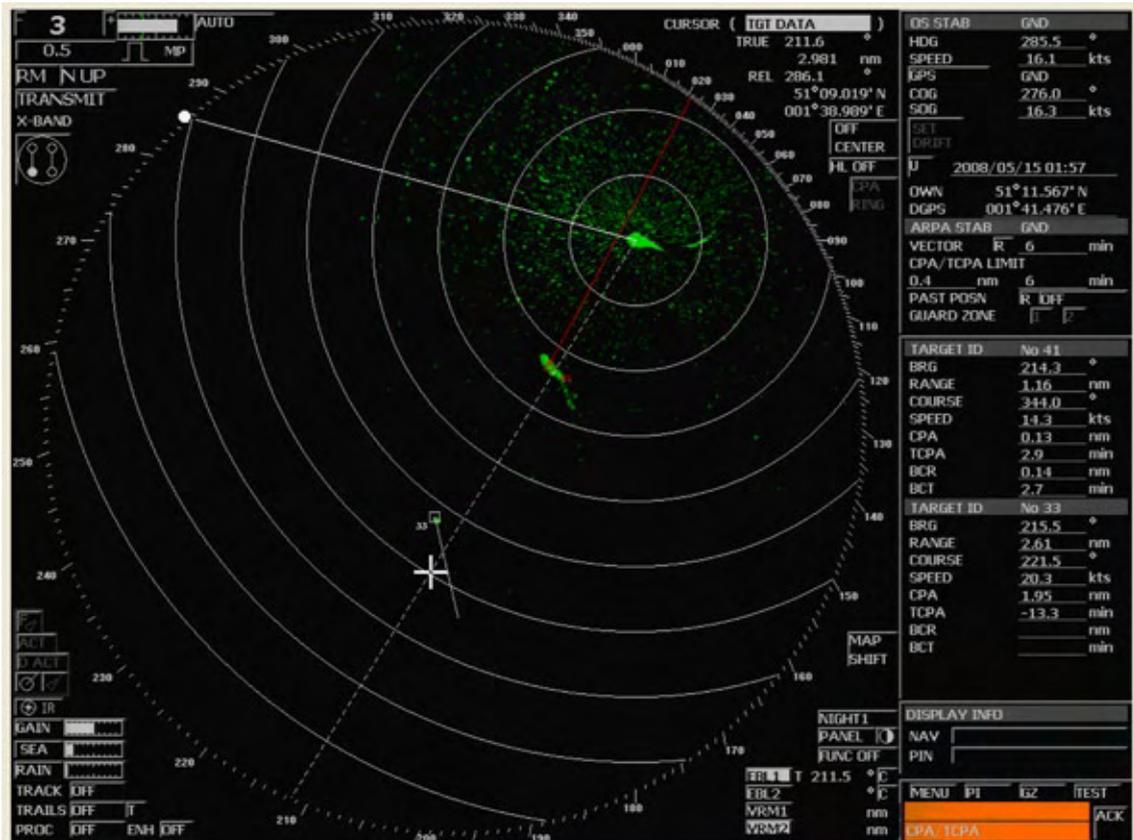
Figure 3

At 0257 the pilot ordered the helm to hard-a-starboard. *Costa Atlantica* was 1.16nm away, with a CPA of 0.13nm in 2.9 minutes (**Figure 3**). He also informed *Costa Atlantica* on VHF radio:

Grand Neptune completed a 360° turn to starboard and, as a result of this evasive action, her CPA with *Costa Atlantica* was 1nm.

Grand Neptune - screen shot of radar at 0257

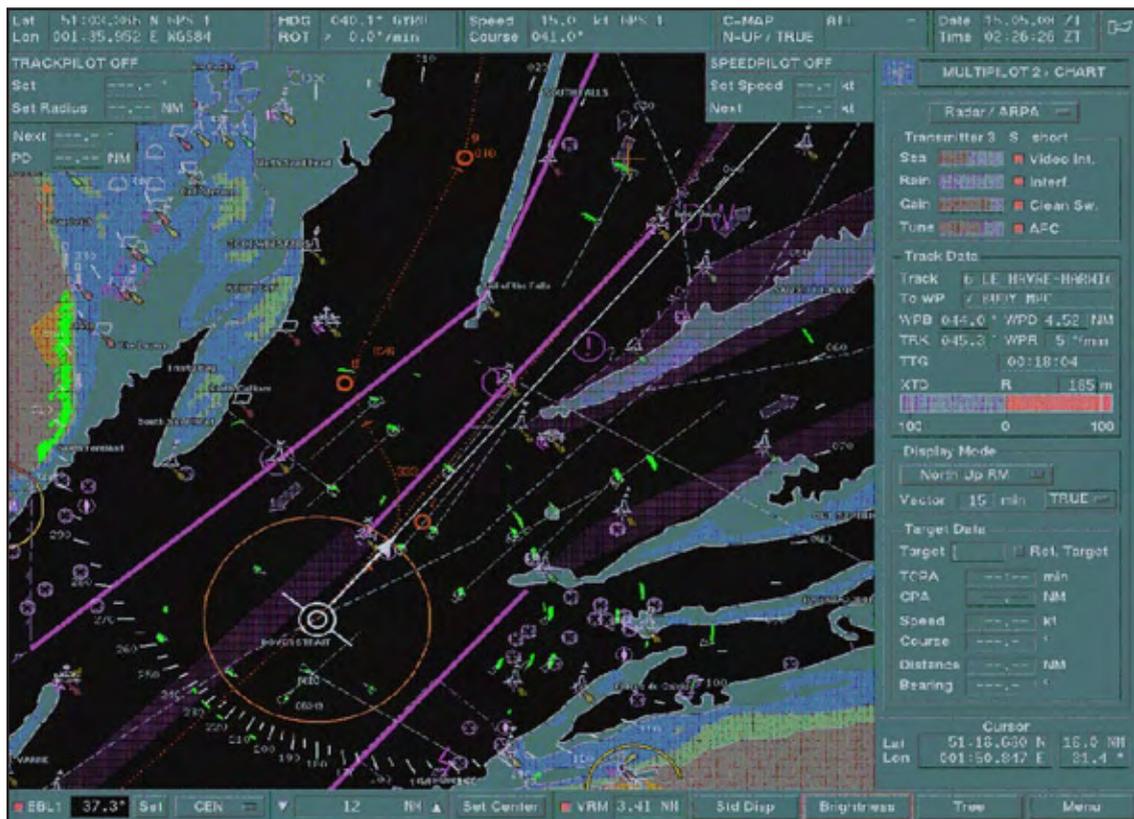
Figure 4

After being called by the OOW, as instructed, *Costa Atlantica's* master arrived on the bridge at 0225. The second officer was the OOW, and retained the con with the third officer assisting with the navigation. The vessel was in hand steering and on a course of 042° at a speed of 15 knots following the north-east lane of the Dover Strait. The next planned course alteration to 333°, which took the vessel across the south-west traffic lane, was 3.4nm ahead, beyond the MPC buoy. In preparation for the alteration, the master and second officer viewed the radar on the 12nm range scale, which was also offset towards the south-south-west, and assessed the traffic situation. At 0226, two radar targets were acquired by ARPA, both of which were following the south-west traffic lane; *MSC Serena* was at 16.1nm and *Grand Neptune* at 18nm (**Figure 4**). The radar range scale was then reduced to the 6nm range scale.

Costa Atlantica - screen shot of radar when *Grand Neptune* acquired

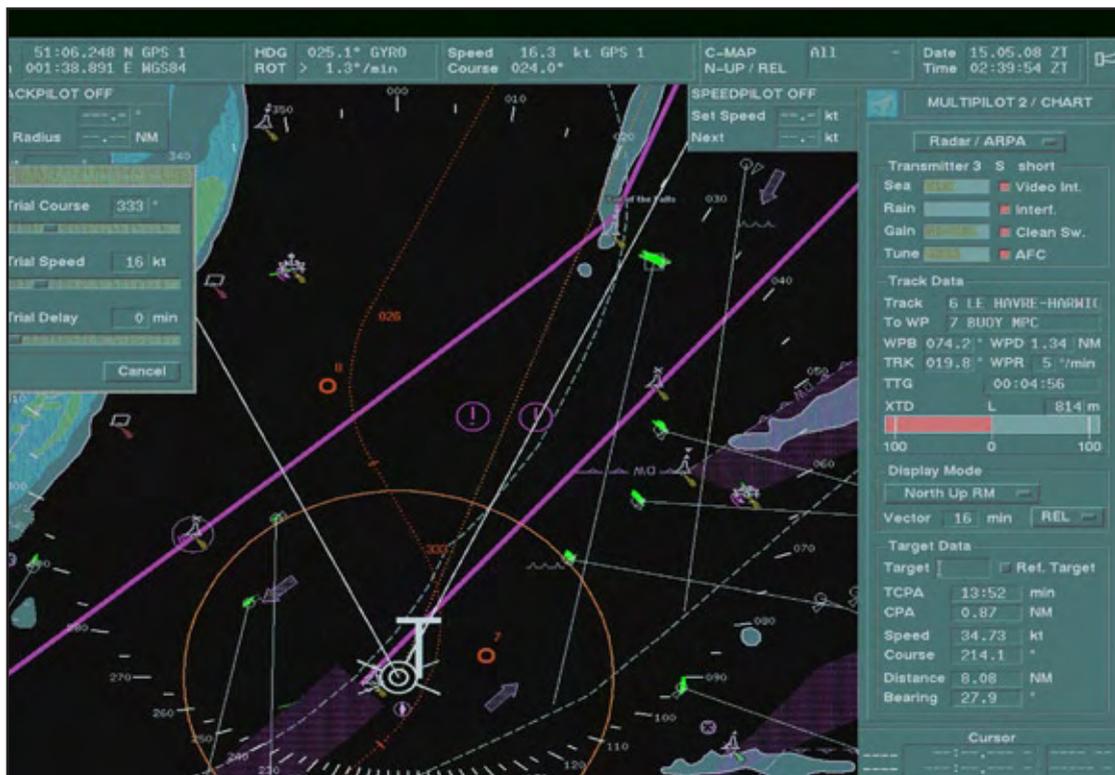
Figure 5

The master instructed the second officer to carry out a trial manoeuvre¹ on the ARPA radar to accurately assess the situation before committing to an alteration of course. This was conducted by the second officer at 0239 (**Figure 5**) and was witnessed by the master, who was standing to the left of the second officer (**Figure 6**). No time delay was entered. The master and second officer read the CPA information displayed at the bottom right hand side of the screen, which indicated *MSC Serena* had a CPA 0.87nm in 13.5 minutes, and understood it to be the results of the trial manoeuvre.

In line with the company's recommended practice, the master intended to cross the south-west lane using a slow rate of turn to achieve a 3nm radius (**Figure 5**). The master estimated that, by the time the vessel had completed her turn to port, the CPA of *MSC Serena* would have reduced significantly. Accordingly, the second officer was told to initially adjust the course to pass close astern of *MSC Serena*, and continue the alteration to port to pass ahead of *Grand Neptune*.

Trial manoeuvre carried out by *Costa Atlantica* at 0239

¹ A trial manoeuvre is a mandatory facility of an ARPA that allows the operator to evaluate the possible navigational consequences on all tracked targets of an own-ship manoeuvre by changing the parameters for course and speed.

When the OOW on board *Costa Atlantica* indicated to the master that he intended to alter course to cross the SW traffic lane, the master's decision to verify the second officer's assessment that *Costa Atlantica* would pass ahead of *MSC Serena* by using the 'trial manoeuvre' facility on the ARPA radar was a reasonable precaution. However, in conducting the 'trial manoeuvre' without a time delay, and evidently mistaking the real time CPA data at the bottom right hand corner of the radar display (**Figure 5**) for the CPA following the intended alteration, the information on which the master based his decision to adjust course to pass between *MSC Serena* and *Grand Neptune* was inaccurate. It also demonstrated that neither the master nor the second officer were familiar with the 'trial manoeuvre' function.

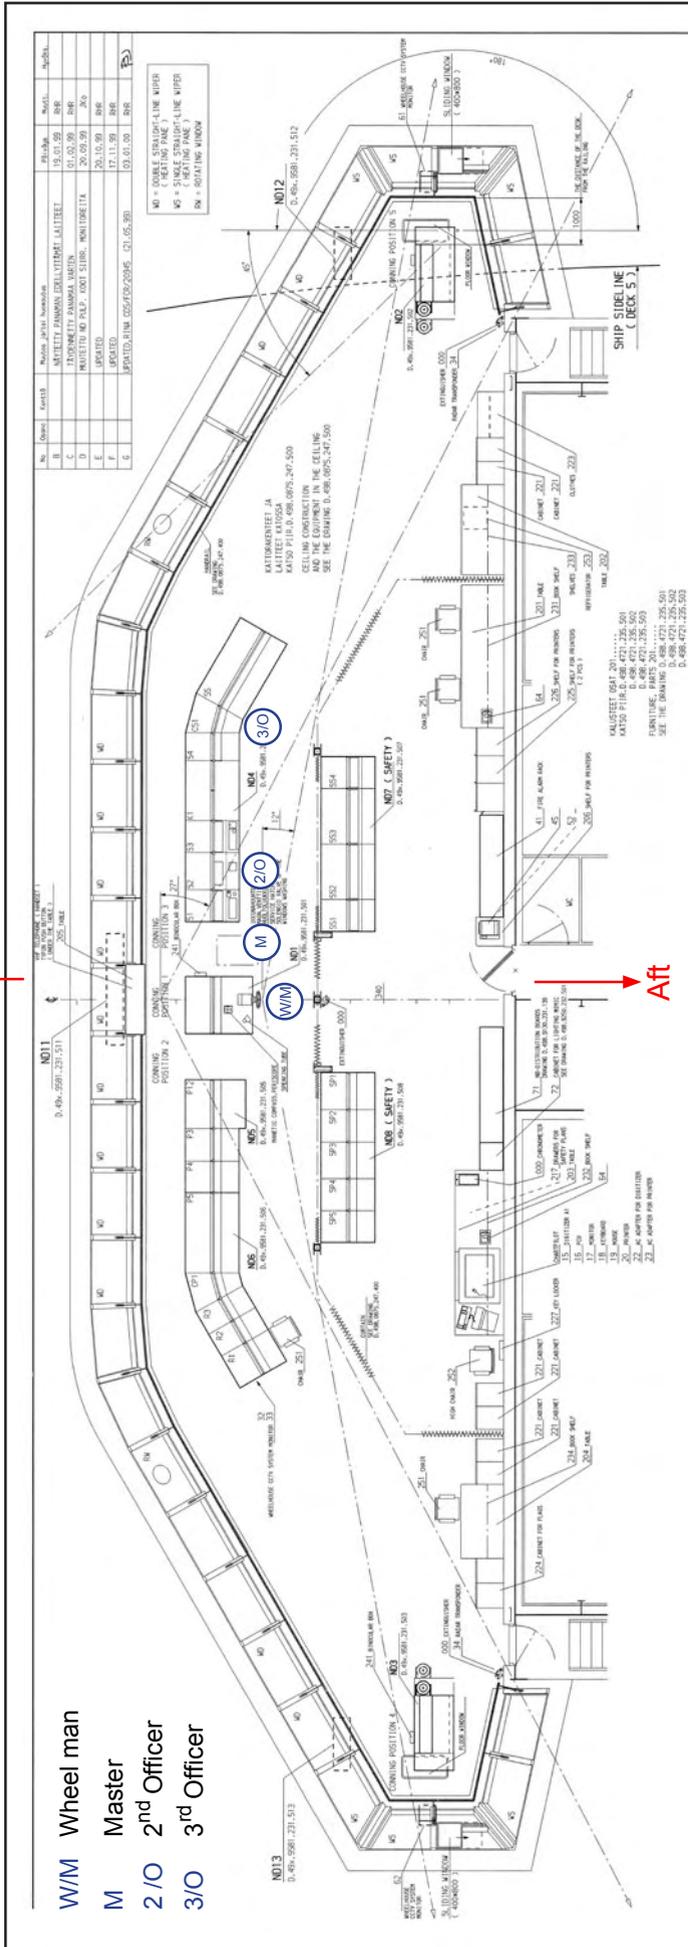
Figure 6

Costa Atlantica - layout of bridge

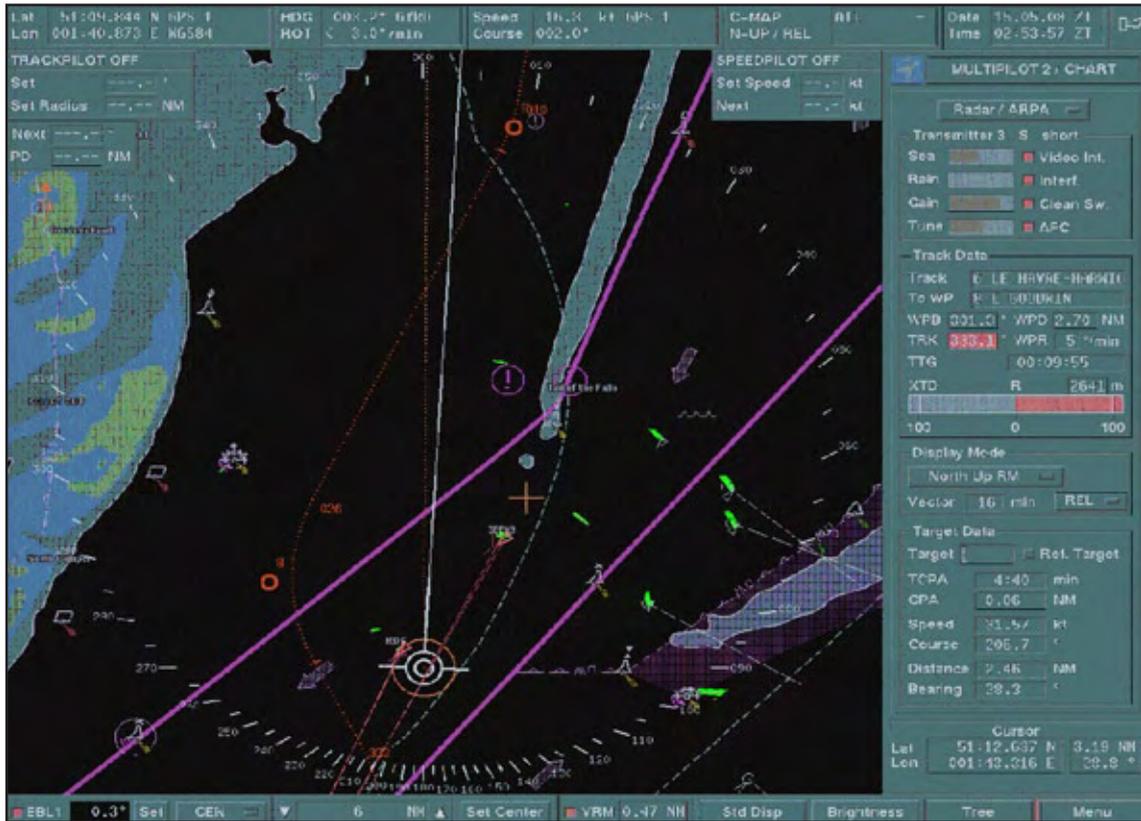
Figure 7

As *Costa Atlantica* neared *MSC Serena* at 0254, which was now passing clear, *Grand Neptune* was 2.46nm on her starboard bow with a CPA of 0.06nm in 4.4 minutes (**Figure 7**). *Costa Atlantica* was still under helm to port, but to increase the rate of turn and the CPA with *Grand Neptune*, the second officer ordered port 10 when the heading was 002°, followed by port 5 and, finally, amidships when the heading was 355°. He then gave a series of further orders to continue the vessel's turn to port.

Costa Atlantica - screen shot of radar at 0254

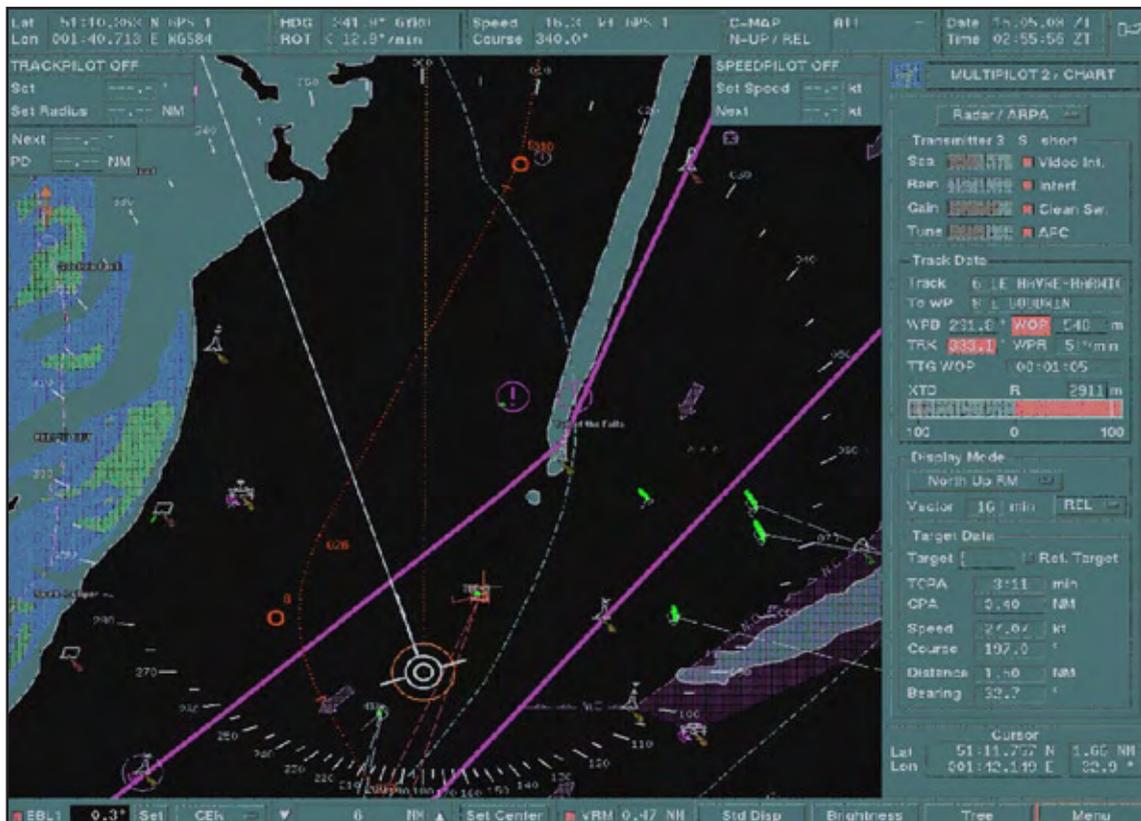
Figure 8

At 0256, Dover Coastguard called *Costa Atlantica* requesting she contact *Grand Neptune* on VHF Channel 16 (**Annex A**). In response, the second officer stated his intention to pass *Grand Neptune* with a CPA of 0.4nm (**Figure 8**).

Costa Atlantica - screen shot of radar at 0256

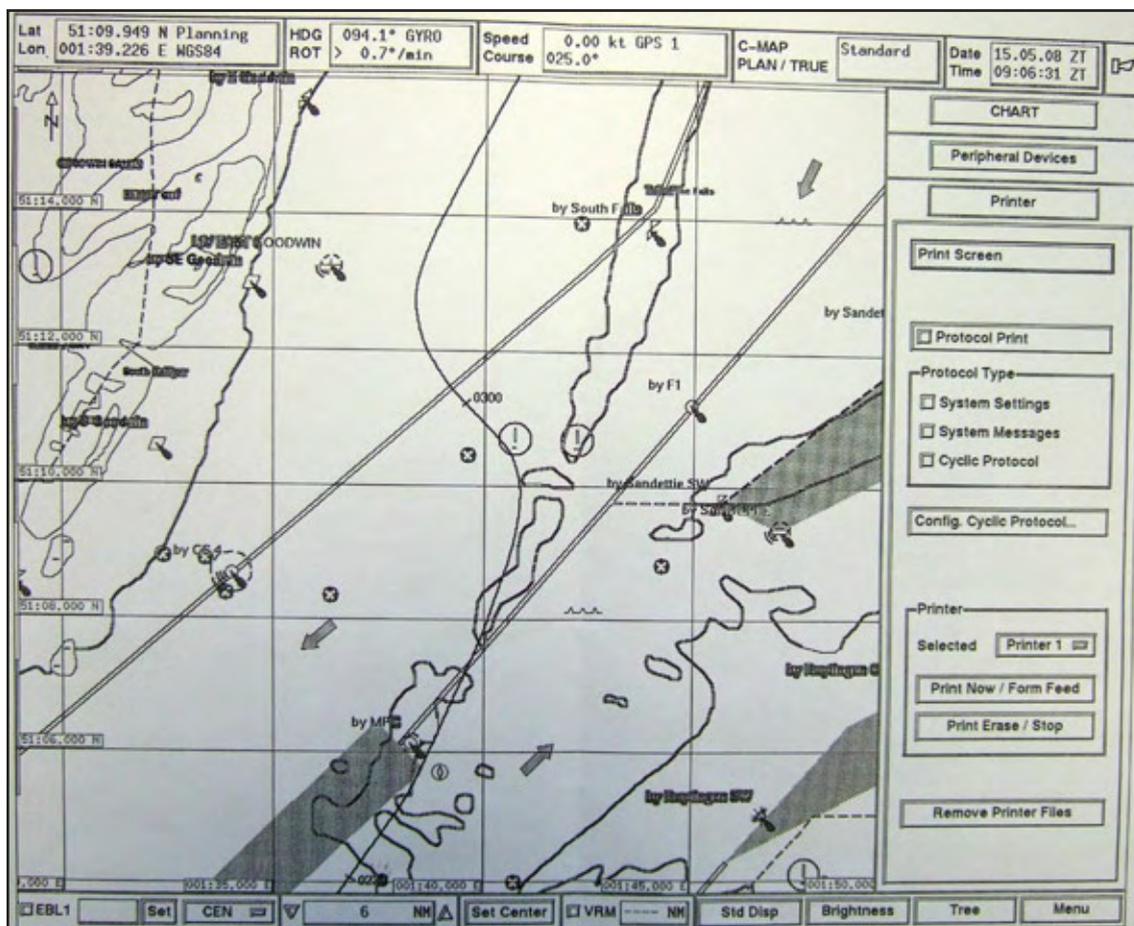
Costa Atlantica's speed was then further increased from 98 RPM to 103 RPM and she was steadied on a course of 320°; the vessel exited the TSS at 0301 without further incident. The resultant track made good by *Costa Atlantica* from passing the MPC buoy to exiting the TSS is at **Figure 9**.

Resultant track of *Costa Atlantica*

As *Costa Atlantica* entered the south-west traffic lane on a course to take her close astern of *MSC Serena*, she did so at a shallow angle (**Figure 9**). This was far from the 90° to the direction of the traffic flow as required by Rule 10(c) of the COLREGS. Indeed, she was sailing more against the general flow of the traffic, rather than across it. It was therefore not surprising that the pilot on board *Grand Neptune* was unsure of the passenger ship's intentions. In addition, although *Costa Atlantica*'s course was progressively altered to port to pass close astern of *MSC Serena* and ahead of *Grand Neptune*, the rate of turn was incremental, and far too slow to be readily apparent either visually or by radar as required by Rule 8(b) of the COLREGS.
