**Report of the Inspector's Investigation into  
the death of one person on the cruise Ship  
*EDINBURGH CASTLE*  
while berthed in Southampton Docks  
on 3 May 1999**

**Extract from**  
**The Merchant Shipping**  
**(Accident Reporting and Investigation)**  
**Regulations 1994**

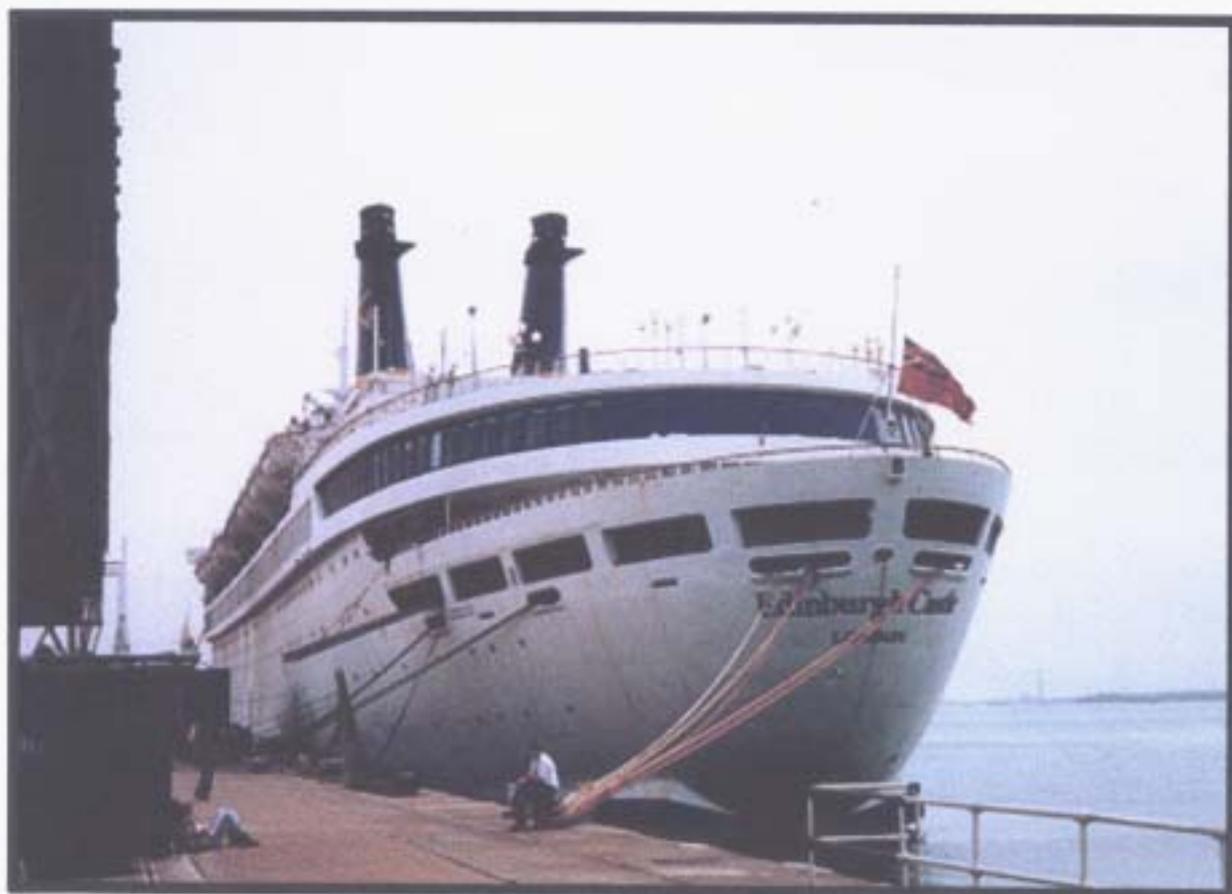
FIGURE 1

*Edinburgh Castle*

(**Figure 1**) shows *Edinburgh Castle* alongside in Southampton.

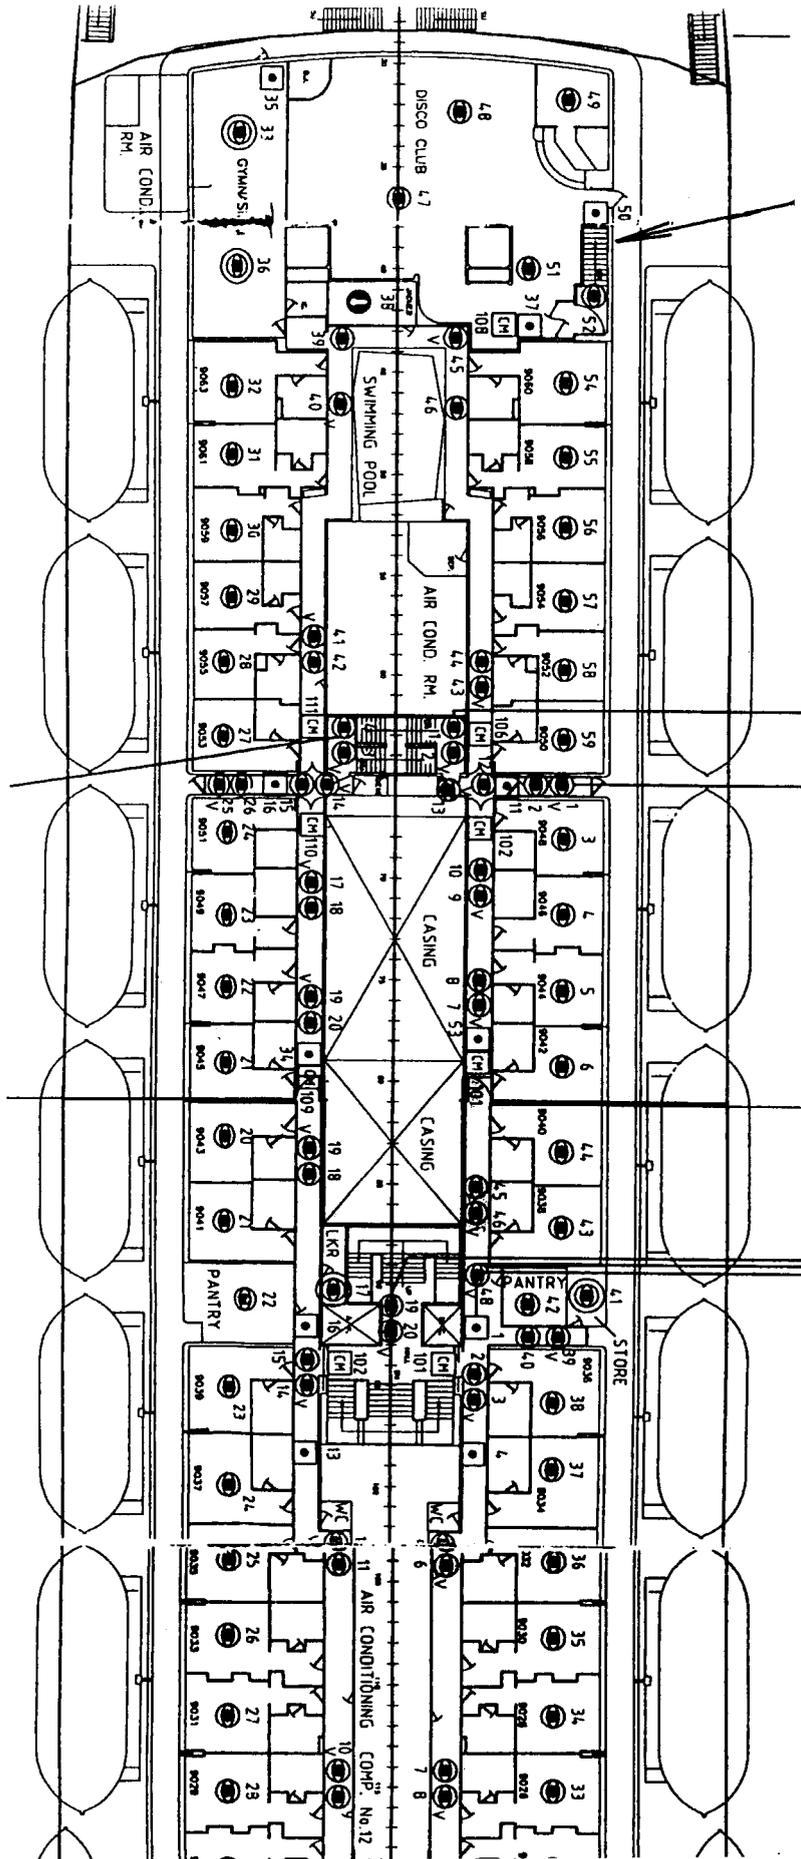
FIGURE 2

The location of the accident is shown on the (part) general arrangement of *Edinburgh Castle* (**Figures 2 and 3**).

DISCO CLUB STAIRS

PART PLAN OF DECK 9

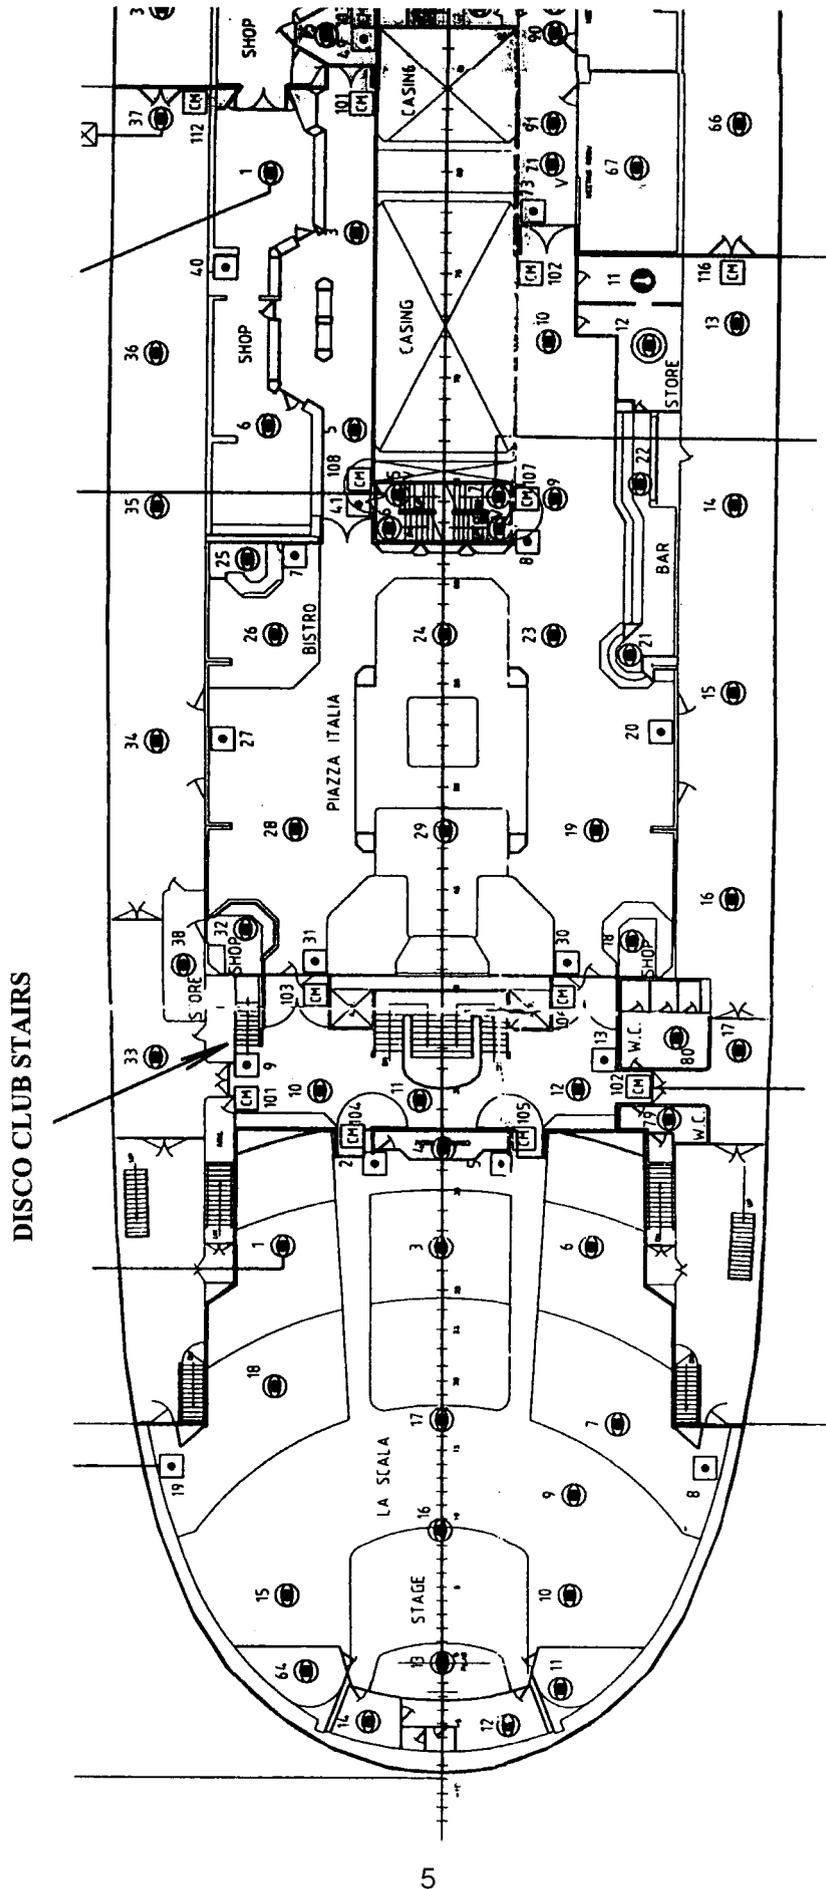
FIGURE 3

PART PLAN OF DECK 8

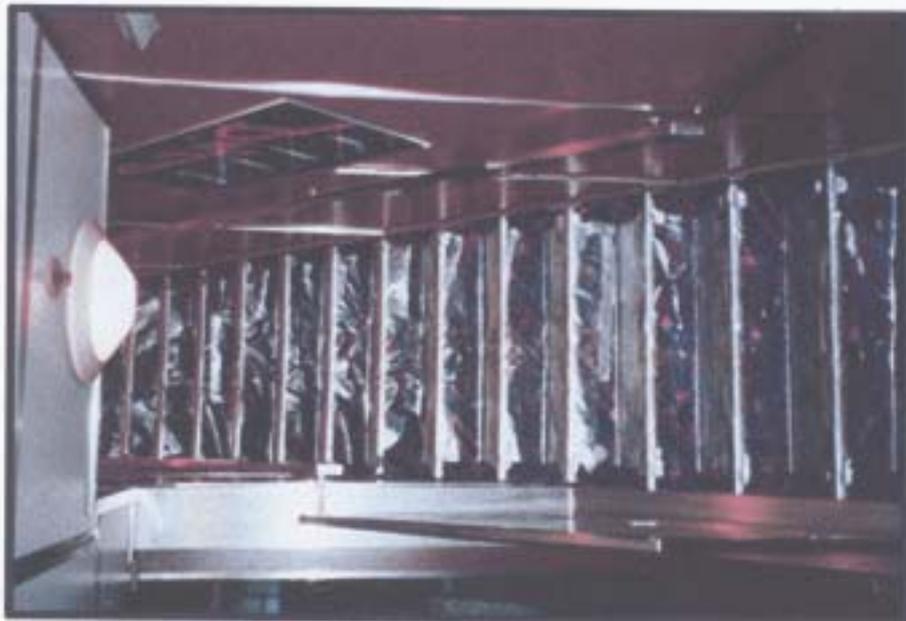
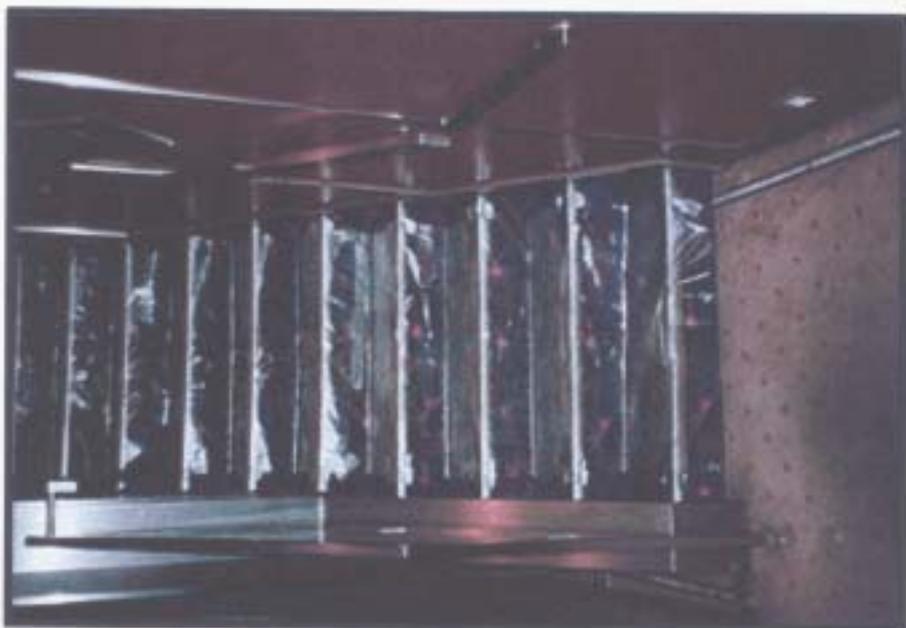
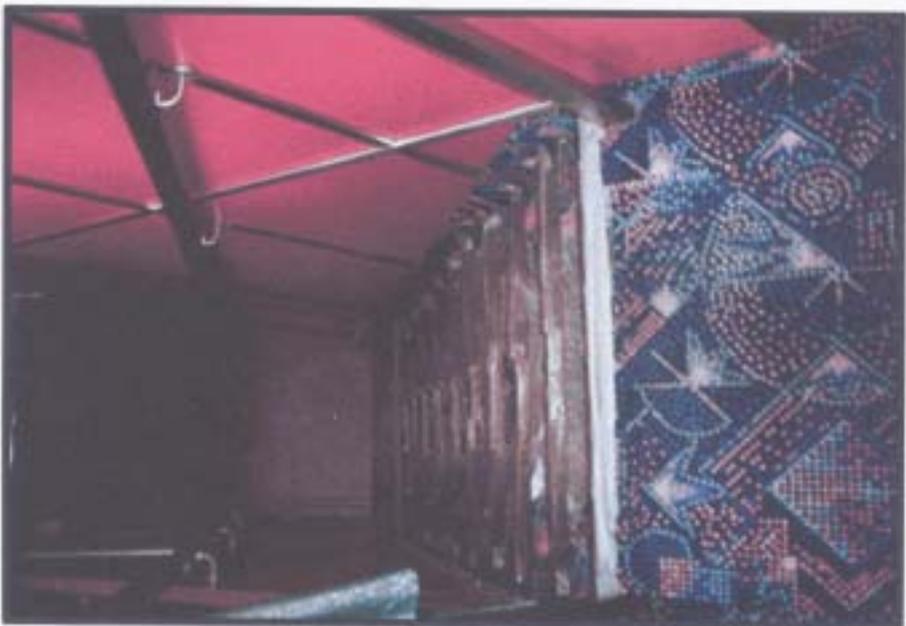
FIGURE 4

Mirosław Brzujszczak was socialising with his friends in the disco club. He seemed quite normal and did not appear to be worried about anything. Shortly after 2300 he announced that he was off to bed. He left, and headed for the disco club stairs (**Figure 4**). He was found at the foot of the stairs, at about 2315, by another crewman, who went immediately to the disco club to raise the alarm. The first officer he saw was the hotel engineer, who on being informed of the accident, left the disco club, followed by a CPO plumber who realised that something dramatic had happened. On reaching the scene, the hotel engineer administered first aid, which included moving Mirosław Brzujszczak to the recovery position, while the CPO plumber went back to the disco club and phoned the bridge. The officer of the watch informed the captain who was in his cabin.

Disco club stairs

The ship’s lighting was switched on at the time of the accident, and the stairway was illuminated. One of the light fittings is shown in (**Figure 4**).

Handrails were fitted on both sides of the disco club stairs (**Figure 4**).

- 2.8 The lighting of the disco club stairs was inspected by the MAIB on 4 May 1999, and was considered to be adequate.

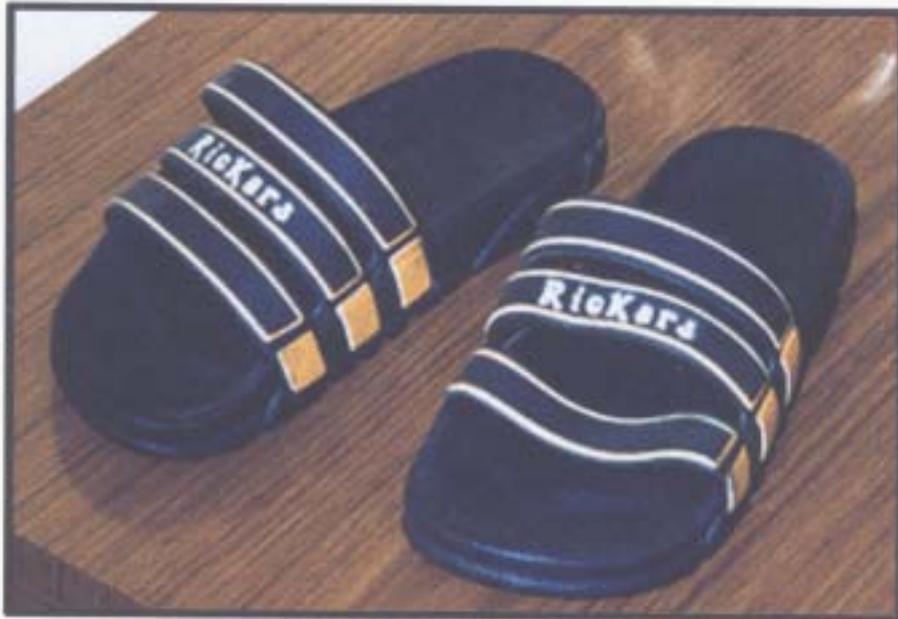
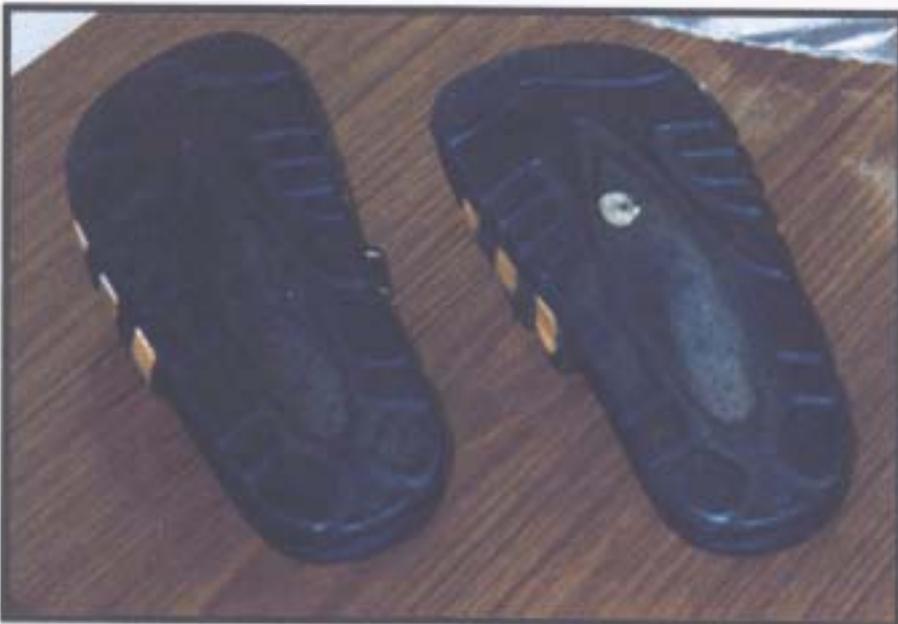
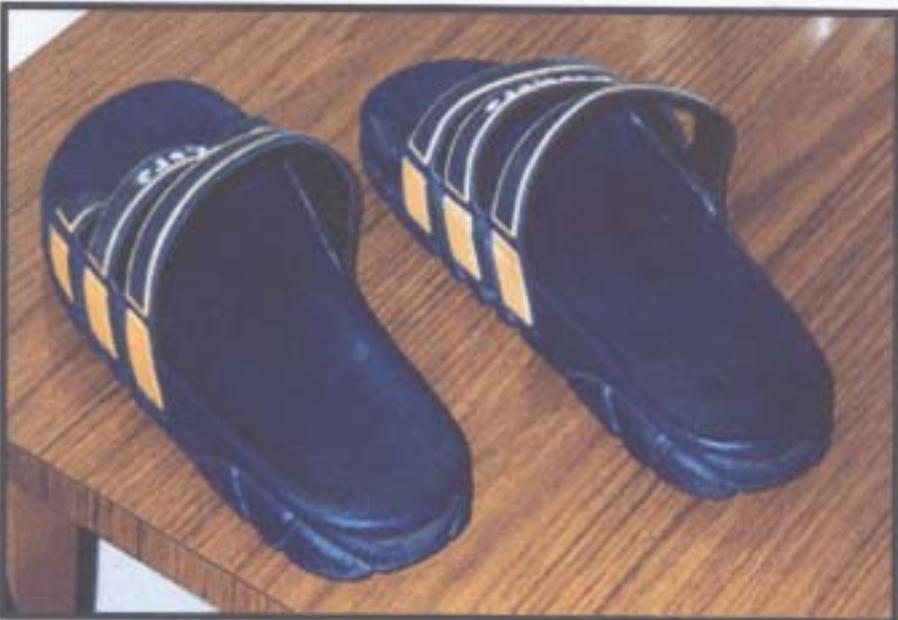
FIGURE 6

Miroslaw Brzujszczak was wearing loose fitting footwear normally referred to as "flip flops" (**Figure 6**). He was also wearing socks. One shoe was found lodged at angle about four steps up from the bottom of the stairway, the other was lying on the deck close to his body.

Footwear

- 2.5 The footwear that Miroslaw Brzujszczak was wearing might have contributed to the accident. Flip-flops are not a secure form of footwear, and when the wearer is intoxicated can lead to trips and falls. The wearing of flip-flops with socks is considered especially hazardous, because grip between the foot and the flip-flop is substantially reduced.

7. Miroslaw Brzujszczak was wearing loose fitting footwear, which presented an additional hazard in his intoxicated condition. [1.6]
8. The disco club stairs were fitted with protective plastic sheeting, which had become ragged near the top. This caused a further hazard to Miroslaw Brzujszczak in his intoxicated condition. [1.7]

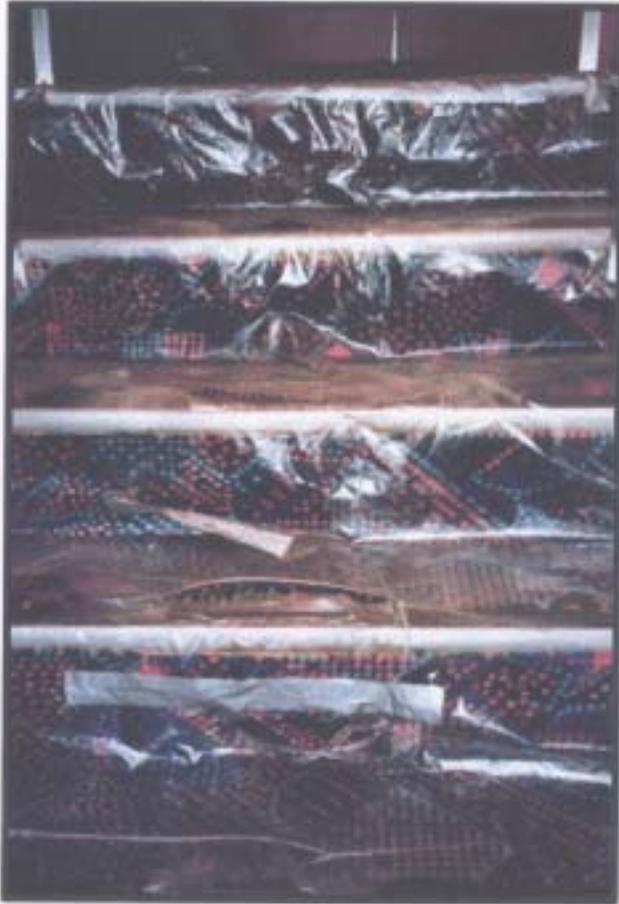
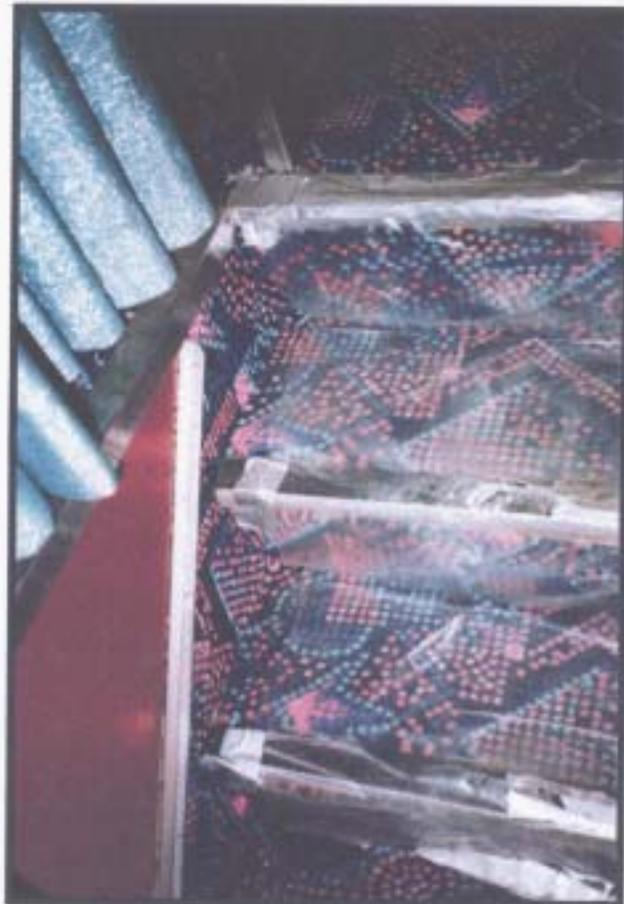
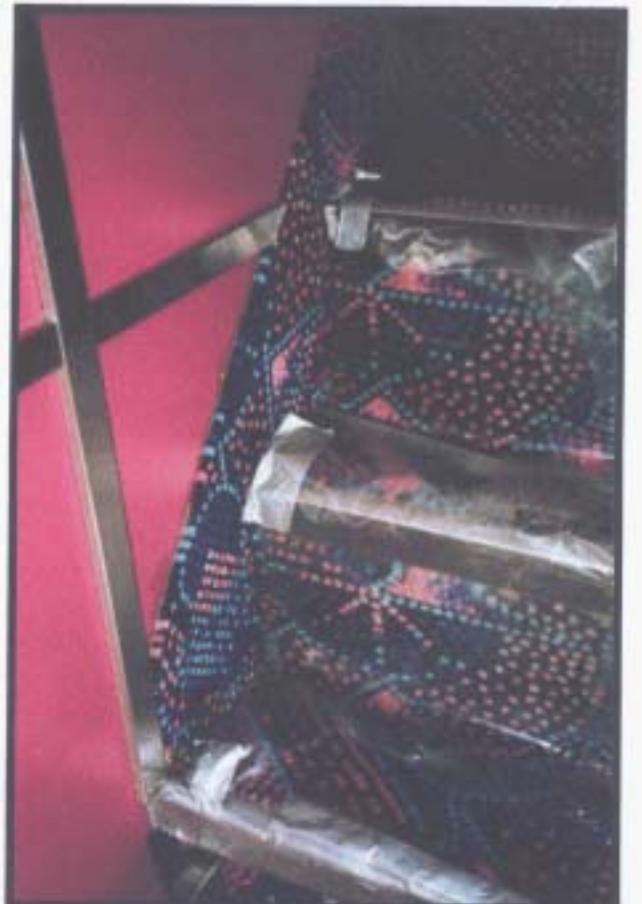
FIGURE 7

result, the sheeting had become ragged in some places. One of these areas was near the top of the disco club stairs; where the plastic was torn in places and some of the “Duck Tape” strips, used to hold down the sheeting at the edges, had become unstuck (**Figure 7**).

Protective plastic sheeting at the top of the disco club stairs

- 2.6 It is common practice to use plastic sheeting to protect carpets on board while ships are under maintenance or in refit, because contractors, shipyard staff, and others are normally wearing soiled footwear. Plastic sheeting does not present an undue hazard, provided it is maintained in good condition and held down effectively, and also provided those on board take extra care and wear safe footwear. The plastic sheeting on the stairway to the disco club, although showing signs of wear and tear, would not have been unduly hazardous to an alert and properly attired person.

As a precaution, the master, in agreement with the owner, had the plastic sheeting removed from the stairways on *Edinburgh Castle* on the day after the accident.

- 2.7 It was unnecessary to use plastic sheeting in that area since the stairs led only to the disco club, and there was no sheeting there. The decision to remove the plastic sheeting from the stairs after the accident, was a wise precaution.
