Rail Accident Report

Fatal accident at Barratt's Lane No.2 footpath crossing, Attenborough, Nottingham, 26 October 2013

Report 18/2014
August 2014

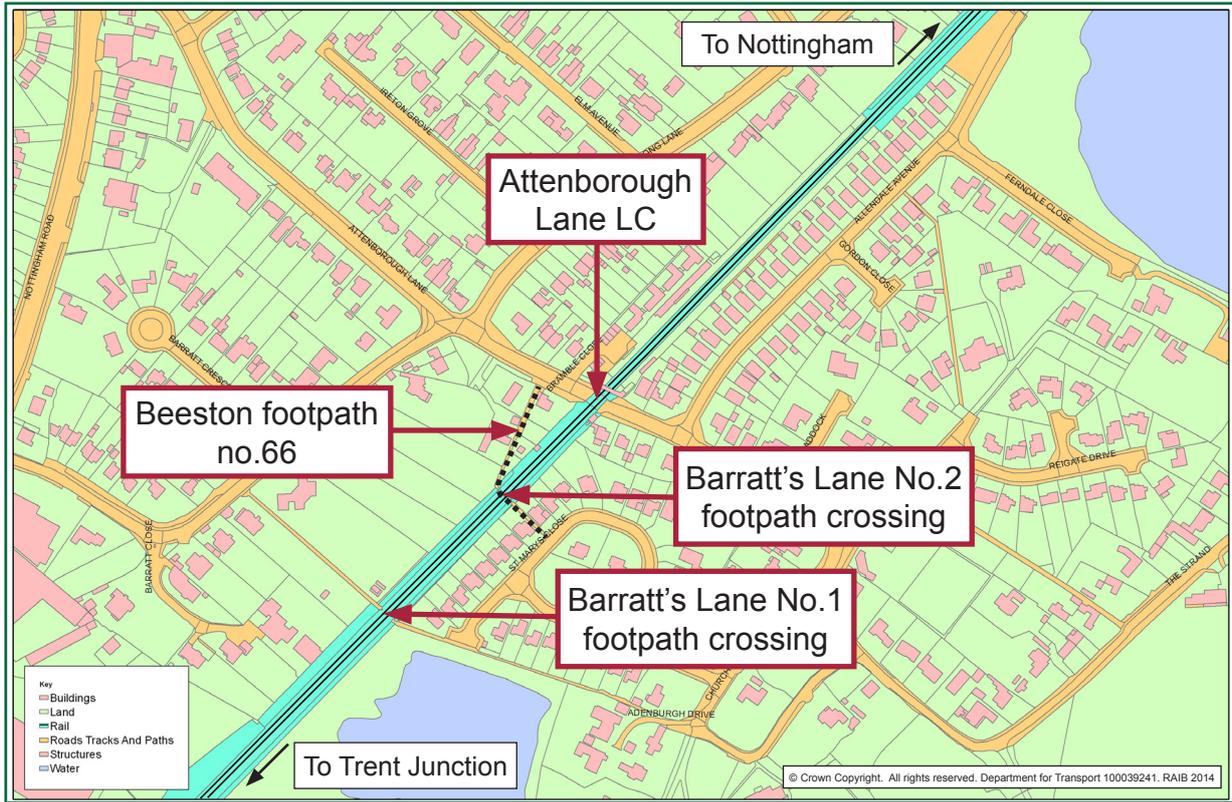
Figure 2: Plan showing route of Beeston footpath no.66 and Barratt's Lane No.2 footpath crossing

- 14 The line is signalled with *track circuit block* signalling controlled from the Trent workstation at the EMCC.
- 15 The footpath over Barratt's Lane No.2 footpath crossing ran from St. Mary's Close on the south side of the line to Attenborough Lane (figure 2). It provided a shorter route from St. Mary's Close to Attenborough station and Attenborough Lane than the route along the road using the road level crossing. At the time of the accident the crossing was provided with *kissing gates* on each side of the line and a timber deck across the tracks. The gates were sprung to meet and make the boundary fence in accordance with Network Rail standard NR/L2/SIG/30015². There were signs at the crossing instructing users to 'Stop Look Listen Beware of trains' (figure 3).

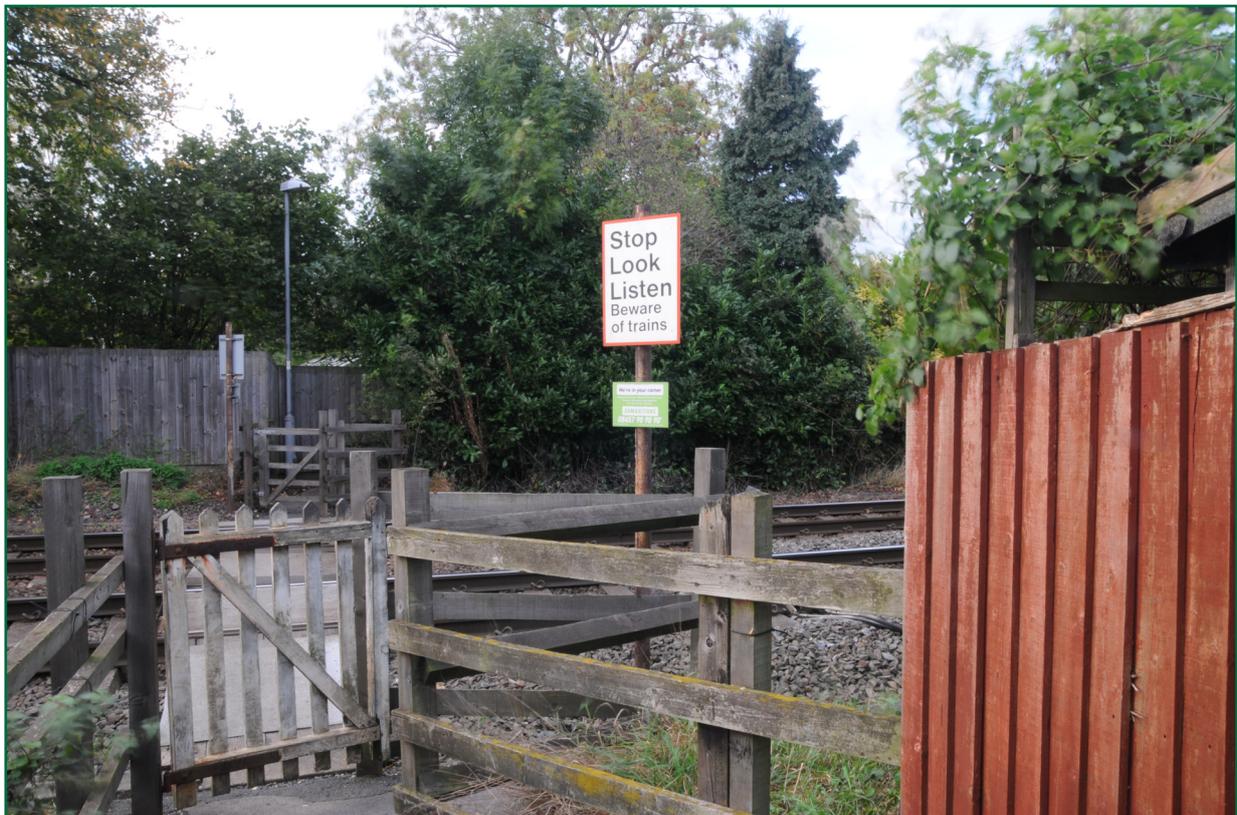
Figure 3: Barratt's Lane No.2 footpath crossing, viewed from the footpath on the south side

- 40 The safe use of footpath crossings relies on the crossing user looking both ways to see that no trains are approaching. The signs at the crossing remind the user to stop, look, listen and beware of trains. These signs were clearly visible to pedestrians using the footpath crossing (figure 3).

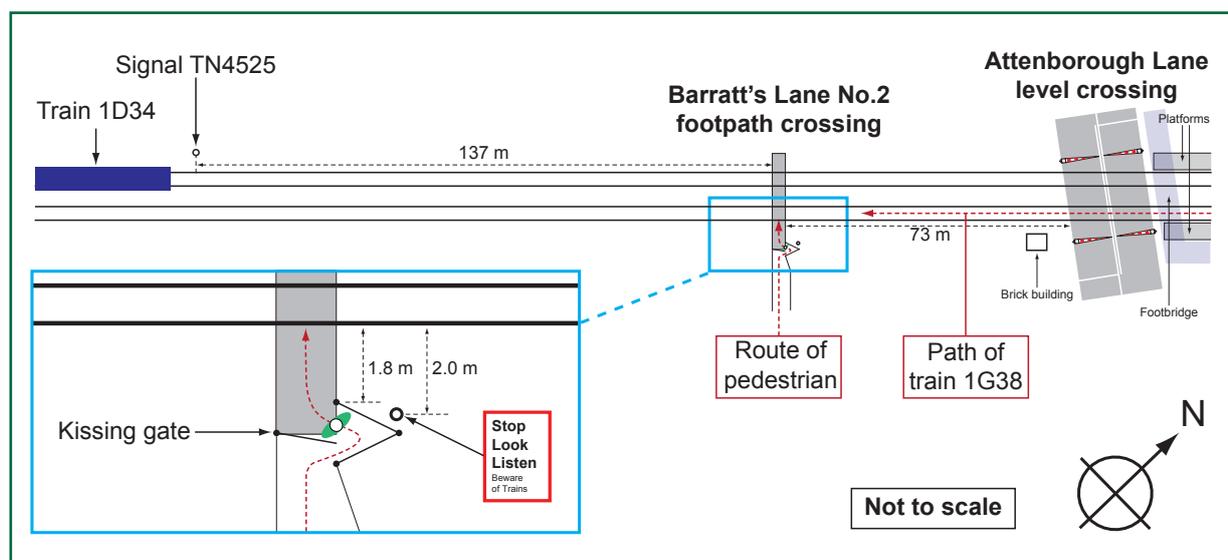
Figure 4: Plan of area showing direction of approach of train 1D34 and route of pedestrian at Barratt's Lane No.2 footpath crossing

- 22 Forward facing CCTV (FFCCTV) on train 1D34 showed that the pedestrian approached the footpath crossing from the south side as train 1D34 was slowing to a stand at signal TN4525. She waited behind the gate for approximately 17 seconds before opening it. Train 1D34 was approaching from her left on the line furthest from the gate where she was standing (figure 4).

- 30 The RAIB carried out a survey of the area around the footpath crossing and the track approaching it (figure 4). The survey showed that train 1G38 would have been visible to an observer standing at the kissing gate, the closest part of which was 1.8 metres from the nearest rail, when it was approximately 500 metres from the crossing, 17 seconds before it reached it. Figure 5 shows the view towards Nottingham from the kissing gate on the south side of the footpath crossing. At a point 2 metres back from the nearest rail, the survey showed that a train approaching from the Nottingham direction would have been visible approximately 450 metres from the crossing. This distance is greater than the minimum required by Railway Safety Publication 7.

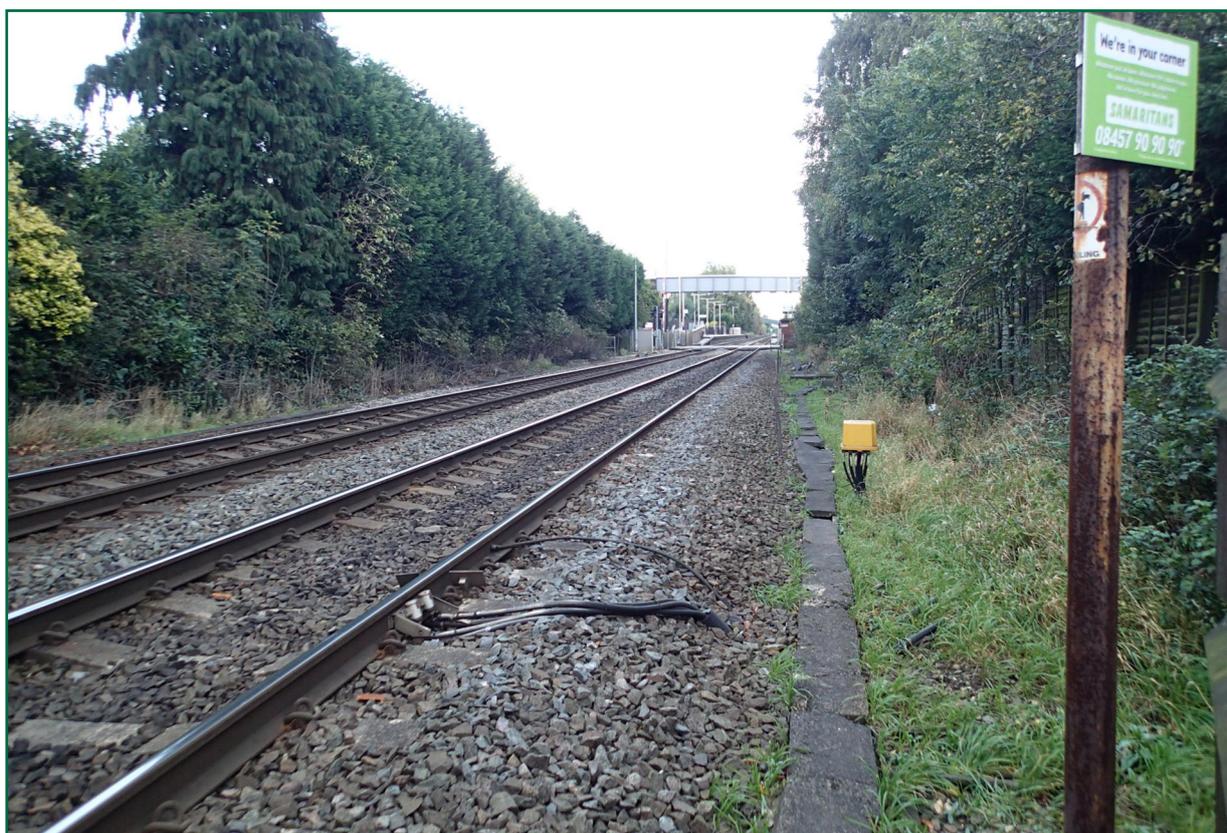
Figure 5: View towards Nottingham from the kissing gate on the south side of the footpath crossing

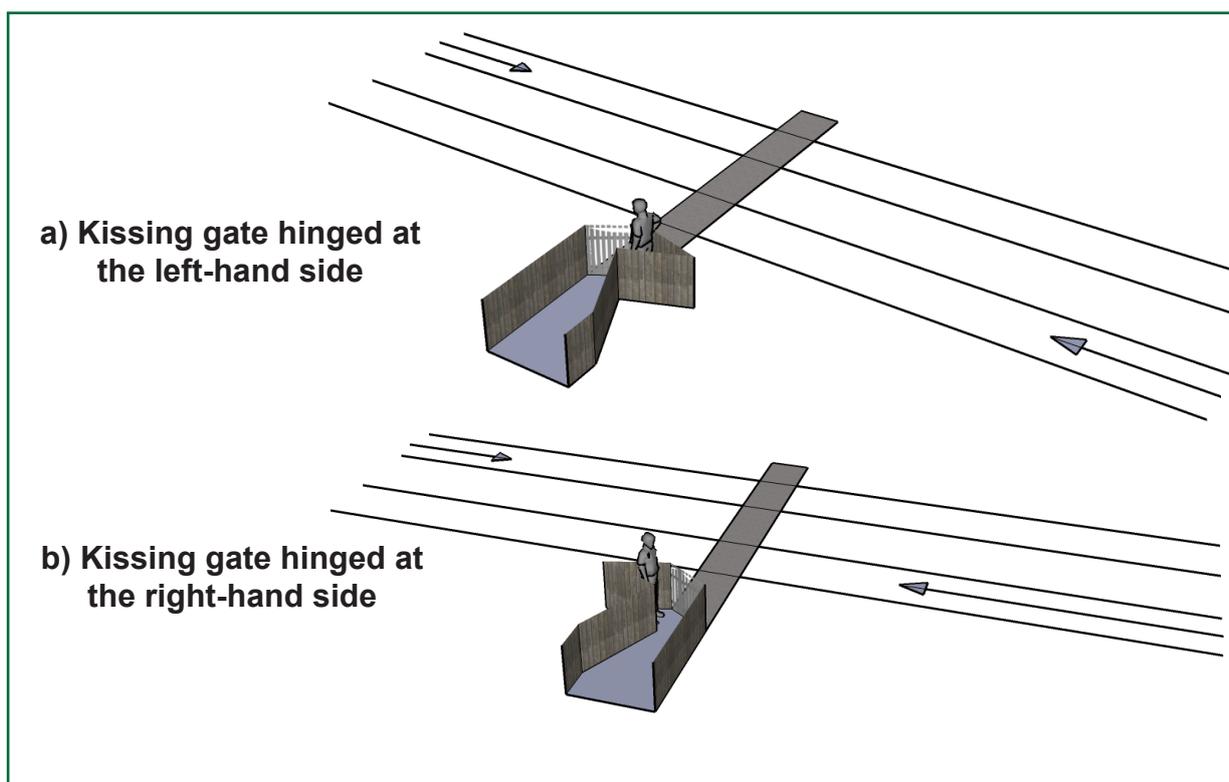
Figure 6: Effect of kissing gate orientation on pedestrian's direction of view

- 31 The kissing gate at the crossing was hinged at the left-hand side, as viewed by a pedestrian approaching along the footpath. This would cause the pedestrian to first face towards a train approaching from the right, from where trains will generally approach on the nearest track (figure 6a), and then towards a train approaching from the left. Train 1G38 was too far away to be visible from the gate when the pedestrian was facing in this direction. The orientation of the kissing gate may have made it more likely that the pedestrian focussed her attention on train 1D34, which was on her left prior to stepping onto the crossing.
- 32 The RAIB observes that kissing gates hinged on the right (figure 6b), would normally cause pedestrians to face towards oncoming traffic on the line nearest them as they exit from the gates.

For double track lines, kissing gates arranged with the hinge on the right-hand side encourage footpath users to face towards the oncoming traffic on the nearest line as they exit from the gate (paragraph 32). This is particularly relevant where the gate is close to the track. RSSB is shortly to provide advice on how the arrangement of gates and barriers at a crossing influences the behaviour of pedestrians (project T984), and will include this in a future update of the level crossing risk management toolkit (paragraph 60).

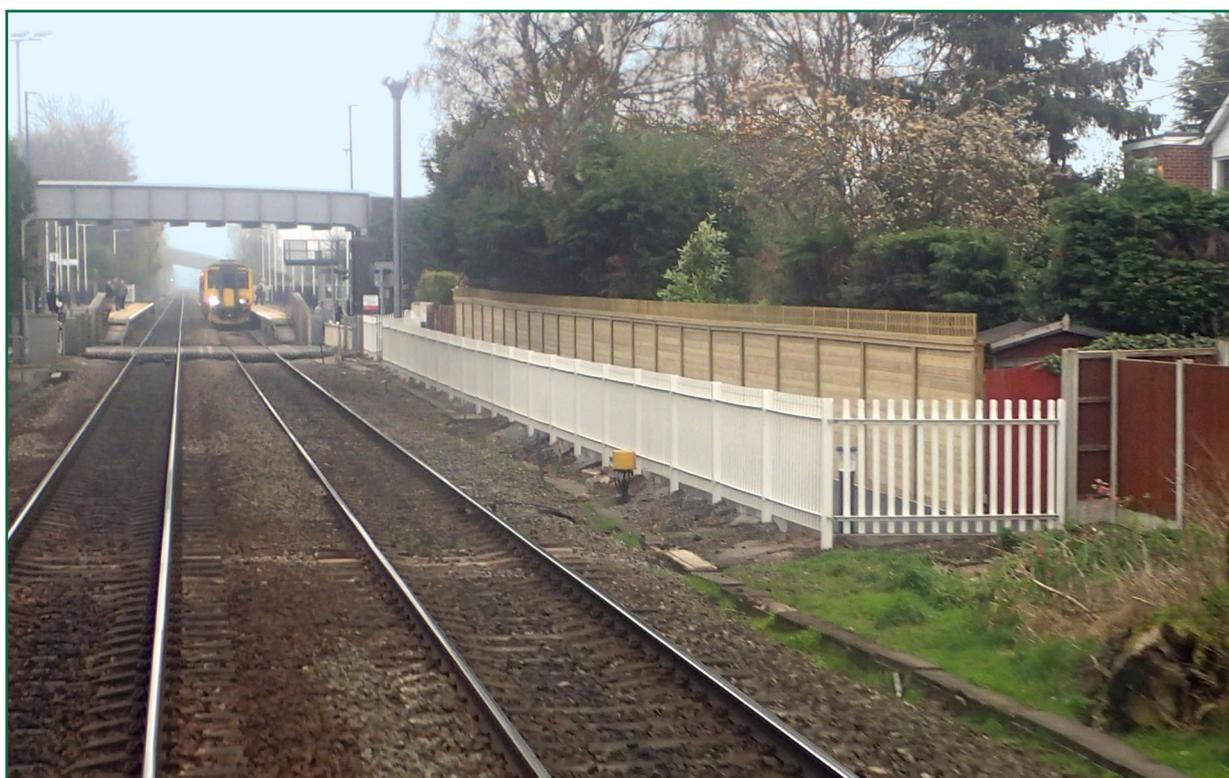
Figure 7: Diverted route via Attenborough Lane level crossing

- 58 The ORR wrote to Network Rail to recommend that it apply to the highway authority for an immediate closure of the crossing. Nottinghamshire County Council granted a temporary closure order on 1 November 2013.
- 59 Network Rail applied to Nottinghamshire County Council for a formal diversion order for Beeston footpath 66 on 22 November 2013. An order was made on 17 January 2014 and confirmed on 28 March 2014. This diversion was on the originally proposed route via Attenborough Lane level crossing. Construction of the diversion was completed in March 2014 (figure 7).
