# Rail Accident Report

**Fatal accident at Motts Lane level crossing,  
Witham, Essex  
24 January 2013**

Report 01/2014  
January 2014

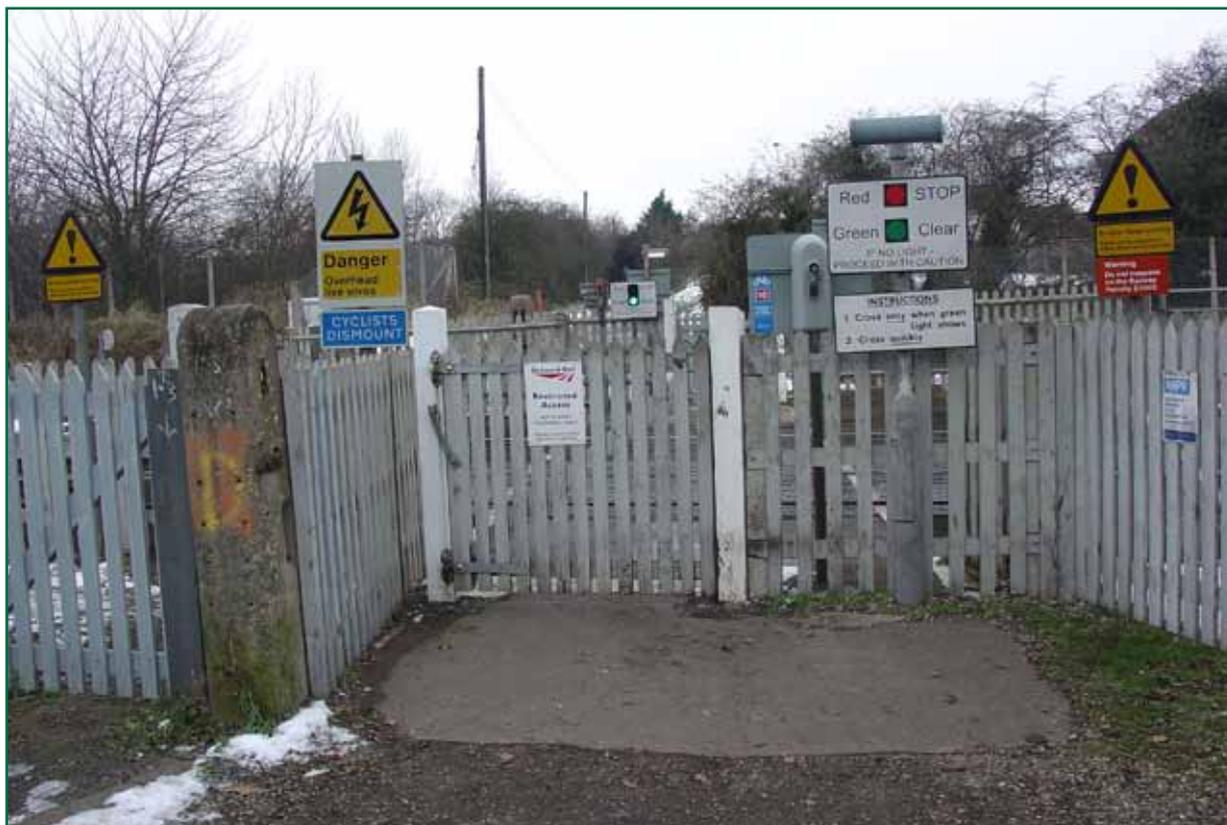
Figure 4: Motts Lane crossing from the south-east, showing instruction signs

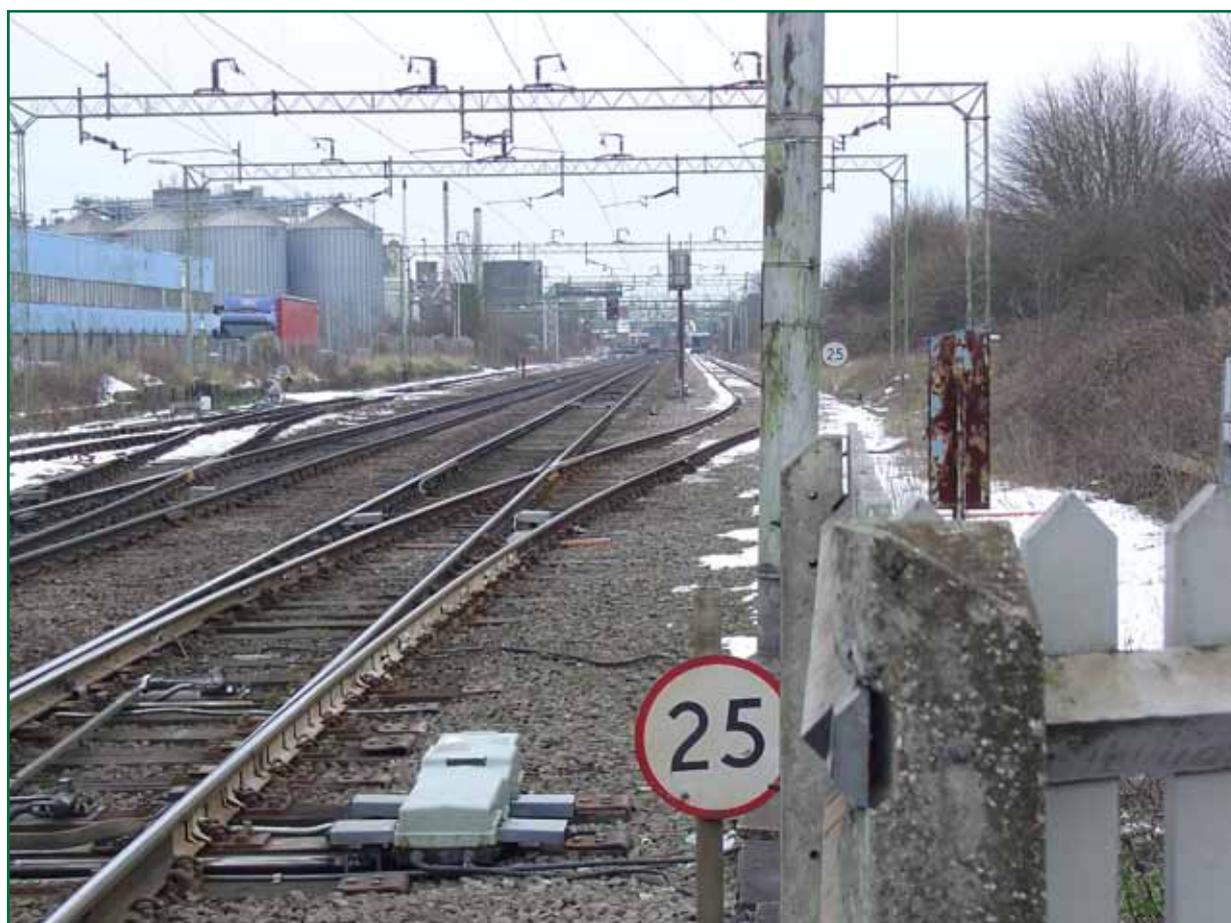
Figure 5: View from north-west (down) side of Motts Lane crossing, looking towards Witham station

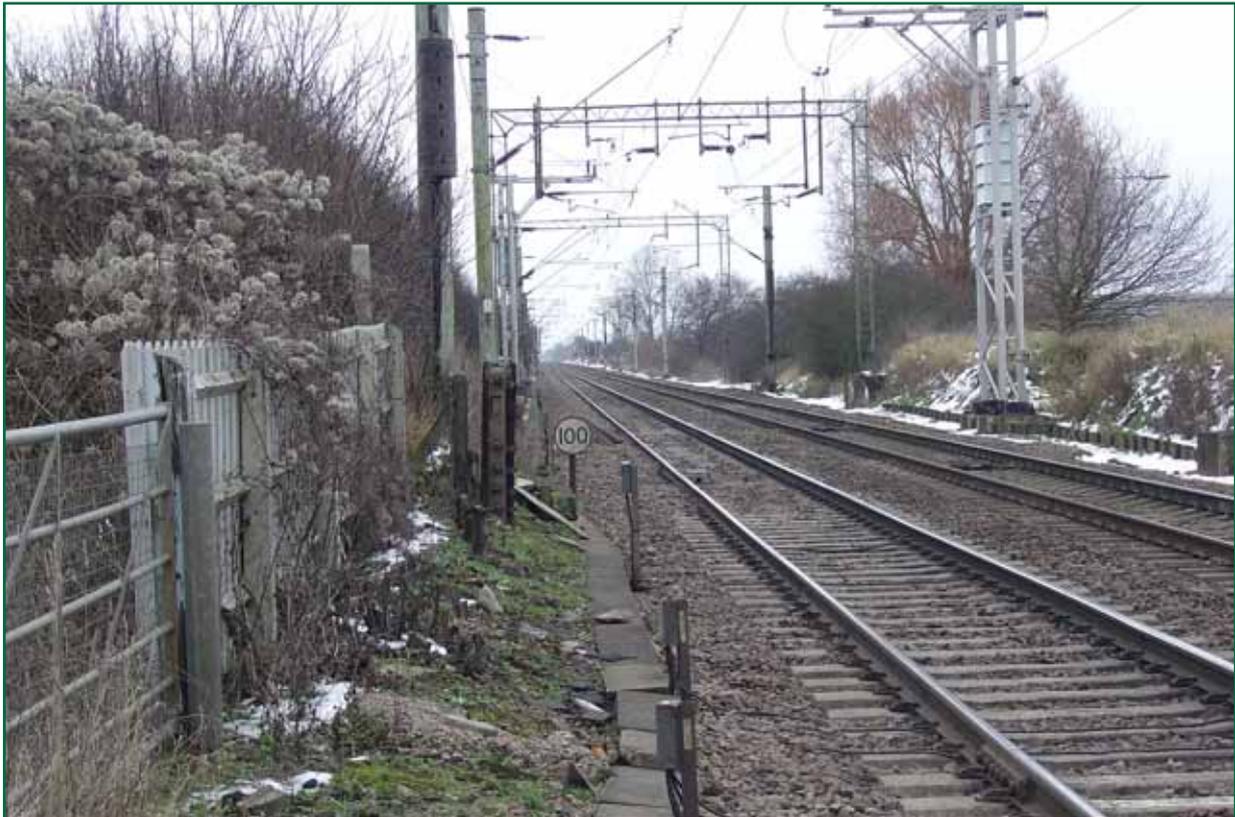
Figure 6: View from north-west (down) side of Motts Lane crossing, looking towards Kelvedon station

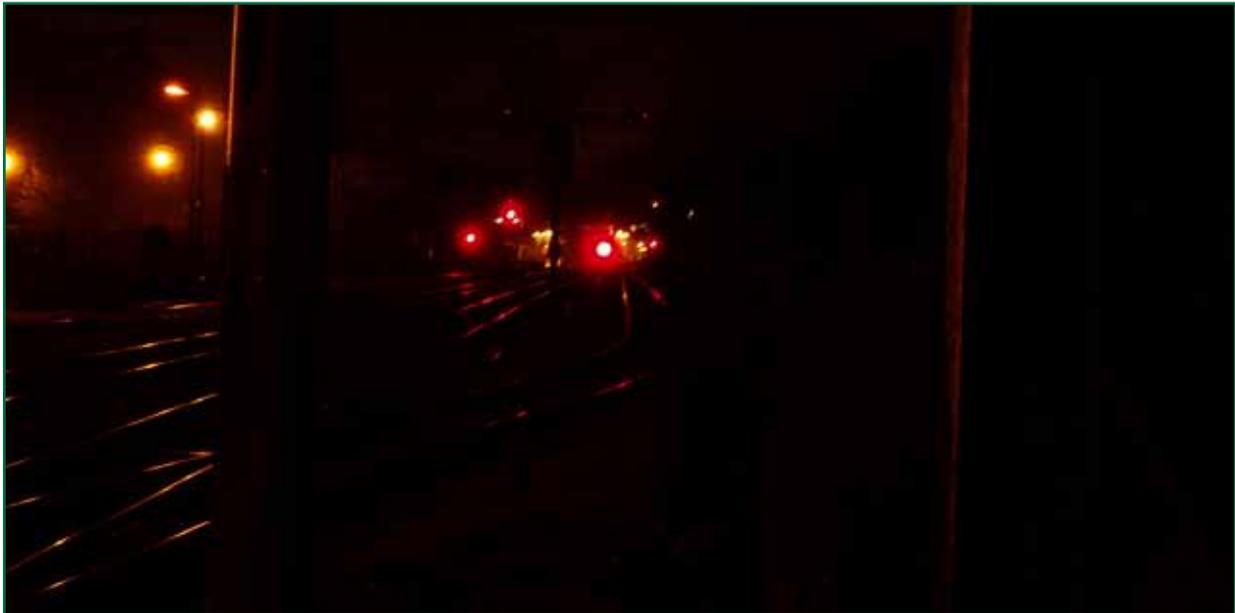
Figure 9: View from the north-west (down) side of Motts Lane crossing towards Witham station, after dark

- 88 The RAIB observed trains approaching Motts Lane crossing after dark, from a position immediately outside the gate on the down side. It was difficult to pick out the headlights of a train from among the station lights until the train had passed through the station. It was also difficult to clearly identify that a train was moving towards the observer until it was less than five seconds running time from the crossing. Research into the human factors associated with this issue has been published and is referred to in a previous RAIB investigation into a fatal accident at a footpath crossing<sup>16</sup>.
