## URGENT FIELD SAFETY NOTICE ALL HOSPIRA PLUM™ A+ FAMILY OF INFUSERS Door Roller

**Product name:** Plum A+ Family of Infusers

**Q.FA.EMEA.2012.015**

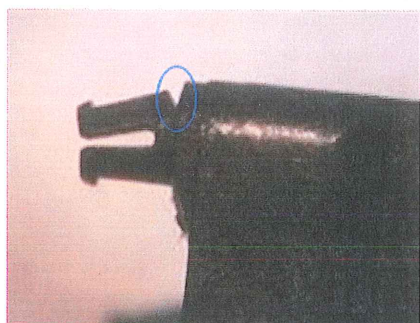
**Half of the pin damaged**

If the door roller or axel appears loose, broken, or missing, then the device needs to be taken out of service until the door assembly is replaced with a corrected door assembly.

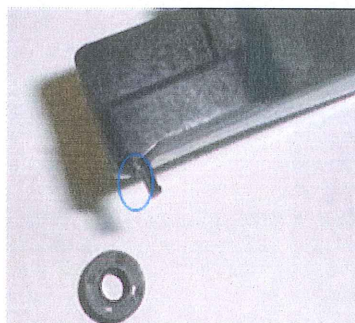
**Half of the pin broke off**
