ACCIDENT

Aircraft Type and Registration:	i) Denney Kitfox, G-TOMZ ii) Cessna F177RG, G-AZTW
No & Type of Engines:	i) 1 x Rotax 912 UL ii) 1 x Lycoming IO-360-A1B6
Year of Manufacture:	i) 2001 ii) 1972
Date & Time (UTC):	23 September 2014 at 0728 hrs
Location:	Near St Neots, Bedfordshire
Type of Flight:	i) Private ii) Private
Persons on Board:	i) Crew - 1 Passengers - None ii) Crew - 1 Passengers - None
Injuries:	i) Crew -1 (Fatal) Passengers - N/A ii) Crew - None Passengers - N/A
Nature of Damage:	i) Aircraft destroyed ii) Damage to engine, propeller, fuselage underside and horizontal tailplane
Commander's Licence:	i) Private Pilots Licence (Medical declaration) ii) Private Pilots Licence (JAA Class 2 medical certificate)
Commander's Age:	i) 46 years ii) 56 years
Commander's Flying Experience:	i) 990 hours (of which approximately 200 were on type) Last 90 days - 36 hours Last 28 days - 4 hours ii) 1038 hours (of which 604 were on type) Last 90 days - 11 hours Last 28 days - 7 hours

Synopsis

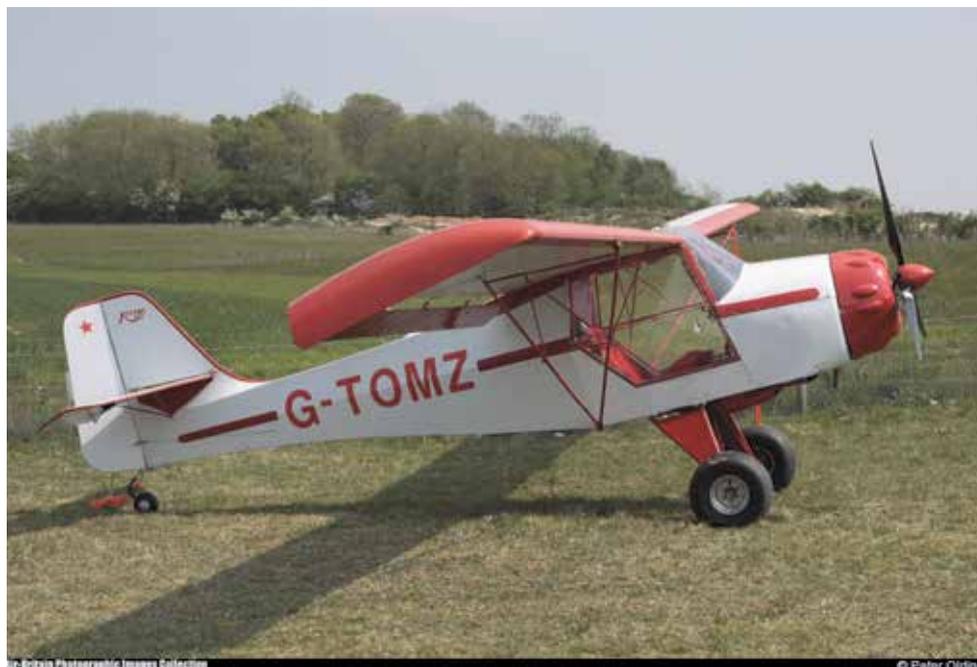
Figure 1

The Denney Kitfox is a two-seat high-wing monoplane with tail wheel landing gear. The aircraft is of tubular alloy, plywood and fabric construction, with a wing span of 9.75 m. G-TOMZ was built in 2001 and was fitted with a Rotax 912 UL engine. The aircraft had a valid Permit to Fly. It was coloured predominantly white with red wings and markings, as shown in Figure 1.

Image of Denney Kitfox G-TOMZ (with kind permission of Peter Olding)

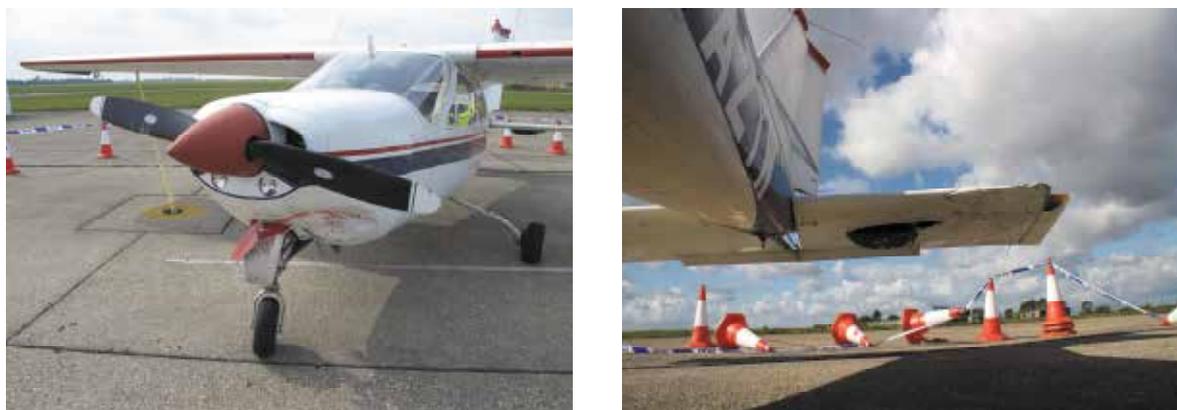
Figure 2

G-AZTW landed successfully at Bedford Aerodrome. There was a 12 cm wide scuff mark on one blade of the propeller, and a 50 cm long dent with red witness marks in the left lower part of the cowling, see Figure 2. Several small pieces of aircraft structure from G-TOMZ were removed from the nose gear door of G-AZTW. There were some scuff marks along the fuselage underside. The landing gear was down, with no evidence of any witness marks that might have occurred had the gear been down during the collision. There was extensive damage to approximately 75% of the underside of the left horizontal tailplane, and a piece of the horizontal tailplane tip fairing was found approximately 500 m from the main wreckage of G-TOMZ.

Images of G-AZTW at Bedford Aerodrome

By comparing the damage and the witness marks on both aircraft it appears that the initial impact was between the rotating propeller of G-AZTW and the right wing tip of G-TOMZ. The damage to the lower left of the engine cowling on G-AZTW suggests that the propeller was around the five o'clock position when this occurred. Thus G-AZTW was slightly higher than G-TOMZ at the time of the collision resulting in the damage to the lower fuselage and horizontal tailplane of G-AZTW.

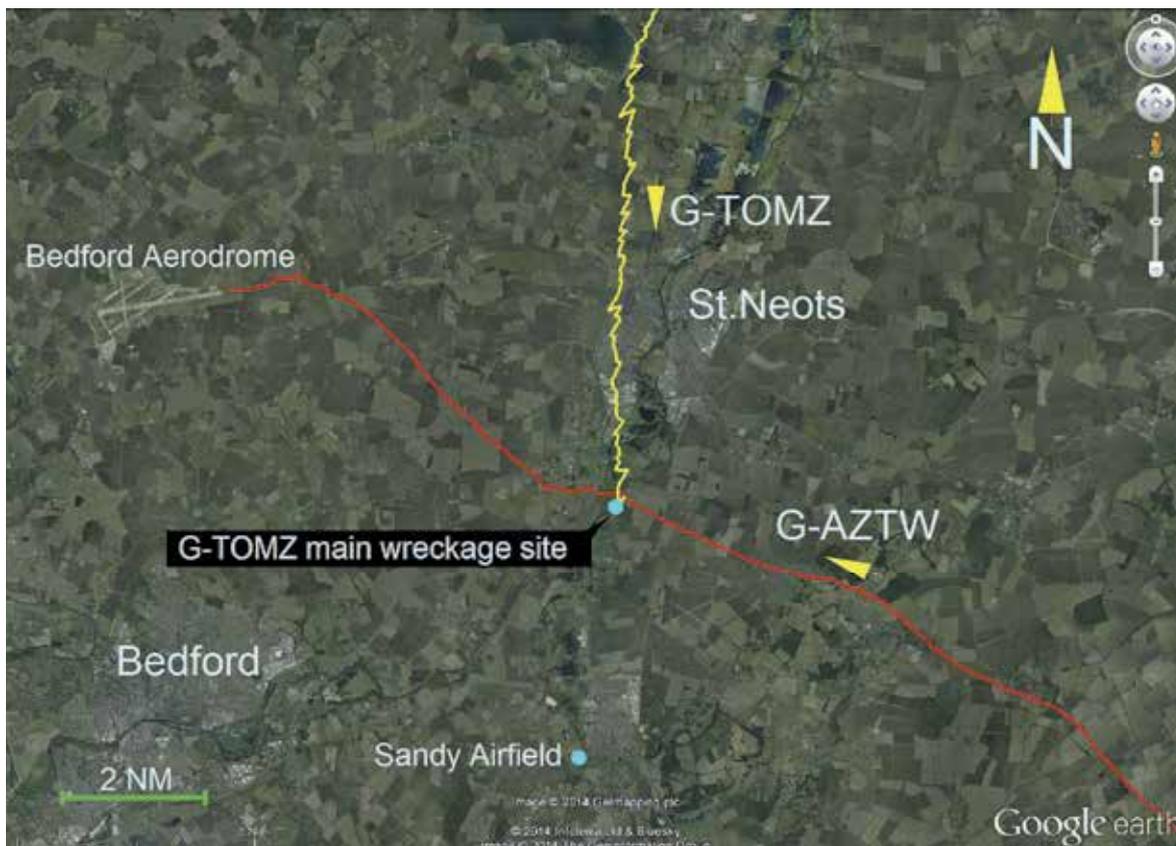
Recorded radar information was available for both aircraft, with primary and secondary (Mode A and C) recorded for G-AZTW and primary for G-TOMZ. Figure 3 provides the radar tracks of the aircraft. Figure 4 plots the positions of both aircraft commencing at a separation of just over 1 nm, with the relative positions identified at four second intervals and angular sizes of 0.2° and 0.5° when viewed from either aircraft. For clarity, the tracks have been illustrated in Figure 4 rather than the actual radar tracks.

Figure 3
Radar tracks of G-TOMZ and G-AZTW

Prior to the collision, G-TOMZ had been maintaining a southerly track of about 180° T at a groundspeed of 64 kt and G-AZTW a track of about 298° T at an altitude of approximately 2,400 ft amsl and at a groundspeed of 118 kt. As the two aircraft approached, they remained on a constant bearing with each other at a closing speed of approximately 157 kt. Assuming a wind from 260° at 10 kt, G-TOMZ would have appeared about 24° to the right of G-AZTW, and G-AZTW would have appeared 50° to the left of G-TOMZ.

Impact is estimated to have occurred at 0728:29 hrs. The main wreckage of G-TOMZ was located approximately 0.15 nm from where the two radar tracks intersected.

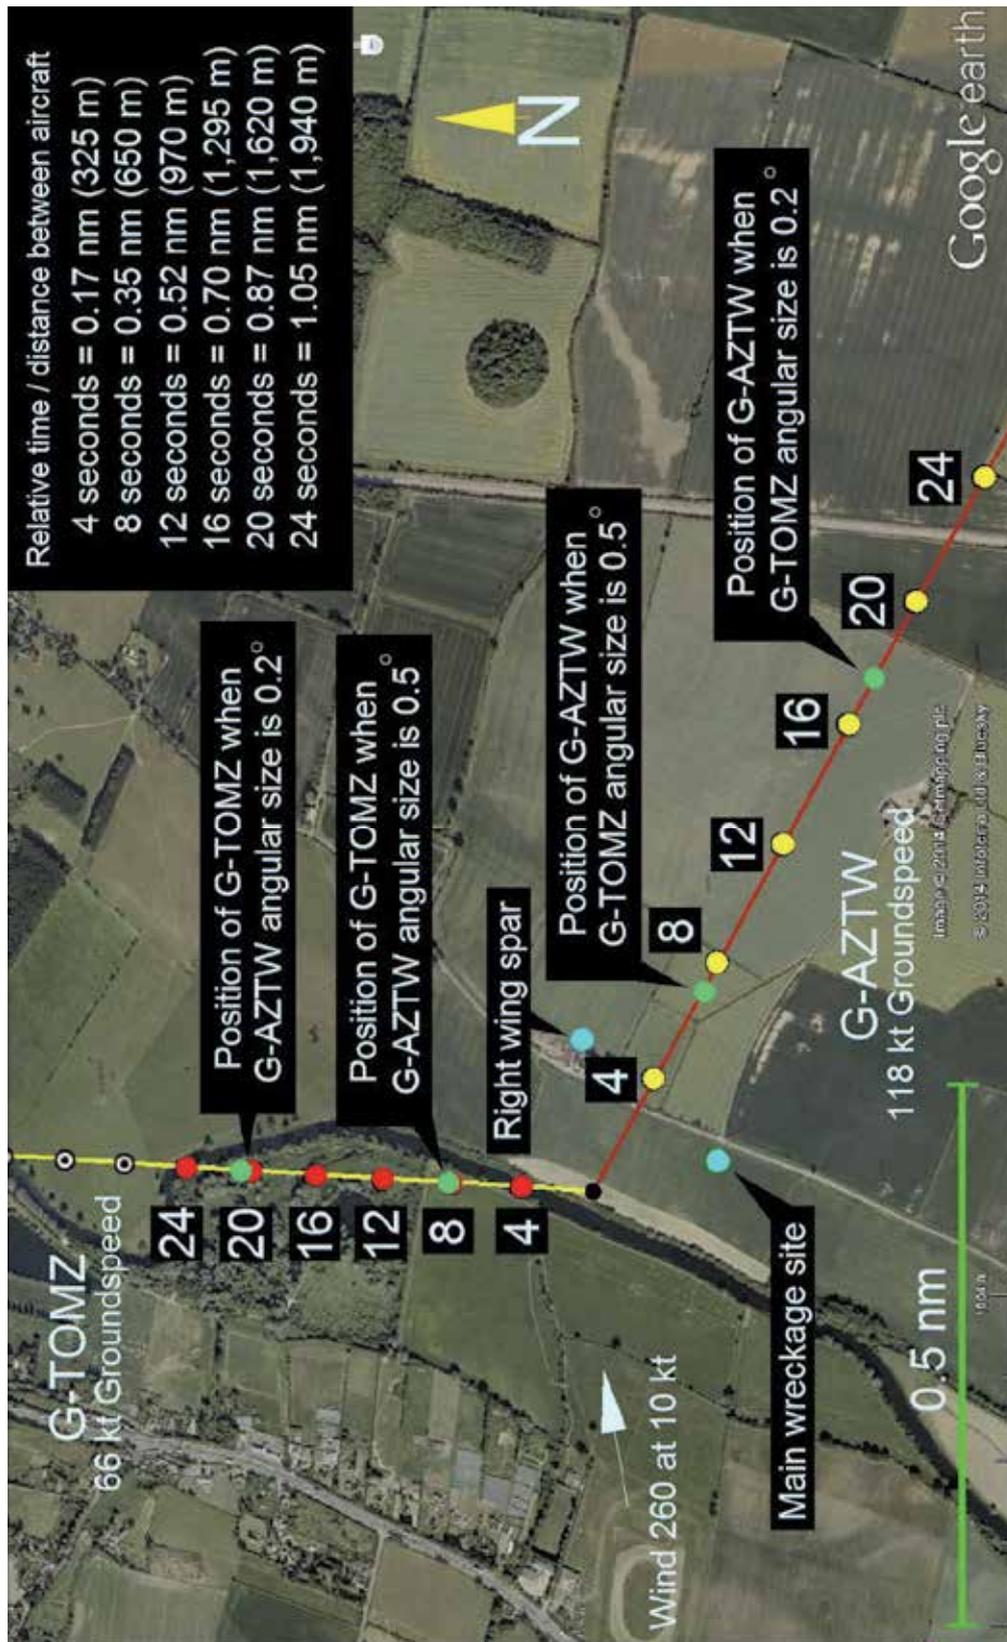
Figure 4

Relative positions of G-TOMZ and G-AZTW prior to collision

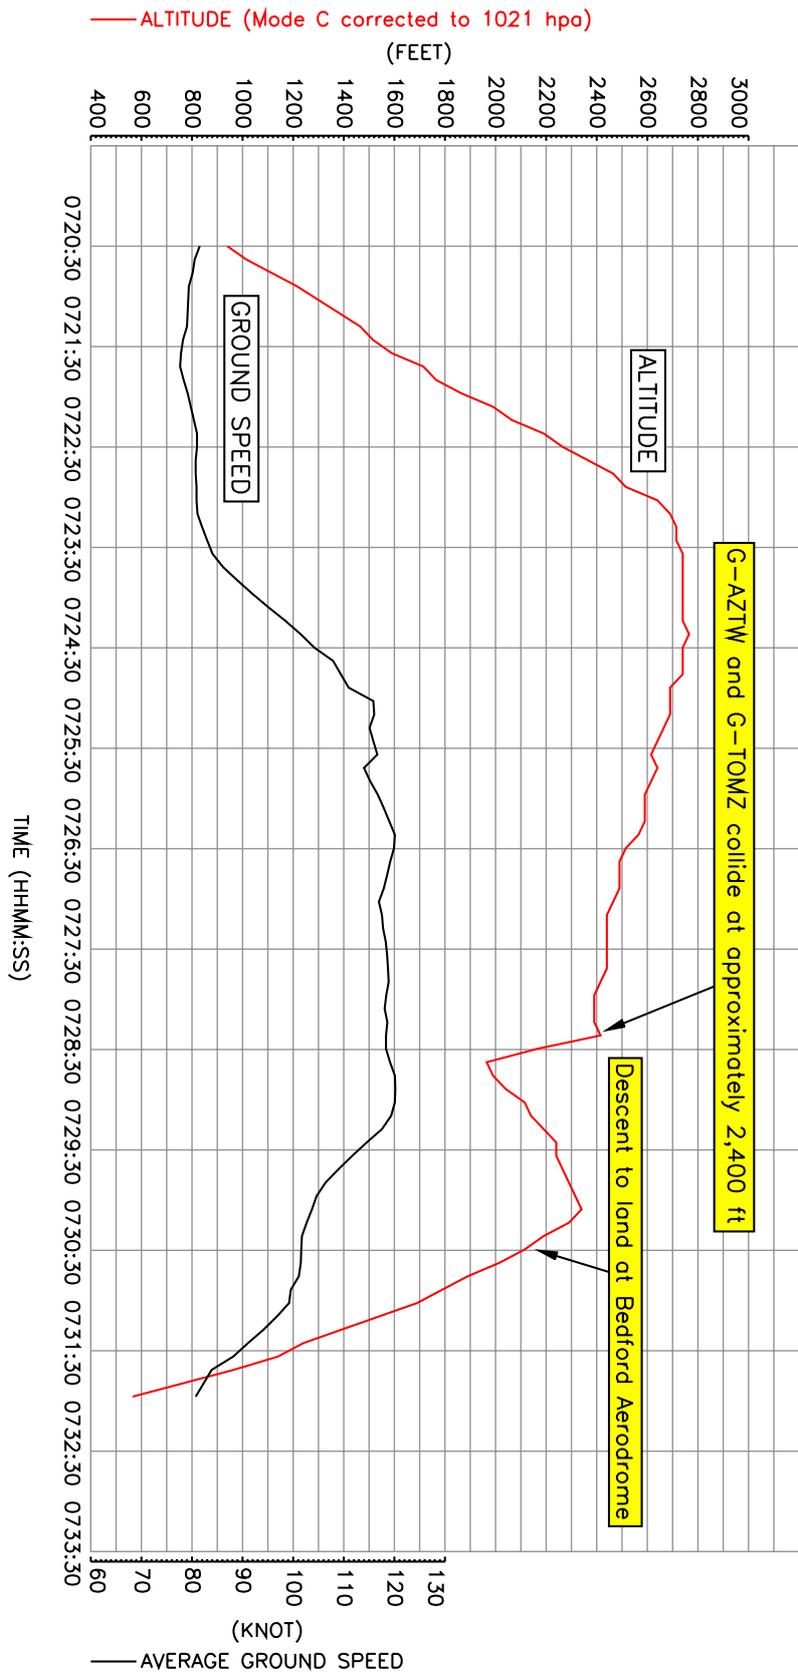
Immediately following the collision, G-AZTW descended rapidly for about 16 seconds at an average rate of 1,700 fpm before recovering at about 1,950 ft (see Figure 5). It then climbed to about 2,350 ft before descending to land on Runway 26 at Bedford Aerodrome.

Figure 5
G-AZTW Altitude and groundspeed

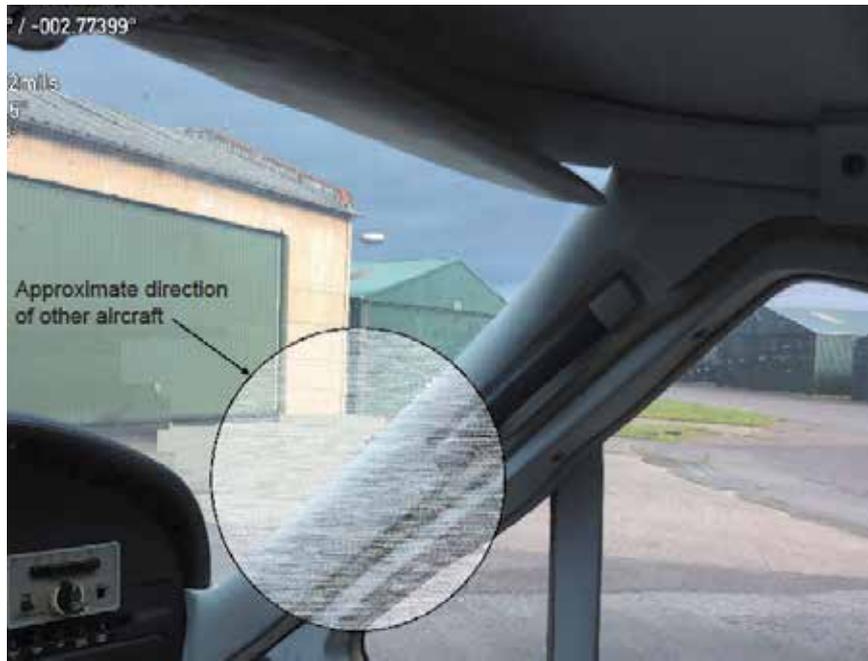
Figure 6

An assessment was made of the likely views that each pilot would have had when looking in the direction of the other aircraft. See Figures 6 and 7. It was determined that G-AZTW had a large door frame to the right side of the cockpit; G-TOMZ had a wingstrut outside the left window.

Pilot's eye view from a F177RG in the direction of G-TOMZ

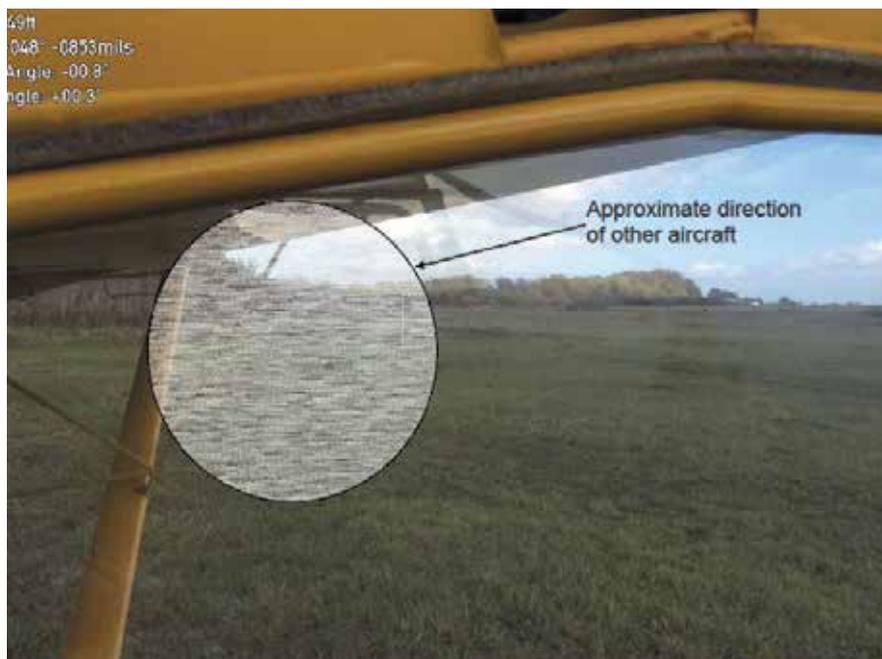
Figure 7

Pilot's eye view from a Denney Kitfox in the direction of G-AZTW
