**SERIOUS INCIDENT**

<b>Aircraft Type and Registration:</b>	(1) Robin DR 400-180, F-GSBM (2) SAS Wildthing radio-controlled model glider
<b>No &amp; Type of Engines:</b>	(1) 1 Lycoming O-360-A3A piston engine (2) Unpowered
<b>Year of Manufacture:</b>	(1) 1997 (2) Unknown
<b>Date &amp; Time (UTC):</b>	30 April 2015 at 0953 hrs
<b>Location:</b>	Near Shoreham Airport, West Sussex
<b>Type of Flight:</b>	(1) Private (2) Private
<b>Persons on Board:</b>	(1) Crew - 1                      Passengers - 2 (2) Crew - N/A                  Passengers - N/A
<b>Injuries:</b>	(1) Crew - None                  Passengers - None (2) Crew - N/A                  Passengers - N/A
<b>Nature of Damage:</b>	(1) Right wing leading edge scrape damage (2) Minor damage to aileron and rudder
<b>Commander's Licence:</b>	(1) Private Pilot's Licence (2) N/A
<b>Commander's Age:</b>	(1) 32 years (2) Unknown
<b>Commander's Flying Experience:</b>	(1) 1,083 hours (of which 861 were on type) Last 90 days - 33 hours Last 28 days - 15 hours  (2) N/A

**Synopsis**

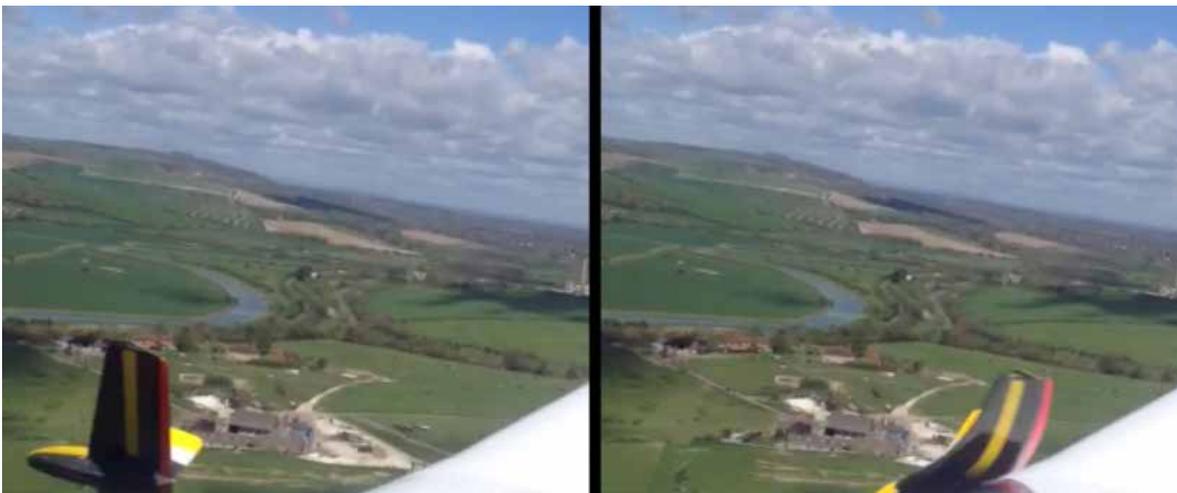
**Figure 1**

While on the base leg, at an estimated altitude of 600 to 800 ft amsl, the aircraft's right wing struck a model glider. The pilot initially thought he had been hit by a large bird, but the collision was caught on a passenger's video camera which revealed that it was a model glider (Figure 1). The aircraft continued to handle normally and the pilot turned final and landed uneventfully. He had not been aware that there was a model glider flying site on the base leg to Runway 20.

Moment before and at the time of the mid-air collision as captured from a video camera on F-GSBM

The pilot of F-GSBM estimated that he was at 600 to 800 ft amsl on left base when the collision occurred. The view of the surrounding terrain in Figure 1 indicates that he could have been as low as 400 to 500 ft amsl but probably not lower; this would have placed him about 220 to 320 ft agl at the point of collision. Although this might seem low, being at 400 to 500 ft aal (given that the runway was at sea-level) at 1 nm from the runway threshold is within the normal range. The PAPI<sup>8</sup> angle for Runway 20 is 4.5° which means that an aircraft would be on the correct flight path at 500 ft aal at 1 nm from the threshold.

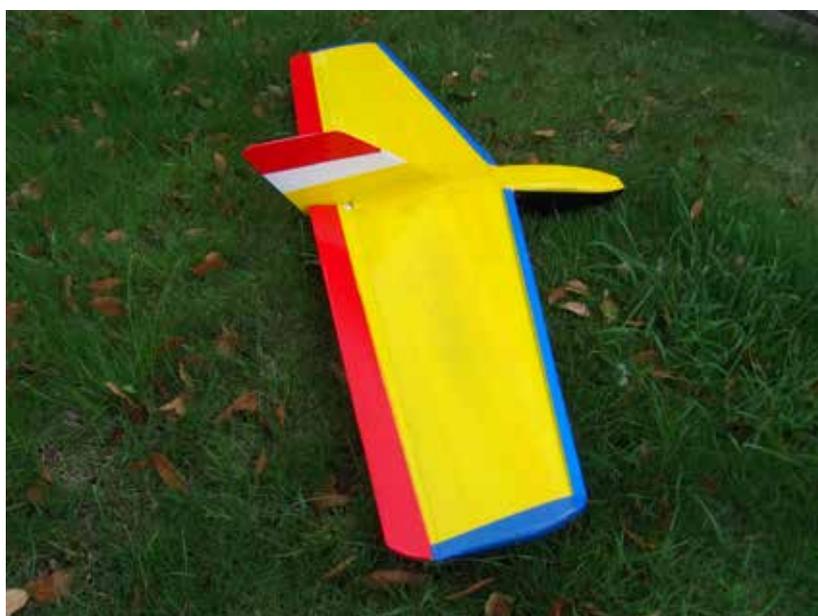
**Figure 2**

The SAS Wildthing is a radio-controlled model glider constructed of expanded polypropylene (EPP) which is an engineered plastic foam material (Figure 2). It weighs 0.615 kg and has a wingspan of 1.17 m.

SAS Wildthing model glider

The model glider suffered minor damage to the right elevon and the rudder involving a £3 repair.

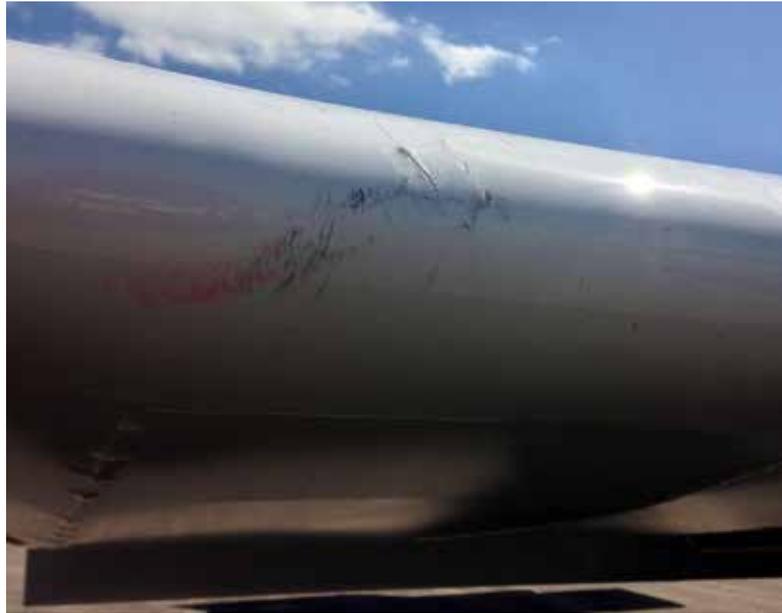
**Figure 3**

The right wing leading edge of F-GSBM suffered scuffing and scraping damage which cost £1,400 to repair (Figure 3).

Damage to right wing leading edge of F-GSBM

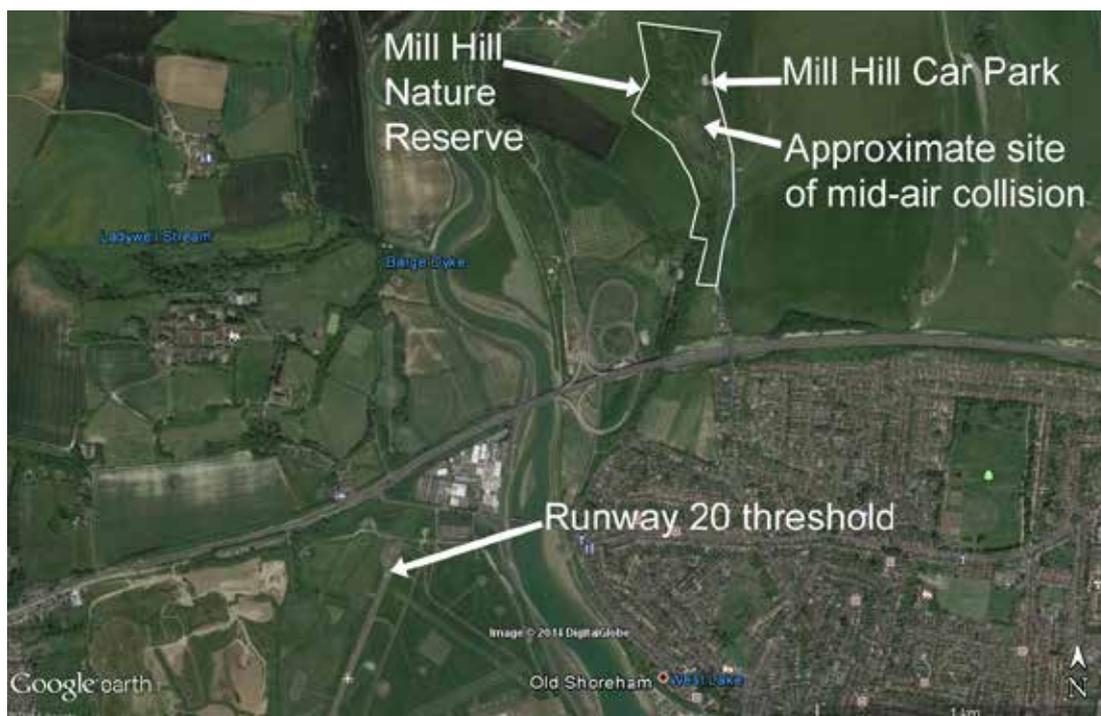
**Figure 4**

The model glider was being flown from the Mill Hill nature reserve (Figure 4). This is an area that is popular with model glider pilots and has been used for model glider flying since the 1970s. The pilot of the SAS Wildthing was standing on the south side of the hill, about 150 m south of the Mill Hill car park, within a few metres of his estimated location of the

mid-air collision, as depicted in Figure 4. The approximate elevation of the area where he was standing was 180 ft amsl. The Mill Hill car park is at 260 ft amsl, and the highest point in the nature reserve, north of the car park, is at 295 ft amsl.

The Mill Hill car park is located 1.05 nm north-east of the Runway 20 threshold at Shoreham Airport, on a bearing of 033°. The approximate location of the mid-air collision was 0.98 nm north-east of the Runway 20 threshold on a bearing of 035°.

Location of Mill Hill nature reserve, Shoreham's Runway 20 and the approximate location of the mid-air collision  
(image copyright GoogleEarth)

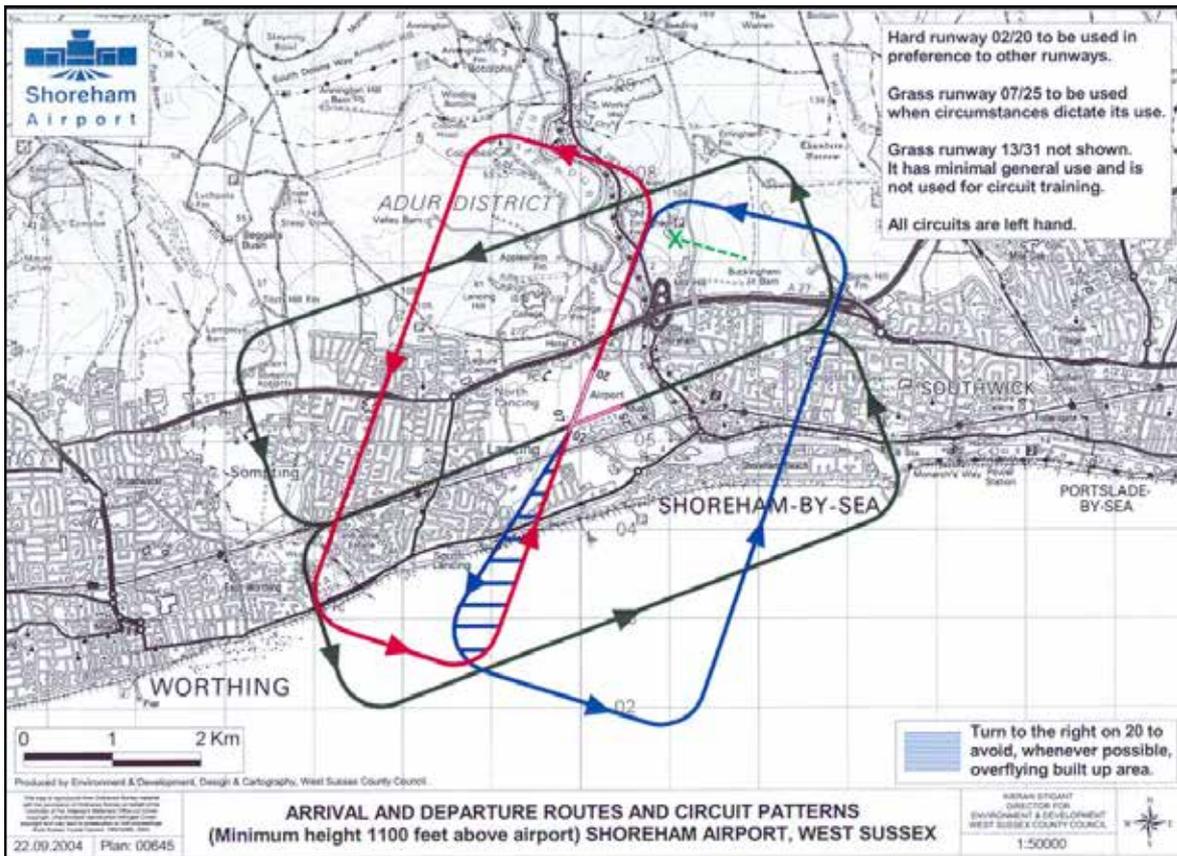
**Figure 5**

The Shoreham Airport (also known as Brighton City Airport) website, flybrighton.com, contained a 'General Information' section for pilots. This section did not refer to the model aircraft site and it contained a circuit diagram (Figure 5) which did not highlight the location of the model aircraft site. The estimated track of F-GSBM has been added, as a dashed green line, in Figure 5 and the location of the mid-air collision has been added as a green 'X'.

Circuit diagram from Shoreham Airport website with location of mid-air collision marked with a green 'X' and F-GSBM's estimated track marked with a dashed green line

The model aircraft pilot reported that most light aircraft turned behind the hill, more closely following the blue line on the circuit diagram (Figure 5) which passes outside the nature reserve, so separation was not an issue. It is probable that many locally-based pilots follow a circuit pattern closely matching the blue line, but there is no requirement to follow the blue line. The circuit diagram is not part of the AIP and therefore it only serves as guidance to pilots. There is no requirement to check an airfield's website so some visiting pilots will not be aware of the circuit diagram. Many visiting pilots will fly a circuit that is of similar size to the one at their home airport, and the circuit flown by the pilot of F-GSBM was well within what would be considered normal.

would be made clearer by adding bearing information, which the airport operator is considering. Pilots would also be helped if the circuit diagram on the website were amended to highlight the Mill Hill model glider site; the airport operator will consider this and has said it will contact Pooley's to suggest they add information on the model glider site.

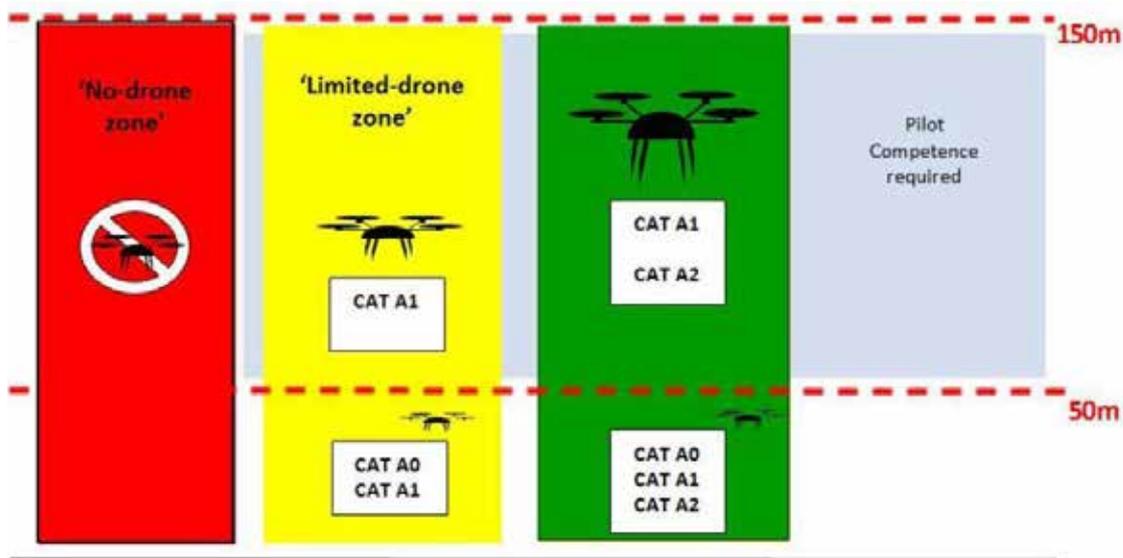
**Figure 6**

- CAT A0: 'Toys' and 'mini drones' < 1 kg
- CAT A1: 'Very small drones' < 4 kg
- CAT A2: 'Small drones' < 25 kg

It proposes restricting operation of Cat A0 drones to 50 m (164 ft) above the ground. Figure 6 summarises the proposed zones of operation for the three subcategories. These are only proposals and may change significantly after the consultation period.

EASA proposed zones of operation for the three subcategories of 'open' drones (A-NPA 2015-10)
