Wallem safety management system completed checklists

Analysis of *Hoegh Osaka* cargo securing web lashings

Tensile Tests & Failure Analysis of 2T Lashing Straps from the Hoegh Osaka

Extract from Report: Investigation into Cargo Securing Arrangements and Simulation of Incident

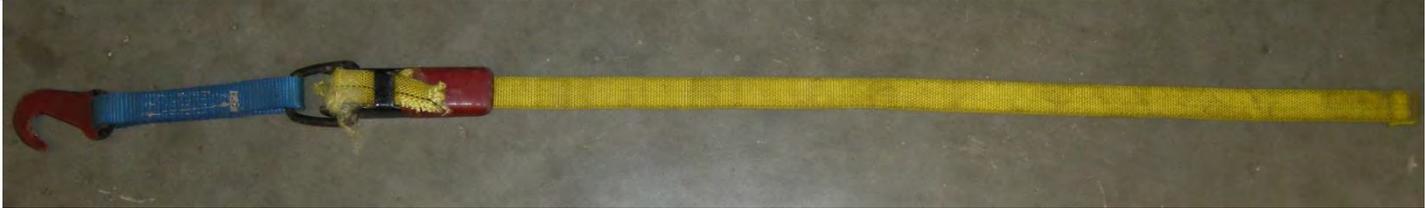
001/ET/OH

Rated Breaking Load:	2T	Condition as received:	Failed
Action:	Comment on mode of failure	ID Markings:	None

Comments:	Failed around tensioner, no evidence of cutting. Image below shows failed end after removal from the tensioner.

Mode of Failure:	Tensile Overload

The tensile test strop (002) and the service failure (001) both failed from tensile overload in a similar manner around the tensioner. It is of note that the tensile test strop failed at 1.65T which is lower than the 2T specified breaking load. Despite the relatively low breaking load this is still significantly above the anticipated SWL of 1T. It is of note that the strop is relatively old (nearly 15 years) and may have degraded over the years.

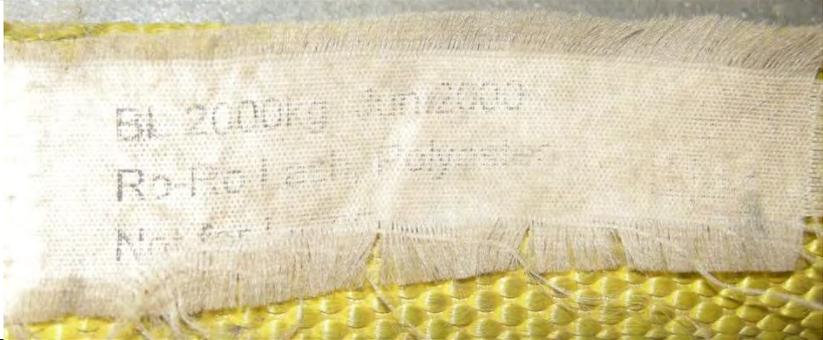
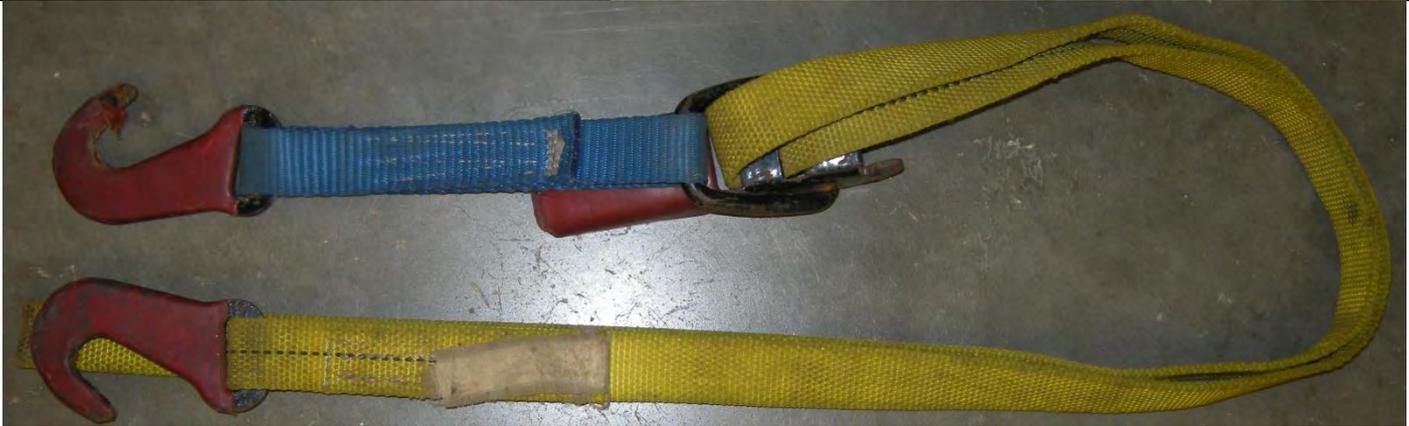
002/ET/OH

Rated Breaking Load:	2T	Condition as received:	Used/Intact
Action:	Tensile Test		
ID Markings:	<i>'BL 2000kg Jun2000 Ro-Ro Lash Polyester' Final line suspected to say 'not for lifting'</i>

Actual Failure Load:	1.65T		
Comments:	Failed around tensioner at below the rated 2T breaking load. No specific features seen on the strap which would have predisposed this item to fail at below 2T, however it is noted to be nearly 15 years old and may have suffered age related degradation. Image below shows the failed end.

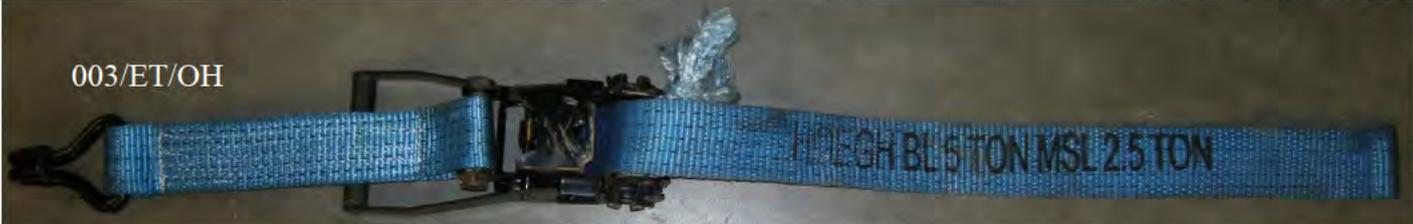
003/ET/OH

Rated Breaking Load:	2.5T SWL 5T Breaking load	Condition as received:	Both failed
Action:	Examination of failure & tensile test. Note tensile test was performed by combining the ratchet from 003 with the unfailed length of strop from 004.		
ID Markings:	'HOEGH BL 5 TON MSL 2.5 TON'

Actual Failure Load:	5.4T		
Comments:	Service failures both tensile overloads, see image below. Tensile tests resulted in a failure at ratchet at above the 5T rated breaking load. Bottom image below shows the test failure.

Service failures 003 & 004/ET/OH are both consistent with tensile overloads.

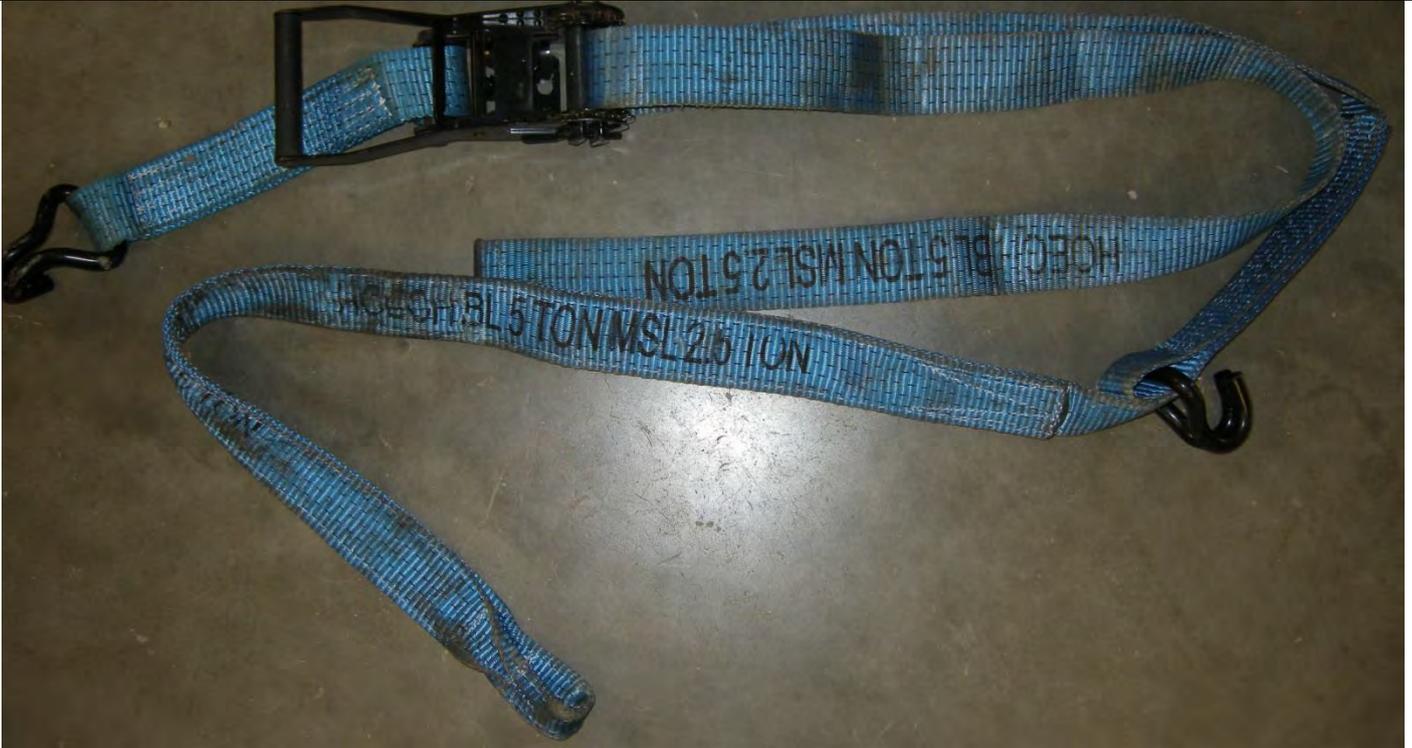
Rated Breaking Load:	2.5T SWL 5T Breaking load	Condition as received:	Used/intact
Action:	Tensile Test		
ID Markings:	<i>'HOEGH BL 5 TON MSL 2.5 TON'</i>

Actual Failure Load:	4.05T
Comments:	Tensile tests resulted in a failure at the hook at 4.05T below the 5T rated breaking load. Examination the eye of the hook did not reveal any sharp edges which could have contributed to this. Image below shows the failure.

The tensile test results for the straps are summarised below. As can be seen 005/ET/OH failed at 4.05T, which is below the 5T breaking load, despite the relatively low breaking load this is still significantly above the anticipated SWL of 2.5T.

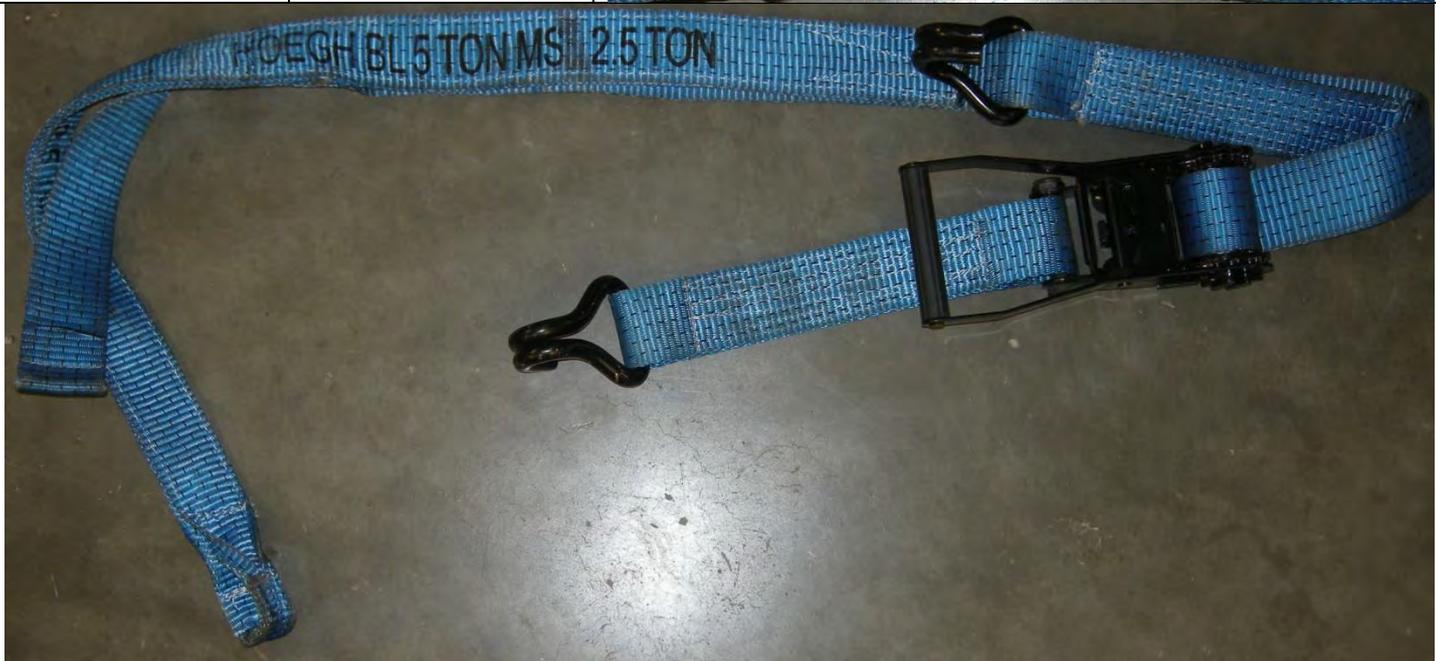
006/ET/OH

Rated Breaking Load:	2.5T SWL 5T Breaking load	Condition as received:	Unused
Action:	Tensile Test		
ID Markings:	<i>'HOEGH BL 5 TON MSL 2.5 TON'</i>

Actual Failure Load:	5.55T		
Comments:	Tensile tests resulted in a failure at the ratchet at 5.55T exceeding the 5T rated breaking load. Image below shows the failure.

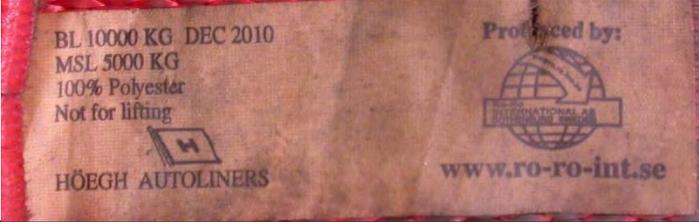
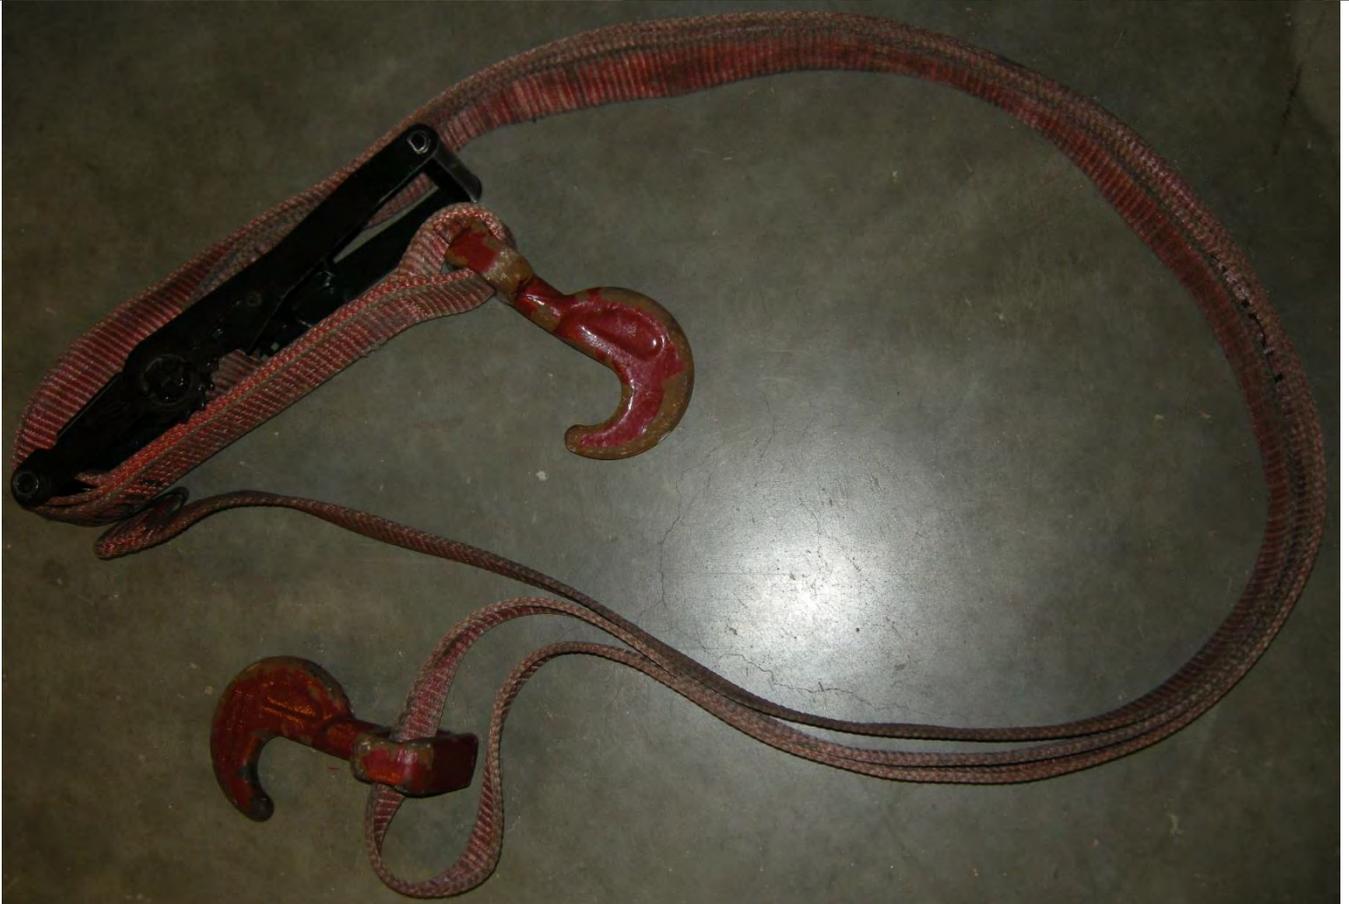
007/ET/OH

Rated Breaking Load:	5T SWL 10T Breaking load	Condition as received:	Unused
Action:	Tensile Test		
ID Markings:	<i>'BL 1000 KG DEC 2010 MSL 5000KG 100% Polyester Not for lifting'</i>

Actual Failure Load:	11.4T
Comments:	Tensile tests resulted in a failure at the hook at 11.4T exceeding the 10T rated breaking load. Image below shows the failure.

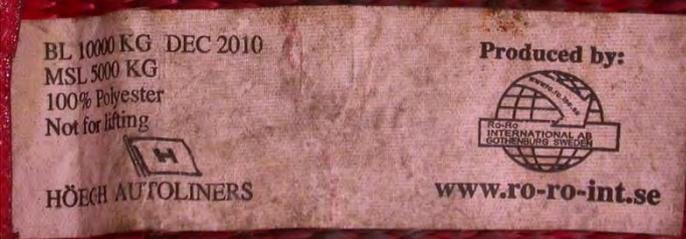
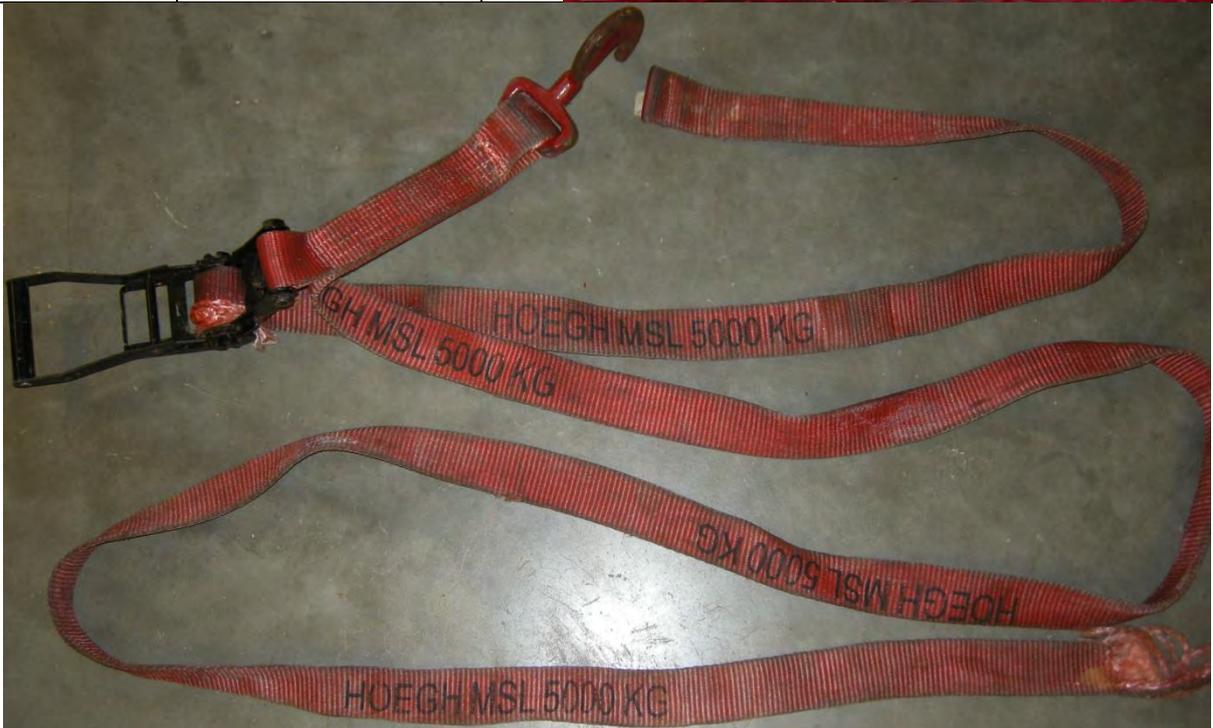
009/ET/OH

Rated Breaking Load:	5T SWL 10T Breaking load	Condition as received:	Failed
Action:	Examination of failure		
ID Markings:	<p><i>'BL 1000 KG DEC 2010 MSL 5000KG 100% Polyester Not for lifting'</i></p>

Comments:	Strop has failed adjacent to the ratchet through tensile overload, possibly where the strop has been in contact with another surface (see witness mark in image below).
------------------	---

Mode of Failure:	Tensile overload
-------------------------	------------------

Service failures 009 & 0010/ET/OH are both consistent with tensile overloads.

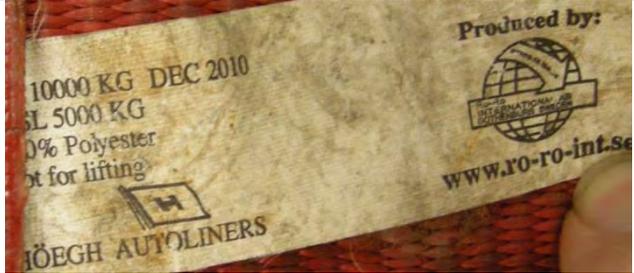
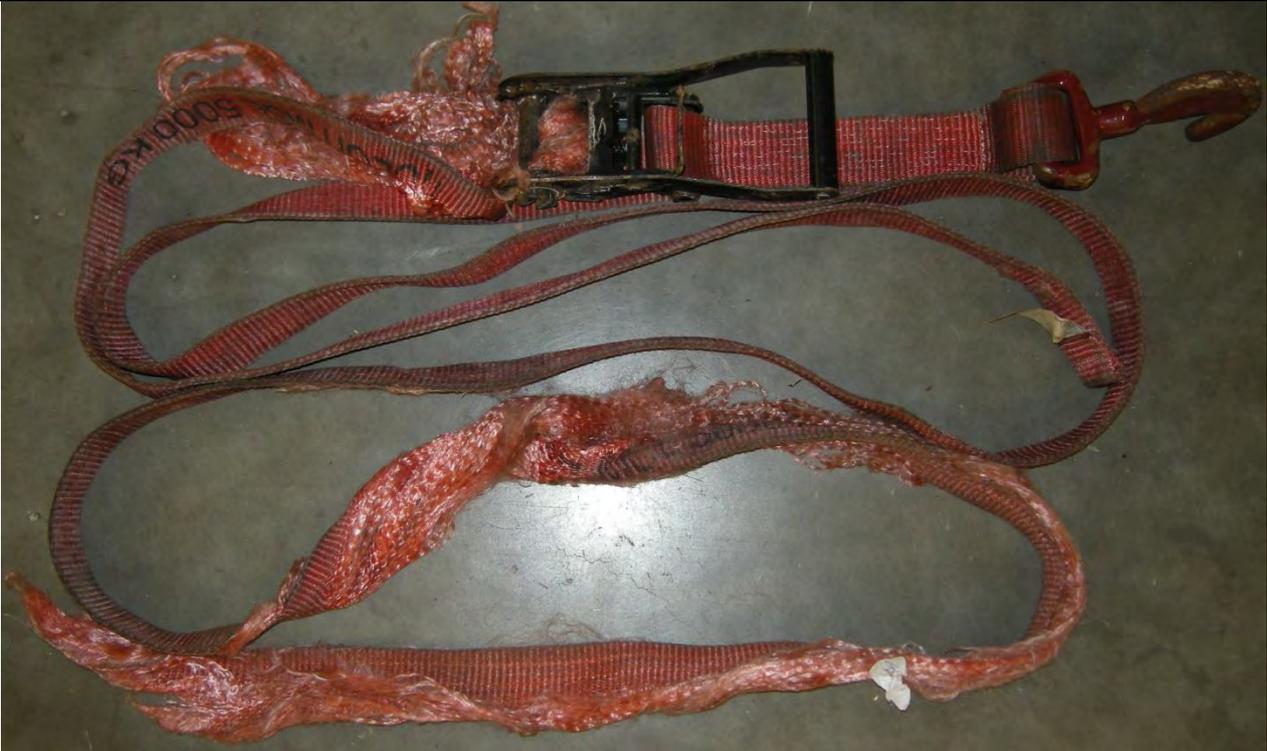
010/ET/OH

Rated Breaking Load:		5T SWL 10T Breaking load	Condition as received:	Failed
Action:		Examination of failure		
ID Markings:		<i>'BL 1000 KG DEC 2010 MSL 5000KG 100% Polyester Not for lifting'</i>

Comments:		Strap has failed adjacent to the ratchet through tensile overload, extensive damage along the strap.

Mode of Failure:		Tensile overload

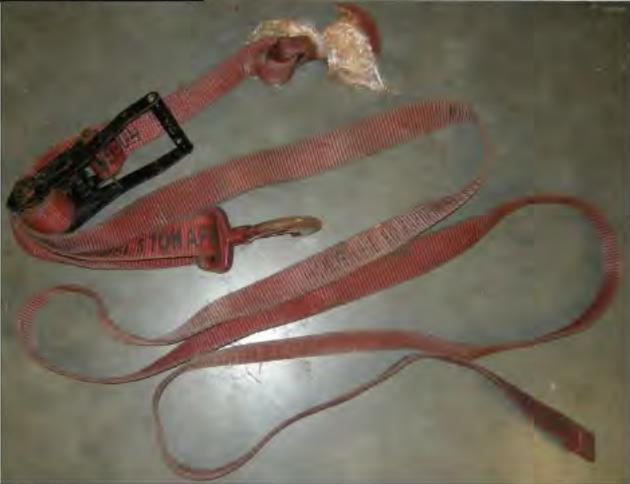
Rated Breaking Load:		5T SWL 10T Breaking load	Condition as received:	Used/intact
Action:	Failure investigation			
ID Markings:	No label, markings on strop difficult to read but say: 'HOEGH BL 10T MSL 5T APR 2009'

Actual Failure Load:	9.05T			
Comments:	Failed remote from the ratchet resulting in substantial amounts of loose fibres (see image below) at below the 10T breaking load. The strop was noted to have a number of small cuts on its surface prior to the tensile test and it is believed it failed at the one shown in the image below.

The tensile test results for the straps are summarised below. As can be seen 015/ET/OH failed at 9.05T, which is below the 10T breaking load, this is suspected to be due to a cut in the strap noted when it was assembled in the tensile tester. Despite the relatively low breaking load on this item it is still significantly above the SWL of 5T.

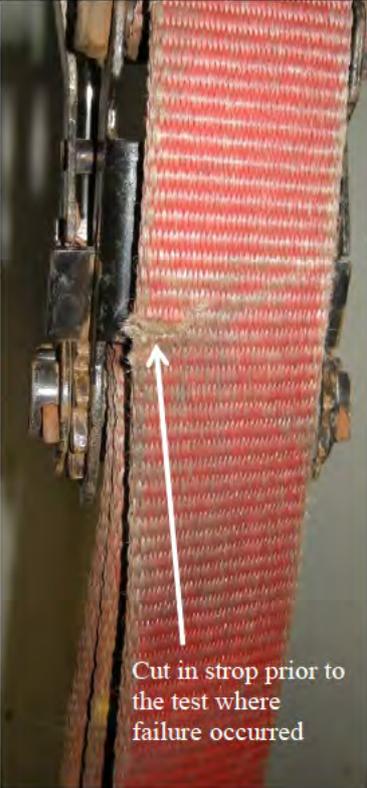
<p>Cut in strop prior to the test where failure occurred</p>

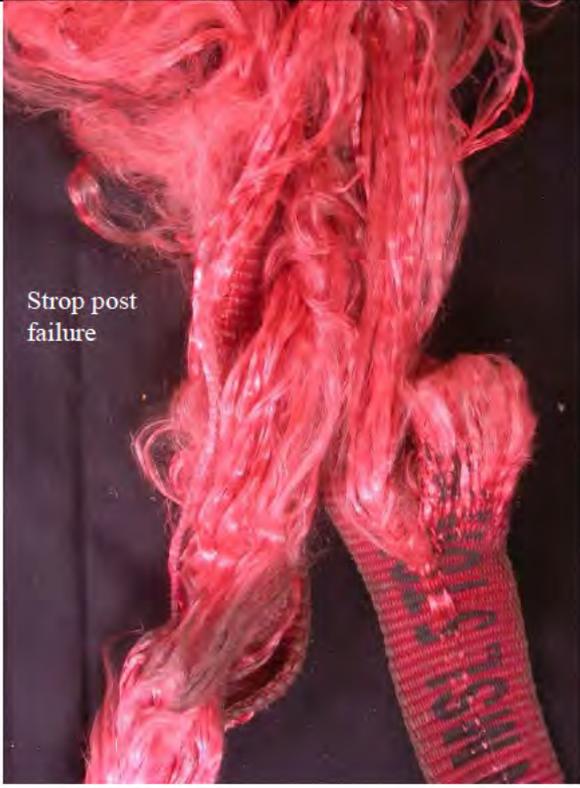
<p>Strop post failure</p>

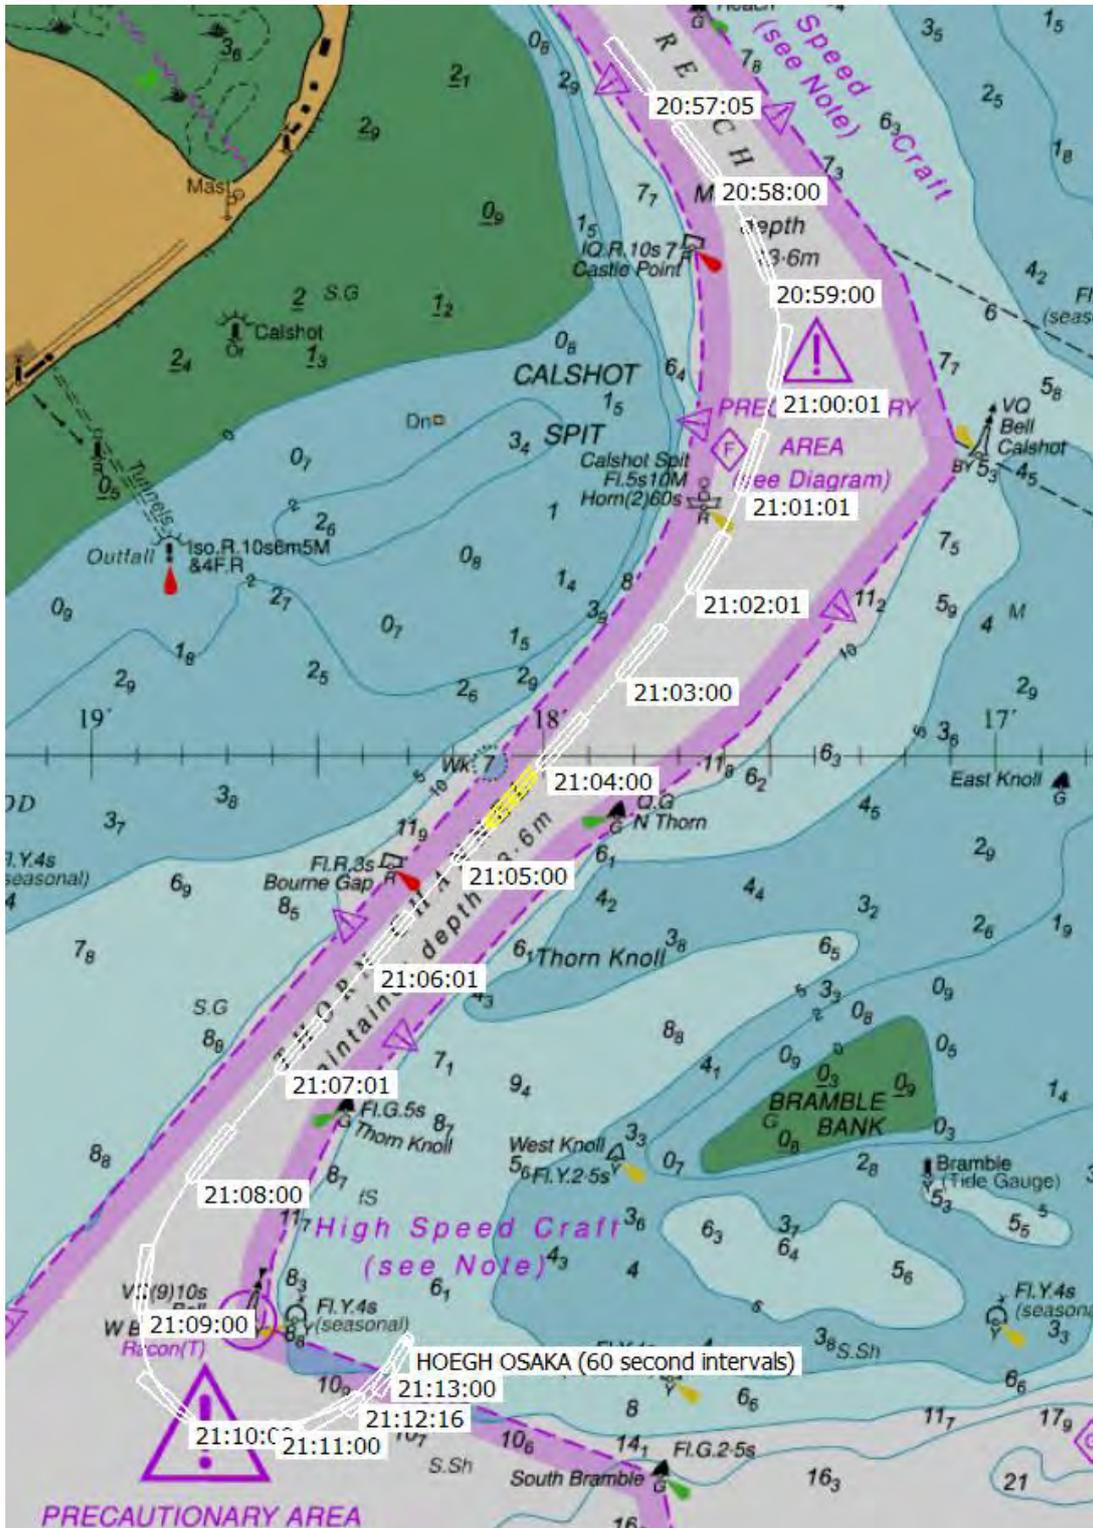
Figure 2 - Vessel positions during Calshot turn and Brambles turn at 60 second intervals

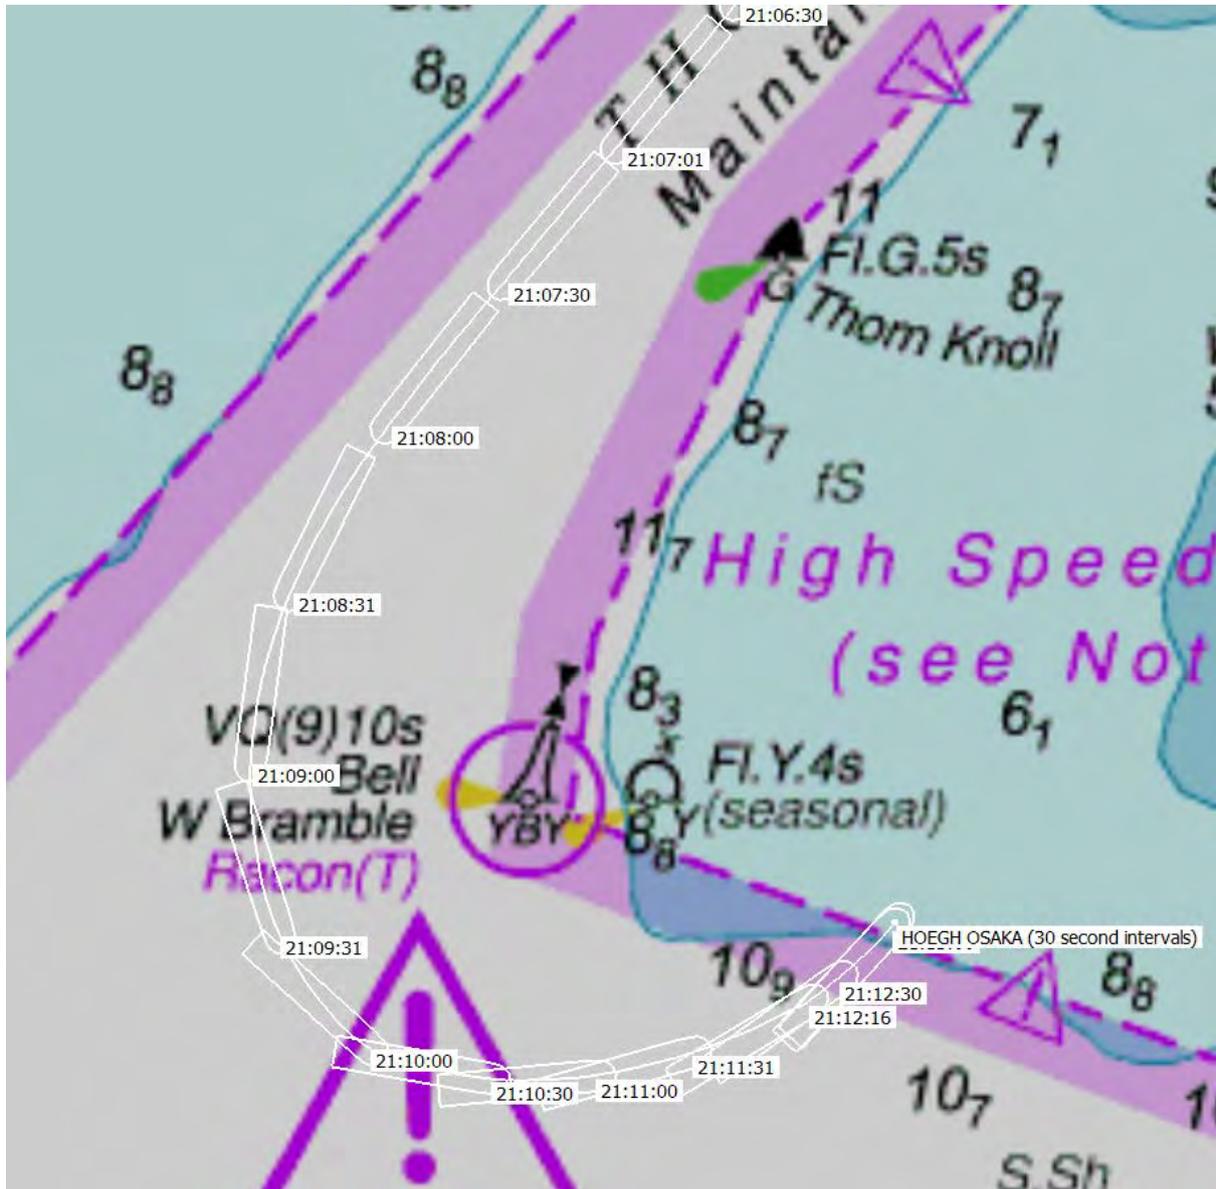
Figure 3 - Vessel positions during Brambles Turn at 30 second intervals.

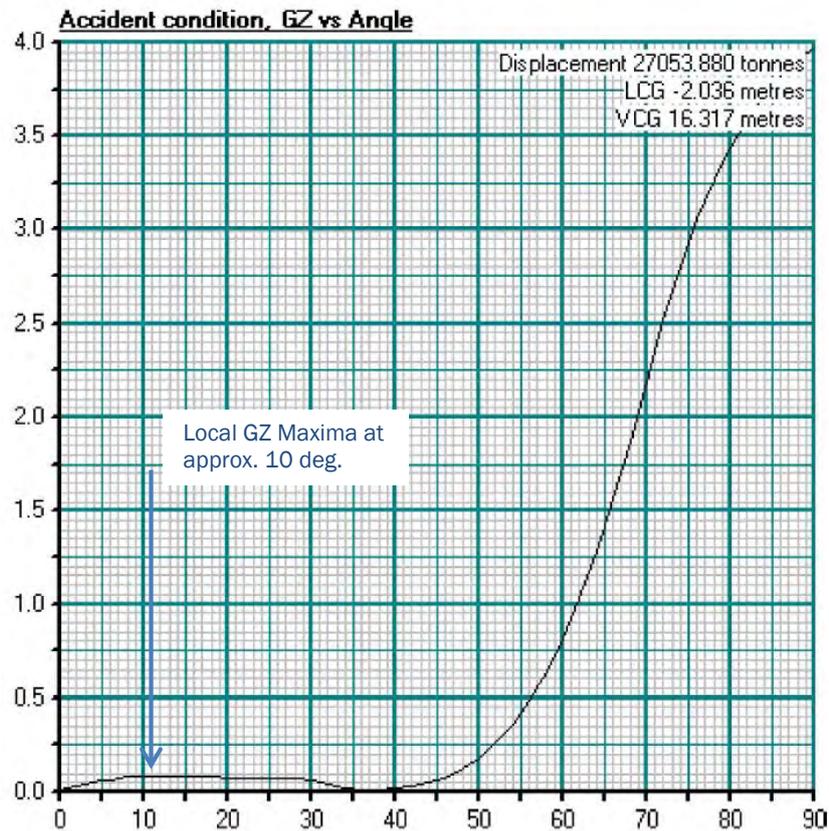
Figure 4 HOEGH OSAKA GZ curve for loading condition with GM = 0.7 metres

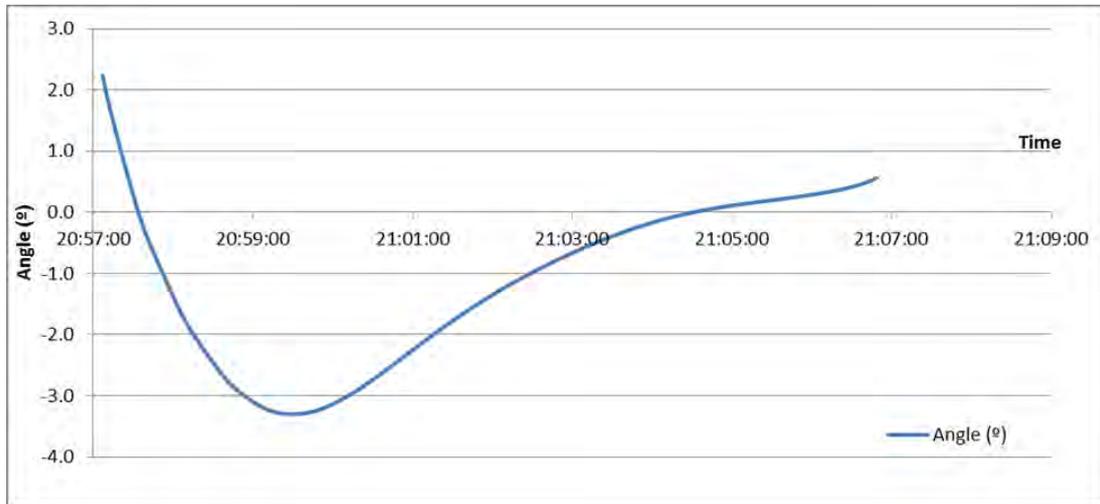
Figure 5 Heel Angles Around Calshot Turn By Quasi-Static Solution (GM 0.7 metres)

11.9 As can be seen from **Figure 5** the vessel makes the turn around Calshot Spit reaching a maximum angle to port of just over 3 degrees. This is not a large heel angle and we believe this would not have been remarked upon by the crew at the time.

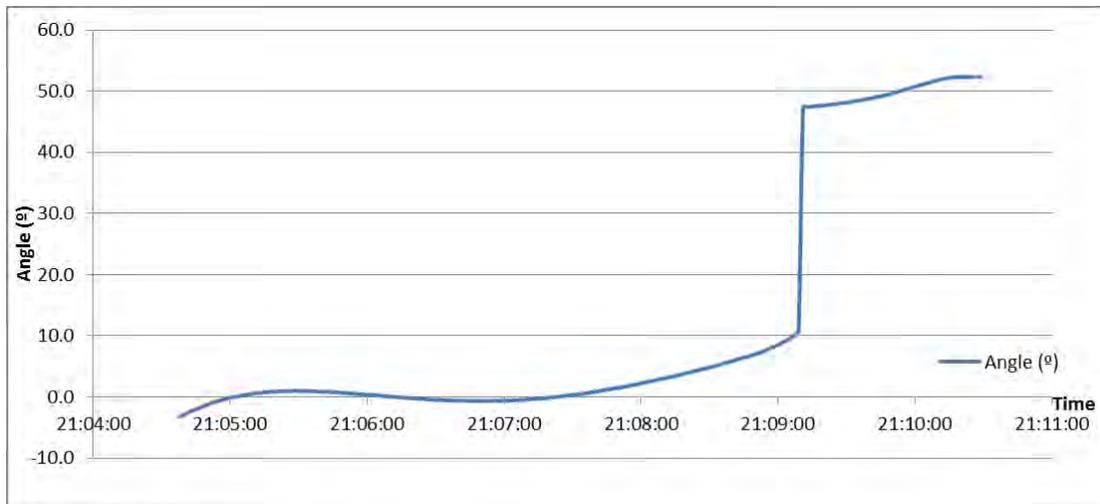
Figure 6 Heel Angles Around Brambles Turn By Quasi-Static Solution (GM 0.7 metres)

11.10 According to **Figure 6** the heel angles around Brambles Bank increased steadily to around 12 degrees before jumping to 48 degrees at around 21:09:11. After this

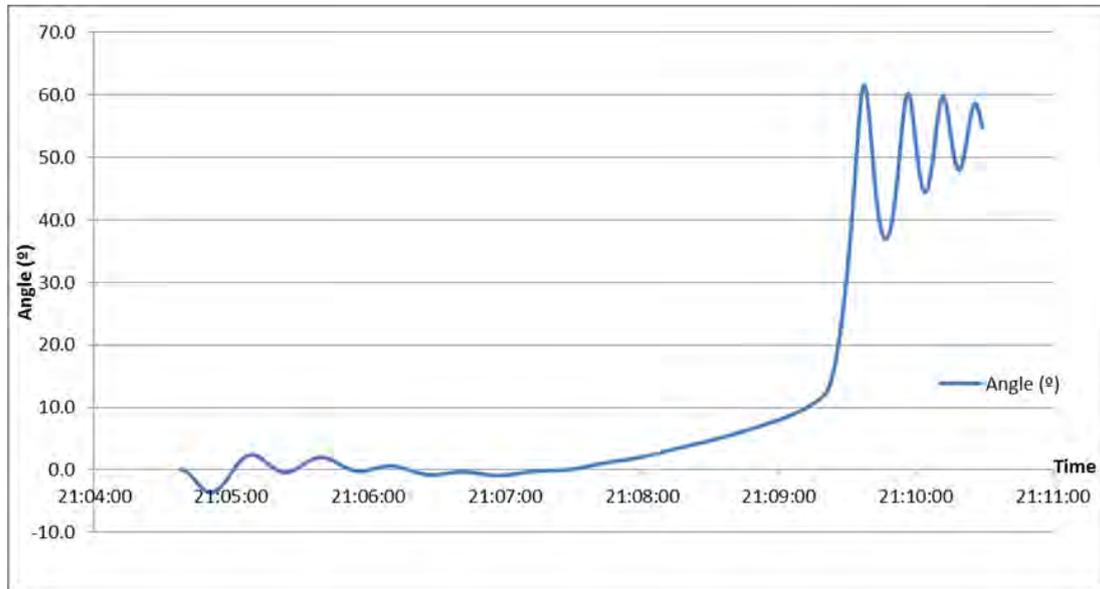
Figure 7 – Simple Dynamic Roll Model (GM 0.7 metres)

11.15 According to these results, the roll angle increases rapidly from the time when the critical angle of 10 degrees is first exceeded at 21:09:21 to a maximum of 60 degrees which occurs at 21:09:39. The roll angle then oscillates around an angle of 48 degrees.

11.16 The simple dynamic roll model predicts that the roll angle at 21:09:20 (the time the cargo is thought to have shifted at) was 12 degrees. The cargo would not have shifted at this angle. However, the heel was increasing rapidly at this time. The roll angle at 21:09:40 was calculated to be 60 degrees which is certainly high enough to cause cargo to shift. Therefore, the analysis described in this section does predict the behaviour of the vessel reasonably well although the timing of the cargo shift has not been replicated to the nearest second.

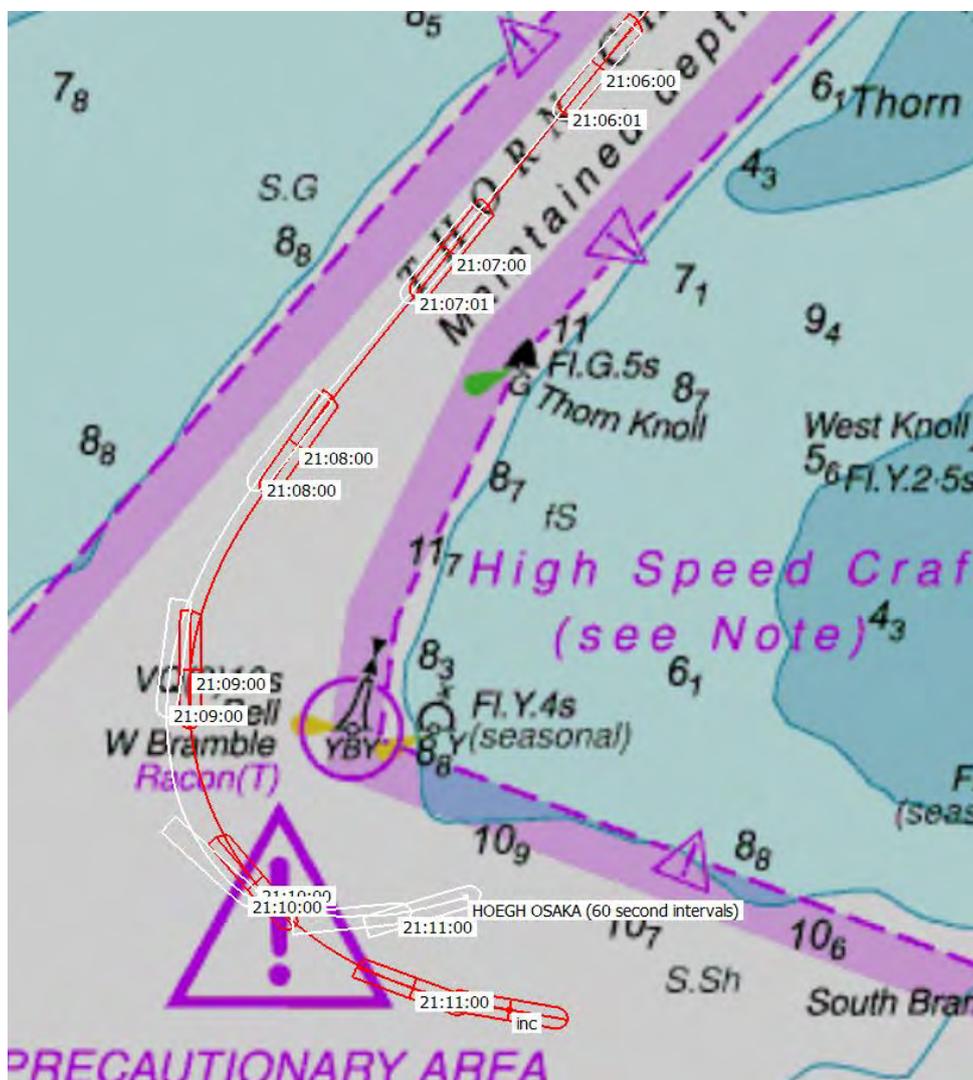
Figure 8 – Comparison of simulated trajectory and recorded trajectory.

13.6 As shown in **Figure 8**, the simulated trajectory closely matches the recorded trajectory until after 21:09:00 at which time the vessel is thought to have lost her stability (see

paragraph 11.10 to 11.11 for further discussion on this). After that time, the actual trajectory takes a much tighter turn to port.

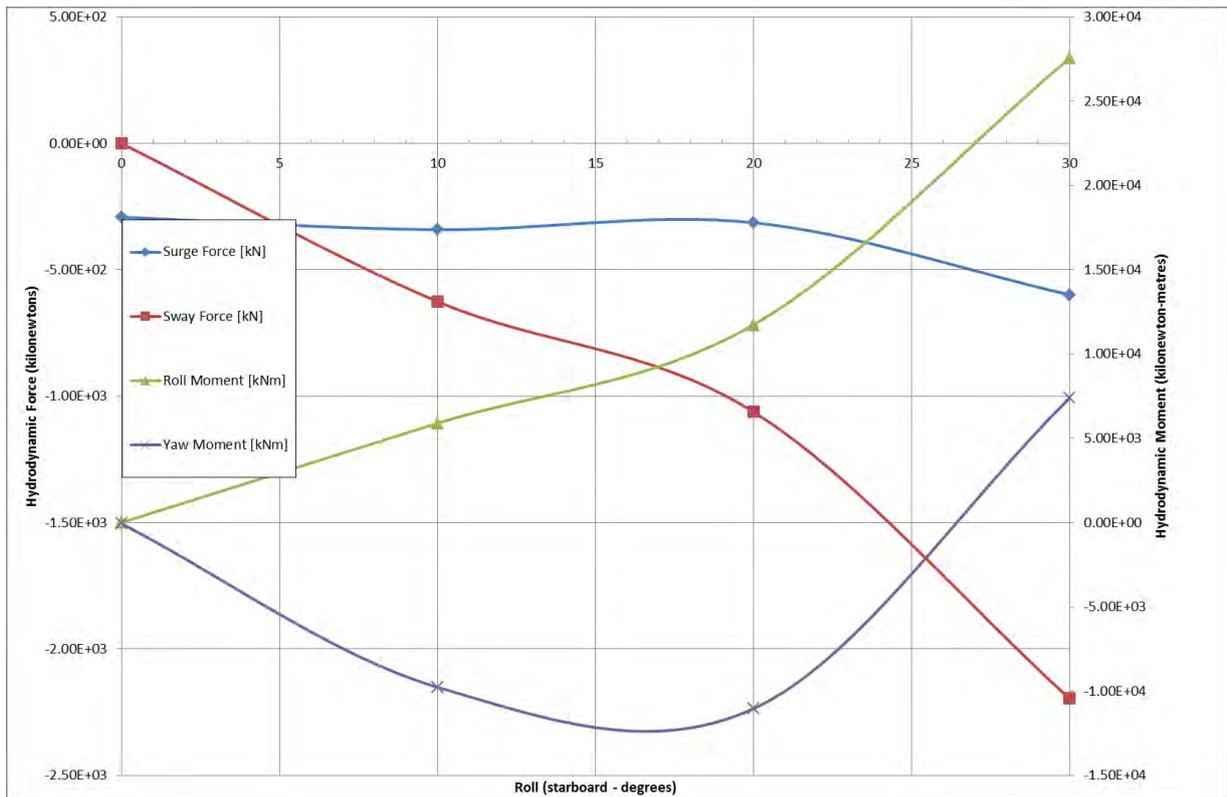
Figure 9 – Hydrodynamic forces and moments on hull for zero drift angle and 10 knots forward speed.

- 13.8 **Figure 9** below shows the variation in hydrodynamic forces for the vessel calculated by CFD (see **Appendix 10** for further details). The roll to starboard is plotted on the x-axis. According to these results a negative yaw moment (acting to turn the vessel to port) reaches a value of -11,000 kilonewton-metres at around 20 degrees and remains negative until a roll of around 27 degrees is reached. This is a significant moment and would have acted to turn the vessel to port at a larger rate than can be explained by the 20 degree port rudder applied at this time. The cause of the large yaw moment can be seen in the pressure distribution around the hull due to its large roll angle to starboard (see **Figure 10**). The asymmetry of the hull produces an area of high pressure (shown in orange) over the starboard side of the bow and another area of high pressure over the port side of the stern. These areas of high pressure act to turn the vessel to port.

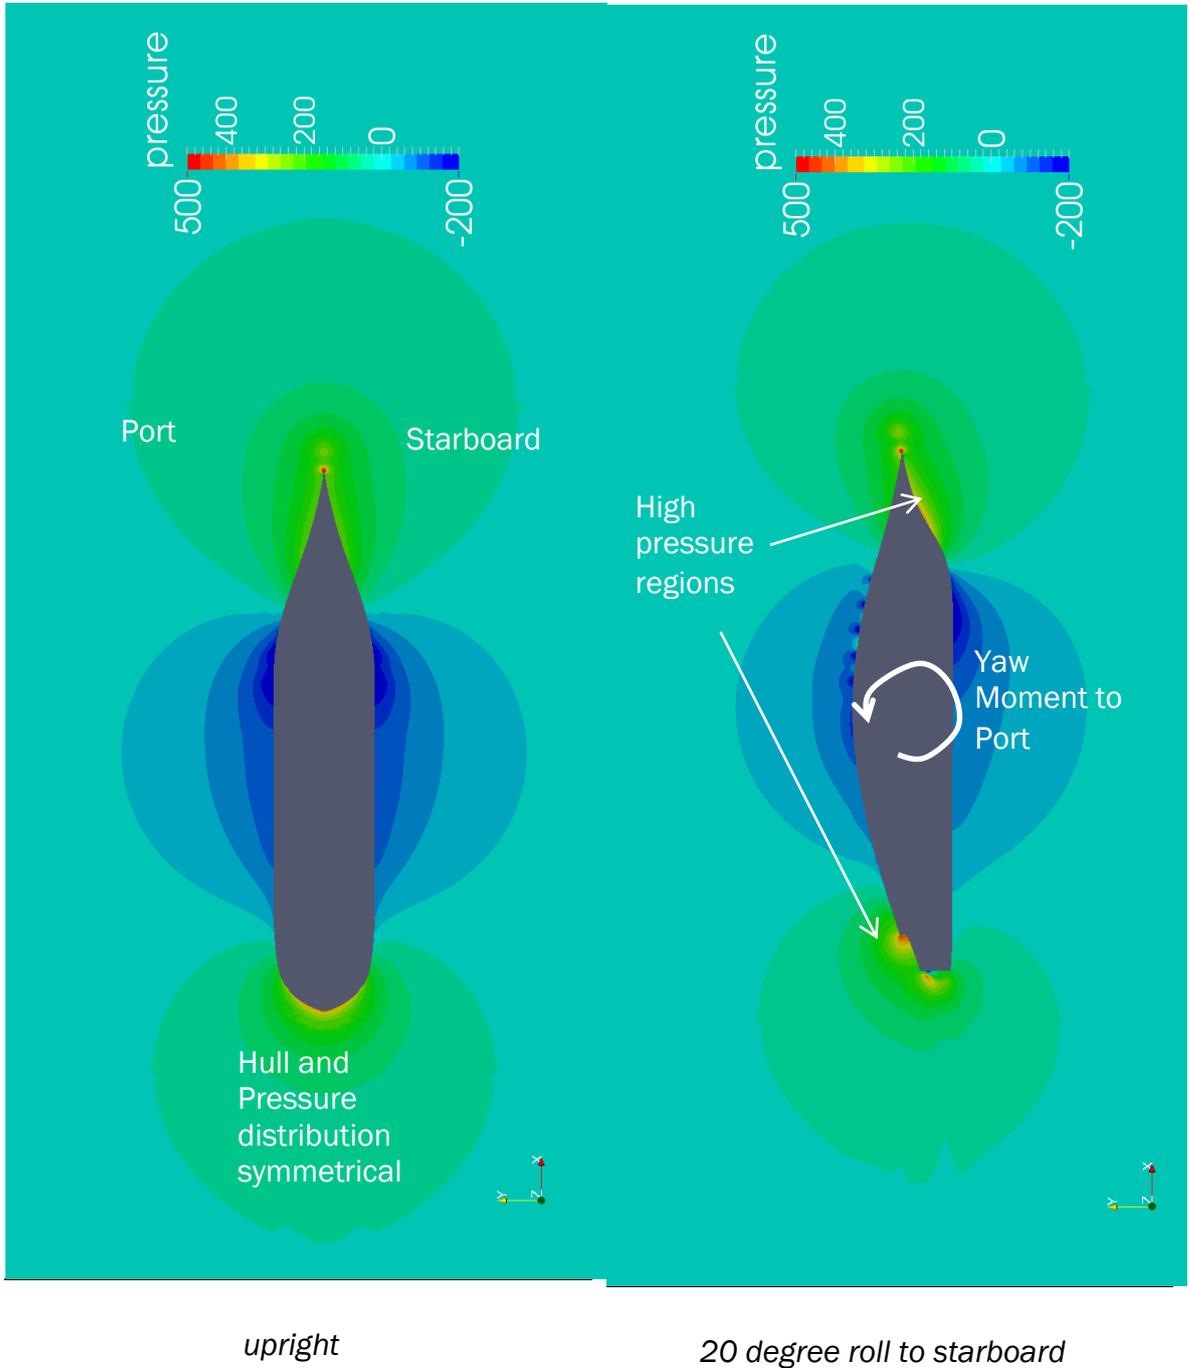
Figure 10 – Pressure Distribution over symmetry plane representing free-surface

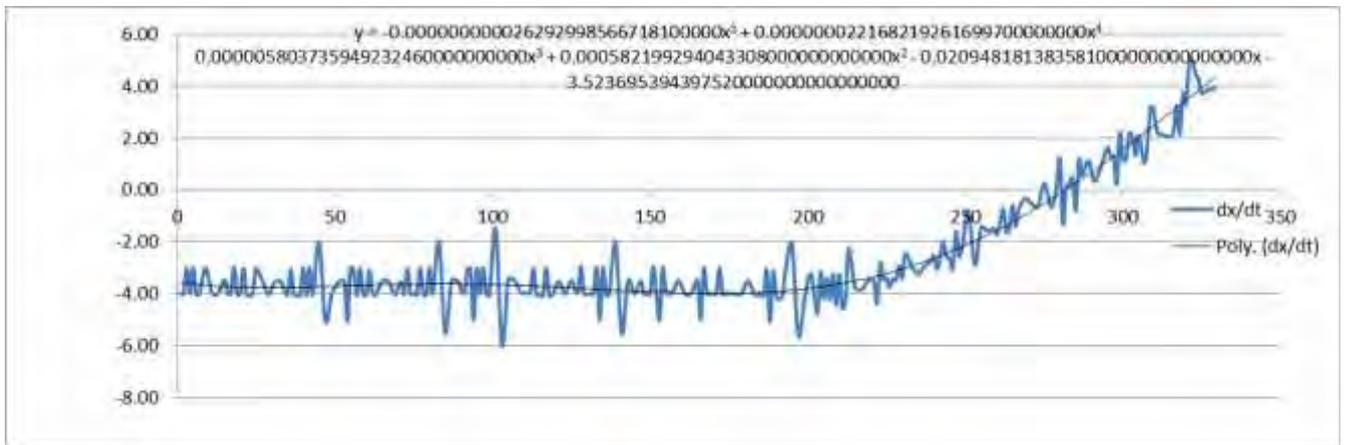
Figure A6.1 – Rate of change of Easting $\left(\frac{dx}{dt}\right)$

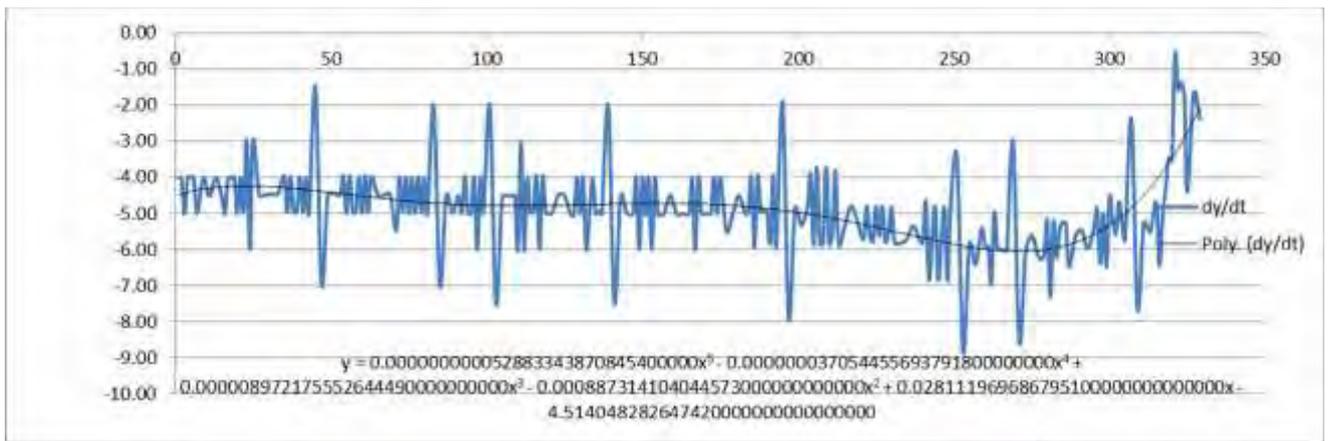
Figure A6.2 – Rate of change of Northing $\left(\frac{dy}{dt}\right)$

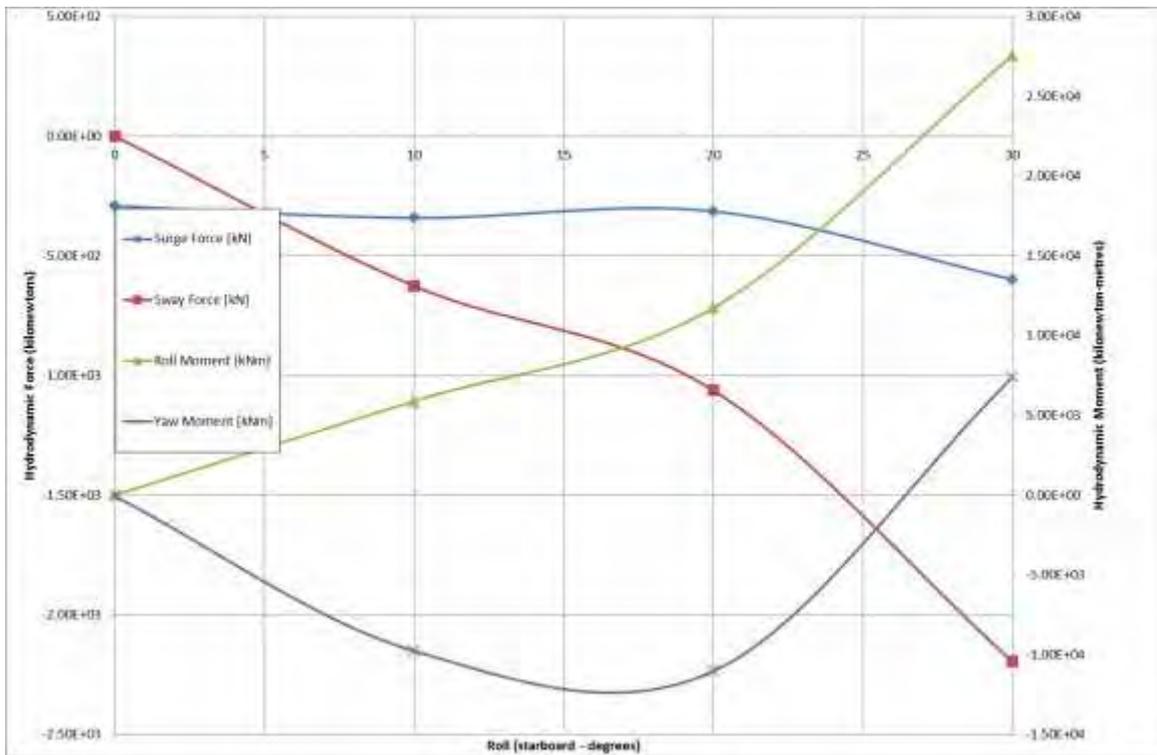
Figure A10.1 Forces and moments for 0-degree drift angle.

A10.6 A Benchmark analysis against the general purpose CFD solver FLUENT was performed for the vessel in the upright position and with a 20 degree roll angle. A comparison of results is provided in **Table A10.1** below. As can be seen in this table the differences between the two CFD software codes are minor which indicates that the figures presented in **Figure A10.1** are an accurate solution of the RANSE equations.
