Wallem safety management system completed checklists

Analysis of *Hoegh Osaka* cargo securing web lashings

Tensile Tests & Failure Analysis of 2T Lashing Straps from the Hoegh Osaka

Extract from Report: Investigation into Cargo Securing Arrangements and Simulation of Incident

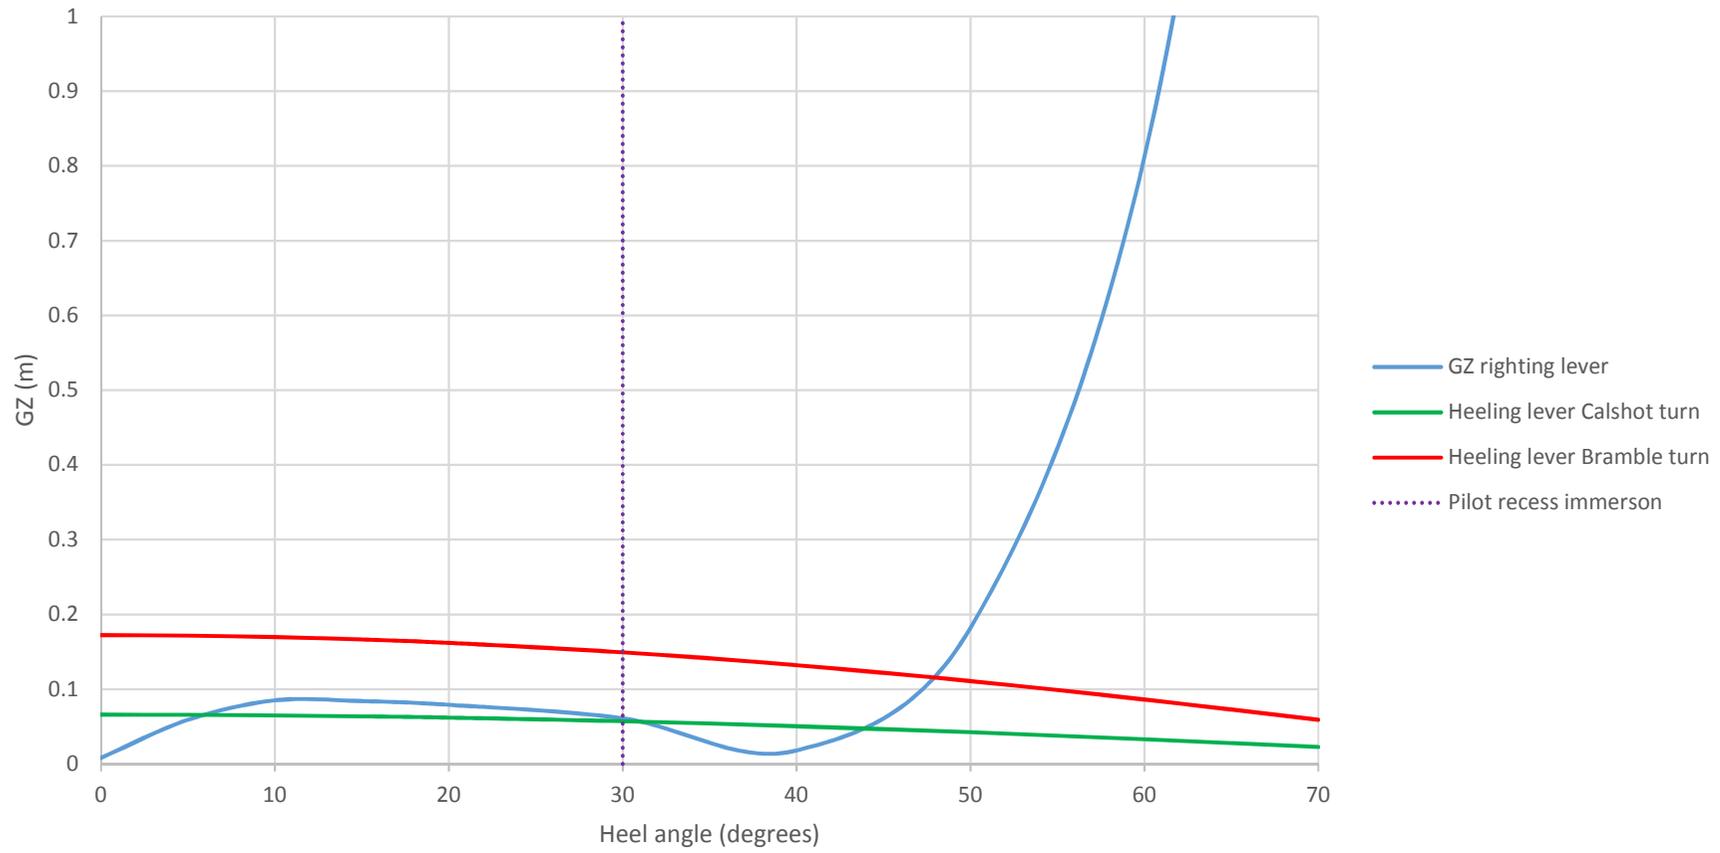
Estimated Hoegh Osaka Intact GZ Curve
