**SERIOUS INCIDENT**

<b>Aircraft Type and Registration:</b>	Boeing 747-436, G-CIVK
<b>No &amp; type of Engines:</b>	4 Rolls-Royce RB211-524G2-19 turbofan engines
<b>Year of Manufacture:</b>	1997
<b>Date &amp; Time (UTC):</b>	23 August 2008 at 2120 hrs
<b>Location:</b>	Heathrow Airport, London
<b>Type of Flight:</b>	Commercial Air Transport (Passenger)
<b>Persons on Board:</b>	Crew - 19                      Passengers - 293
<b>Injuries:</b>	Crew - None                      Passengers - None
<b>Nature of Damage:</b>	Damage to No 7 wheel bearing, hub and axle
<b>Commander's Licence:</b>	Airline Transport Pilot's Licence
<b>Commander's Age:</b>	50 years
<b>Commander's Flying Experience:</b>	8,500 hours (of which 6,000 were on type) Last 90 days - 185 hours Last 28 days - 36 hours
<b>Information Source:</b>	AAIB Field Investigation

**Synopsis**

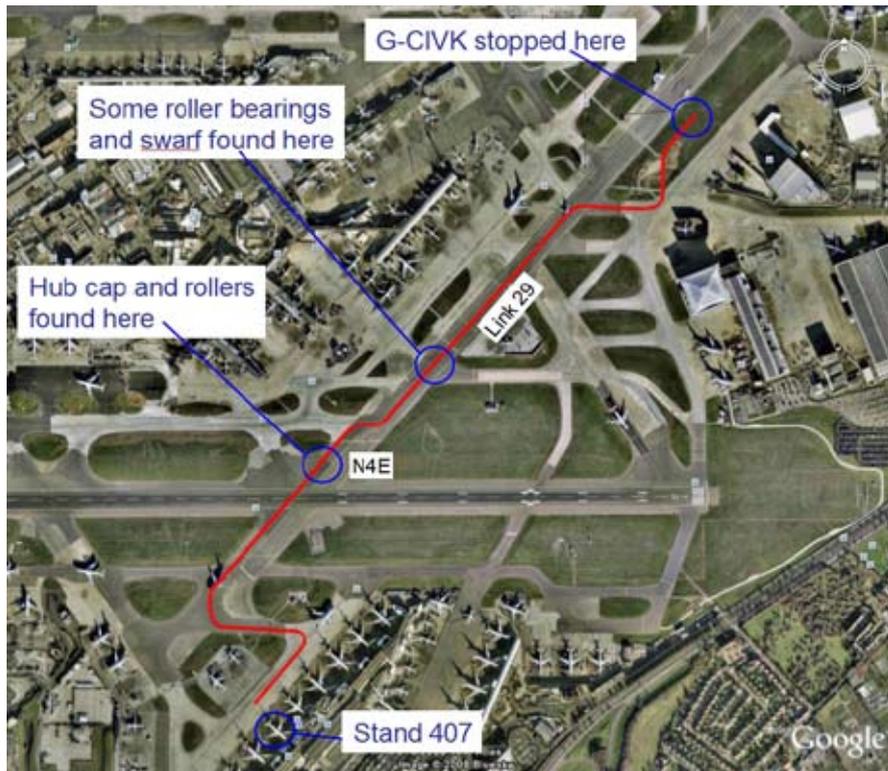
Figure 1

A ground surface inspection by the airport operator revealed that the wheel's hub cap and some bearing rollers were located just north of the N4E Runway 27 intersection, with additional roller bearings and swarf being found further along taxiway Link 29, Figure 1. These parts were collected and passed to the aircraft operator. No debris was reportedly found on

Estimated aircraft ground track based on starting position, the Flight Data Recorder heading parameter and eyewitness reports. The radii of turns are not representative. (Grass is depicted in the area that G-CIVK stopped, but a new taxiway now exists in this area.)

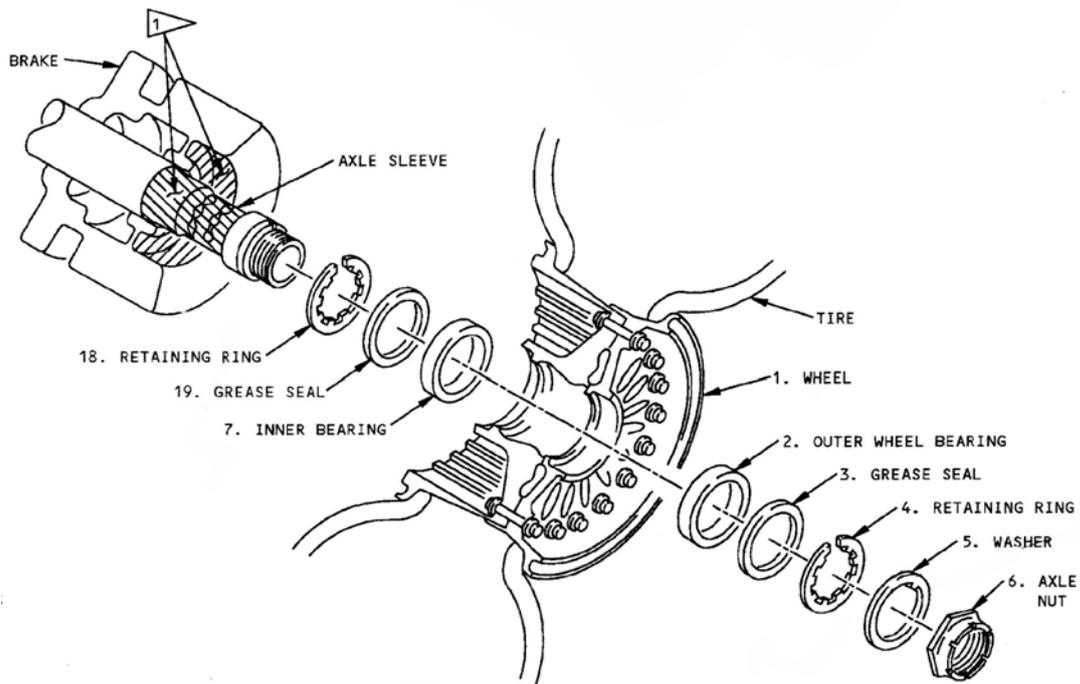
Figure 2

The main wheels on the Boeing 747-400 are mounted on the axle as shown in Figure 2. The Tyre Pressure Indication Sensor (TPIS) and hub cap are omitted from this diagram. When the wheel is delivered to the operator the bearings, grease seals and retaining rings are already installed inside the wheel. The operator slides the wheel onto the axle and then adds the washer and tightens the axle nut. Both the inner and outer bearings are tapered roller bearings and the outer race or 'cup' of each bearing is a press-fit inside the wheel hub and remains inside the hub when the tyre is replaced by a wheel maintenance organisation. The inner race and roller bearing cage or 'cone' of each bearing is removed during each tyre change, inspected and, if deemed serviceable, re-greased and re-installed in the wheel.

Boeing 747-400 main wheel bearing installation diagram

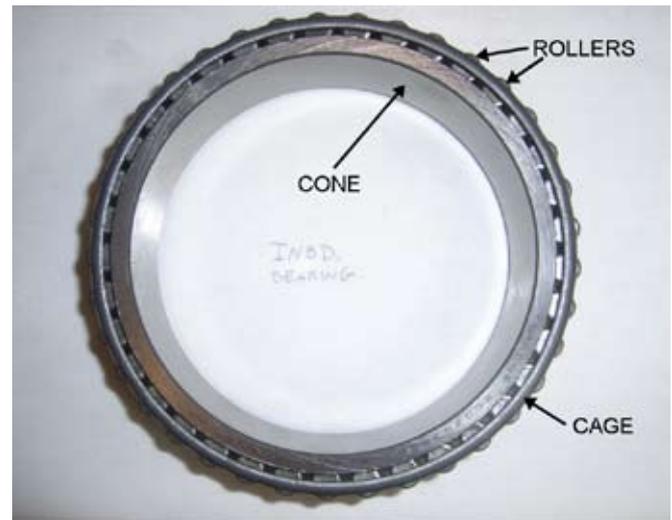
**Figure 7**

Figure 7 shows new rollers installed in their cage and fitted around the cone.

Example of a new inner bearing showing the cone, rollers and cage
