Concorde Type 1 V102, G-BOAC

AAIB Bulletin No: 6/2004	Ref: EW/C2003/06/03	Category: 1.1
INCIDENT		
Aircraft Type and Registration:	Concorde Type 1 V102, G-BOAC	
No & Type of Engines:	4 Rolls-Royce Olympus 593 turbojets	
Year of Manufacture:	1975	
Date & Time (UTC):	13 June 2003, time unknown	
Location:	Transatlantic cruise	
Type of Flight:	Public Transport (Passenger)	
Persons on Board:	Crew - 9	Passengers - 98
Injuries:	Crew - None	Passengers - None
Nature of Damage:	Fire damage in under wing area	
Commander's Licence:	Airline Transport Pilot's Licence	
Commander's Age:	55 years	
Commander's Flying Experience:	17,000 hours (of which 2,200 were on type)	
	Last 90 days - 60 hours	
	Last 28 days - 20 hours	
Information Source:	AAIB Field Investigation

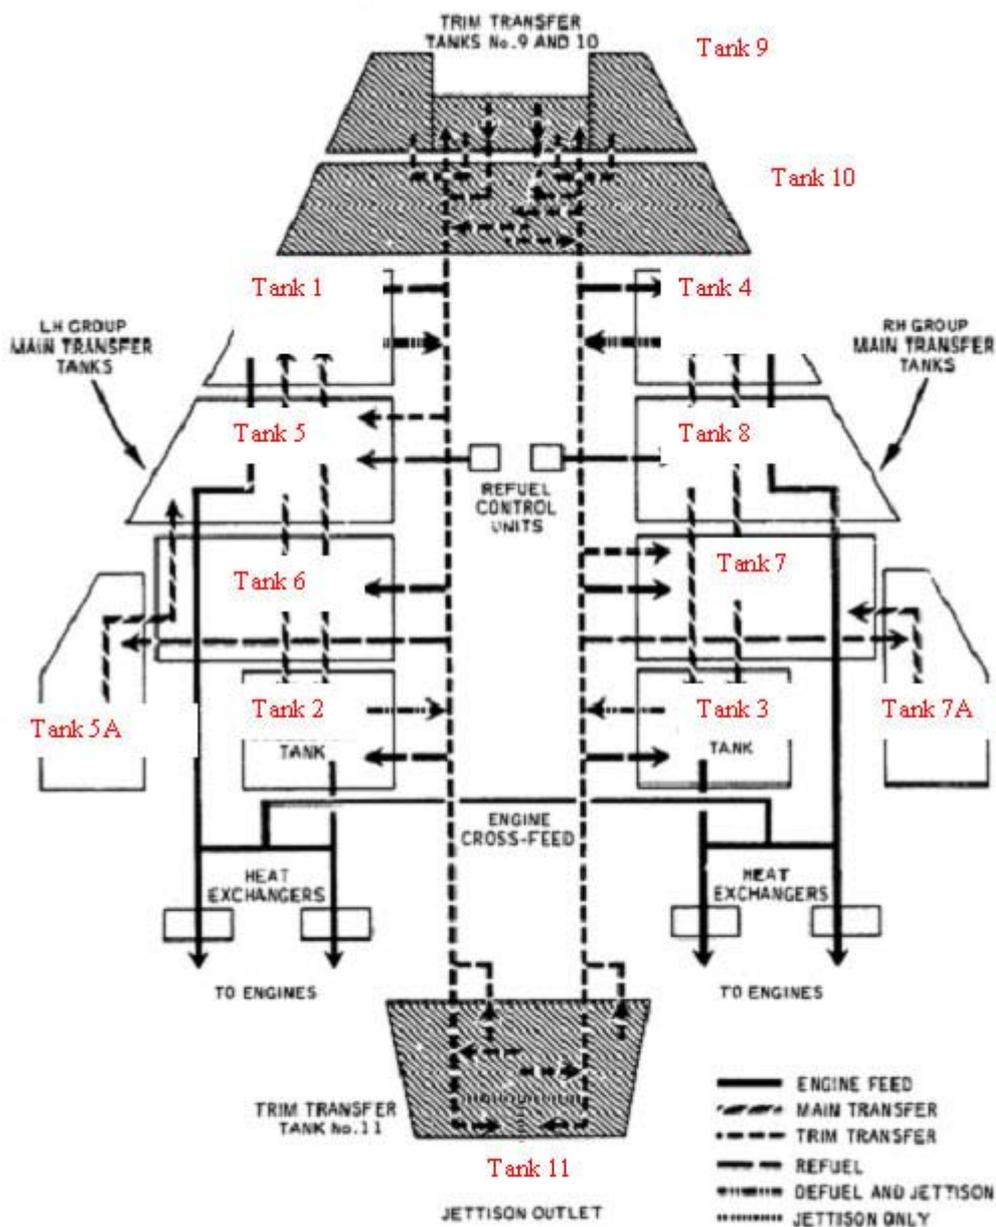
Figure 1: Fuel Tank locations

On Concorde, the fuel system has three functions; to supply fuel to the engines, to control the position of the aircraft CG and to act as a heat sink to absorb kinetic heating from the structure and to dissipate heat generated by the air-conditioning and hydraulic systems. Fuel is stored in thirteen integral tanks, as shown in Figure 1.

Tank numbers shown in red
