ACCIDENT

Aircraft Type and Registration:	Hunting Percival P56 Provost T1, G-AWVF	
No & Type of Engines:	1 Alvis Leonides 503/6A radial piston engine	
Year of Manufacture:	1955	
Date & Time (UTC):	8 July 2009 at 1334 hrs	
Location:	1.3 nm east of Bishop Norton, Lincolnshire	
Type of Flight:	Private	
Persons on Board:	Crew - 1	Passengers - None
Injuries:	Crew - 1 (Fatal)	Passengers - N/A
Nature of Damage:	Aircraft destroyed	
Commander's Licence:	Airline Transport Pilot's Licence	
Commander's Age:	74 years	
Commander's Flying Experience:	13,750 hours (of which 150 were on type) Last 90 days - 11 hours Last 28 days - 2 hours	
Information Source:	AAIB Field Investigation

Synopsis

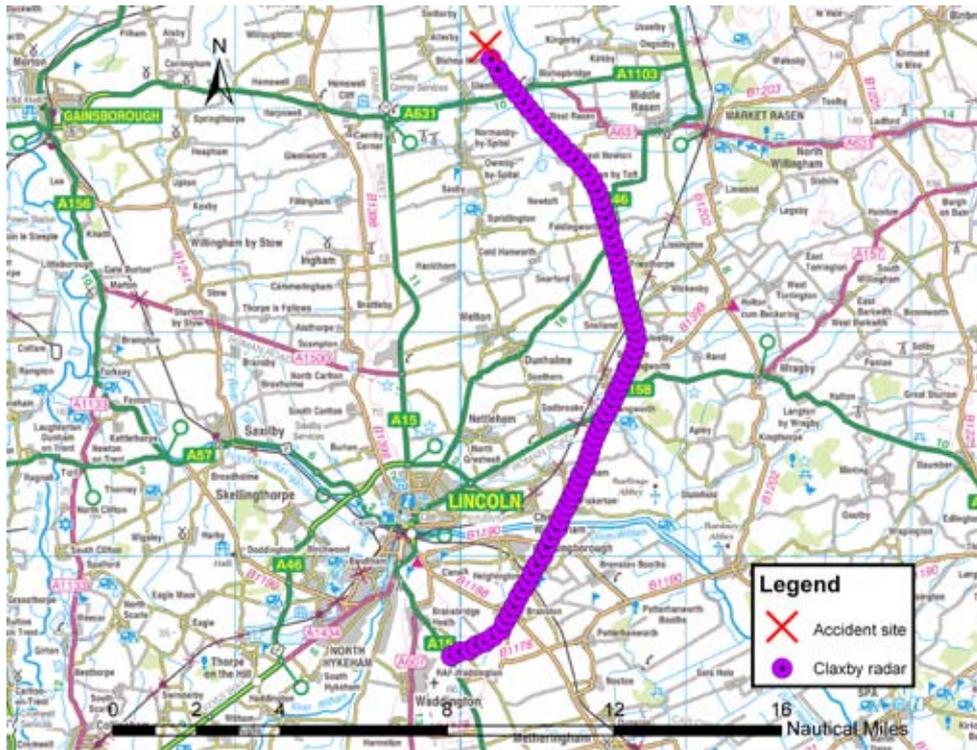
Figure 1 shows the accident track which started at 1323:34 hrs at Waddington Airfield and ended at 1333:41 hrs, approximately 0.33 nm south of the accident site. Figure 2 shows a close-up of the radar track in the vicinity of the accident site.

Radar track of G-AWVF and position of accident site

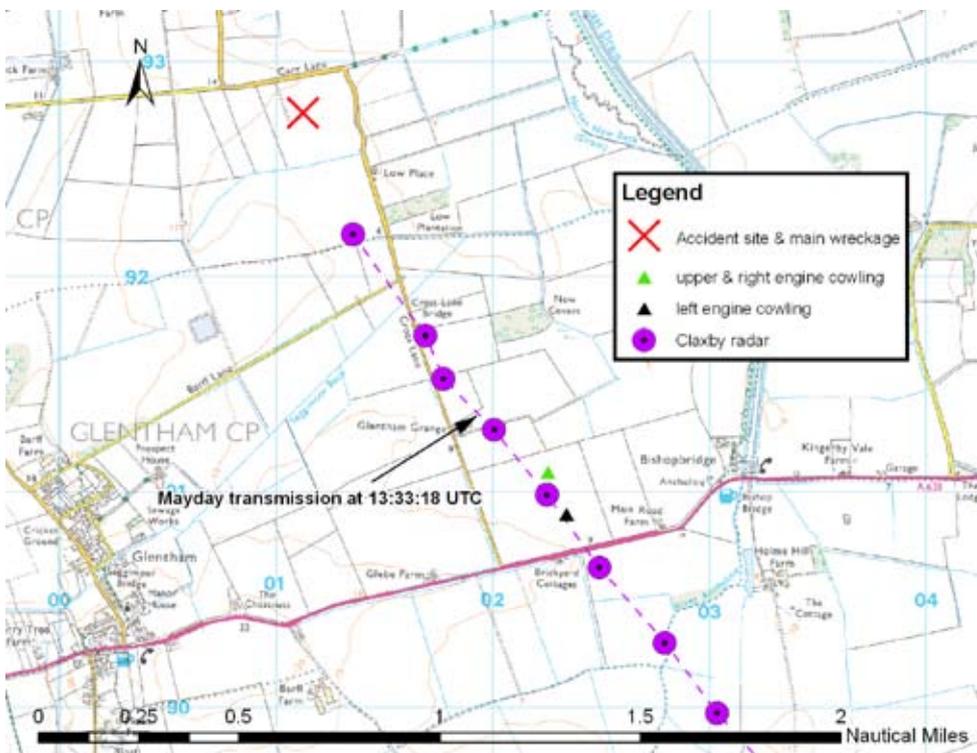
Figure 2

All major aircraft components were accounted for at the accident site, apart from the engine cowlings. The engine cowlings were found, one month after the accident, in a field 1.1 nm south-south-east of the accident site (Figure 2). The upper and right side cowlings were still attached to each other at the hinge. The left side cowling had detached at its hinge and was found 212 m south of the upper and right cowlings. The lower rear corner of the right cowling was burnt and sooted.

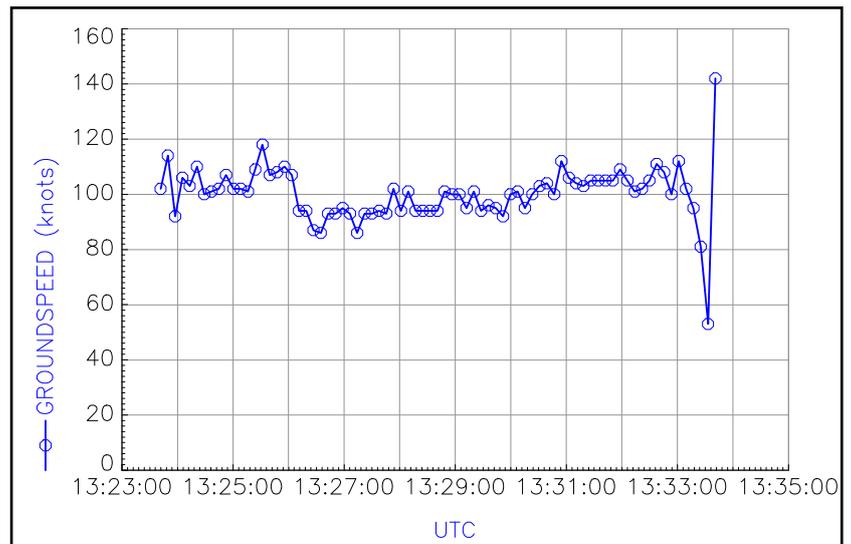
The average groundspeed between each radar point was calculated and is presented in Figure 3 (note that these groundspeeds do not have any vertical speed component). This figure shows that the groundspeed during the majority of the flight was about 100 kt. Towards the end of the flight the groundspeed started to

Accident flight calculated groundspeed from radar data

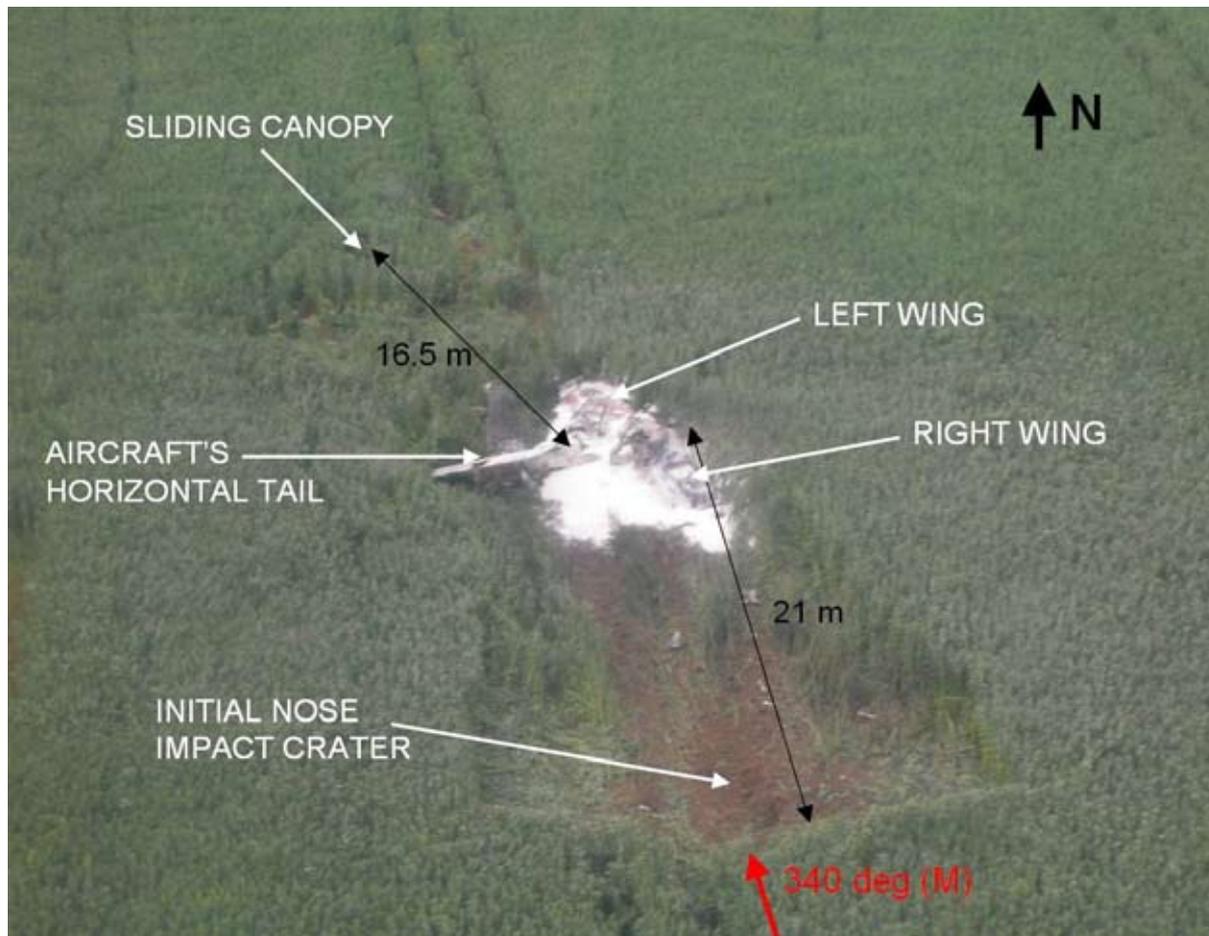
Figure 5

The aircraft had crashed in a field of tall crops about 1.3 nm east of Bishop Norton. From the initial impact point the aircraft had travelled 21 m in the direction of 340°(M) before coming to rest. The damage to the crops near the initial impact crater indicated a steep nose-down impact of approximately 35° to 40° with the wings nearly level. The aircraft's right wing had sheared near the root and its centre fuselage and cockpit area were almost completely destroyed by fire. The pilot's body had been thrown clear of the aircraft and was found 22 m beyond the main wreckage in the approximate direction of aircraft travel. The cockpit's sliding canopy was found 16.5 m north-west of the main wreckage (Figure 5).

Accident site location – the main wreckage is surrounded by white fire-retardant foam that was applied by the fire service after the accident

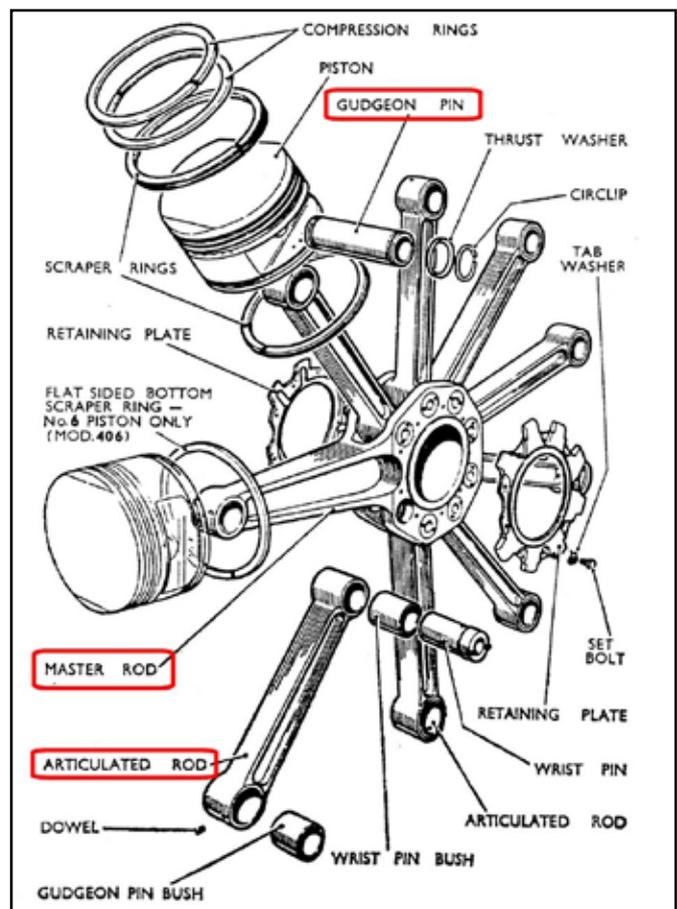
Figure 9

The Alvis Leonides 503/6A is a piston engine with nine cylinders mounted radially. The No 1 cylinder is located at the top ('12 o'clock') position, and the No 5 and No 6 cylinders are located at the bottom, either side of the 6 o'clock position. The No 6 cylinder contains the master rod (shown in Figure 9). This is the strongest connecting rod, and the other eight connecting rods, called 'articulating rods', are connected to the master rod. The crankshaft passes through the centre of the master rod which contains a plain bearing. The master rod and the eight articulating rods (the connecting rods) are connected to their respective pistons via a gudgeon pin (Figure 9). Each gudgeon pin is free to rotate within the bores of the piston bosses.

Connecting rod and piston arrangement in Alvis Leonides 503/6A radial engine

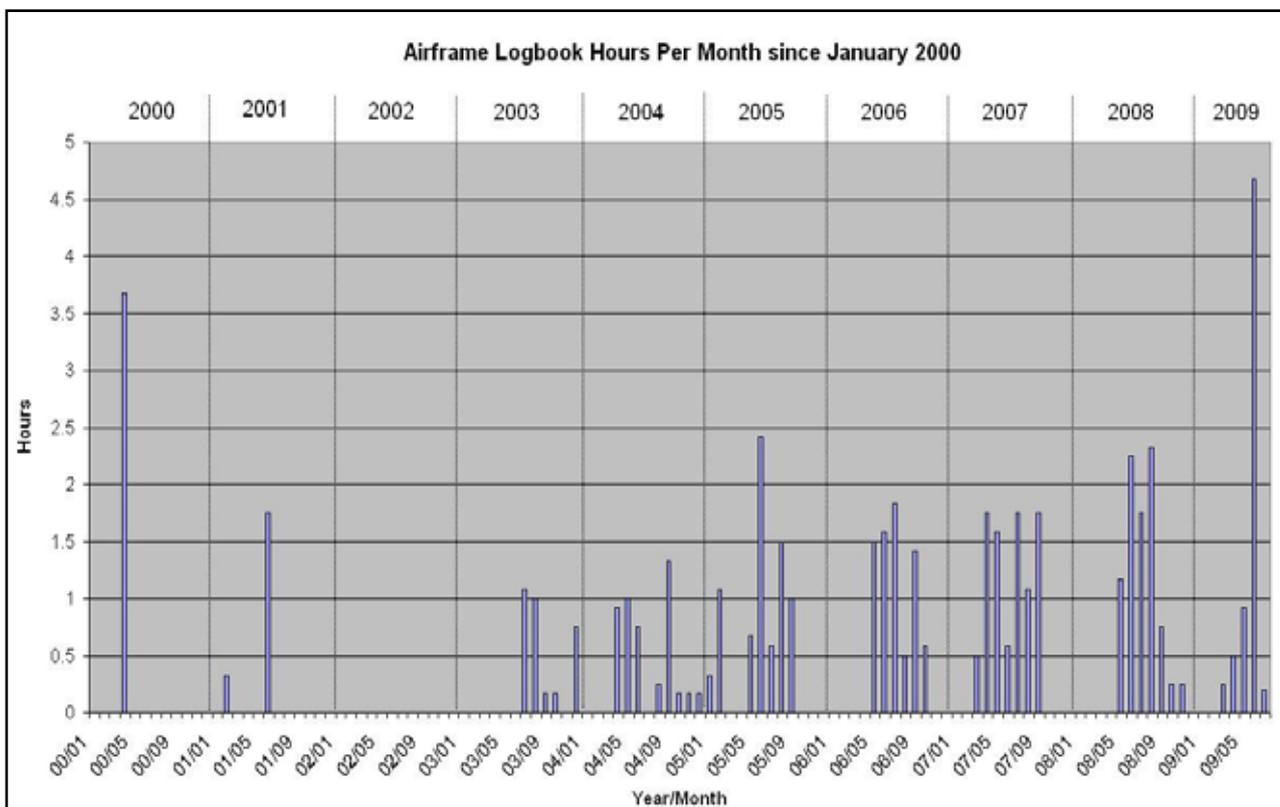
From Figure 17 it can be seen that, in the last six years, the aircraft usually flew between 0.5 hours and 2 hours each month, but did not fly during the winter months. The last extended period of no flight was between 22 November 2008 and 15 March 2009. Between 15 March 2009 and the accident date, the aircraft carried out 17 flights. Seven of these flights were 10 minutes in

G-AWVF airframe logbook hours per month between January 2000 and July 2009

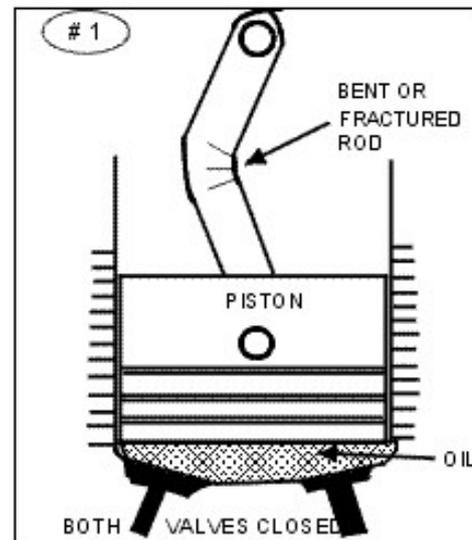
Figure 18

Hydraulic lock is a phenomenon that can occur on piston engines that have downward-pointing cylinders, that is, cylinders orientated such that the piston is moving down during the compression stroke. All radial engines have some cylinders that are pointing downwards and are, therefore, susceptible to hydraulic lock. After a radial engine has been shut down for a period, oil may drain into the combustion chambers of the lower cylinders or accumulate in the lower intake pipes, ready to be drawn into the cylinders when the engine starts. As the piston approaches top dead centre (TDC) of the compression stroke (both valves are closed at this point), the oil, being incompressible, can stop the piston movement (Figure 18). If the crankshaft continues to rotate then damage to the engine will occur – this could result in a cylinder being blown out, a bent or fractured connecting rod, or damage to the gudgeon pin. This phenomenon is known as 'hydraulic lock'. A partial hydraulic lock can also occur when liquid is inside the combustion chamber, but is not sufficient to fill the space between the cylinder head and the piston when it is at TDC. In this situation, the air gap is still reduced and, therefore, the pressure rise within the cylinder can still be sufficient to stop the piston or to result in damage if the piston is forced through TDC during engine start. Damage resulting from a

partial hydraulic lock can be more serious as it could go undetected during the engine start, and then result in failure at some later time in flight.

Diagram showing the possible effect of hydraulic lock on a piston connecting rod
